Environmental Monitoring and Conservation Study of Drayton Hall in Charleston, South Carolina

MICHAEL J. MILLS and GEORGE FORE

Beset by the deterioration of architectural fabric at one of America's great historic houses, the National Trust completed an environmental monitoring and conservation study to serve as the basis for future treatment of the building.

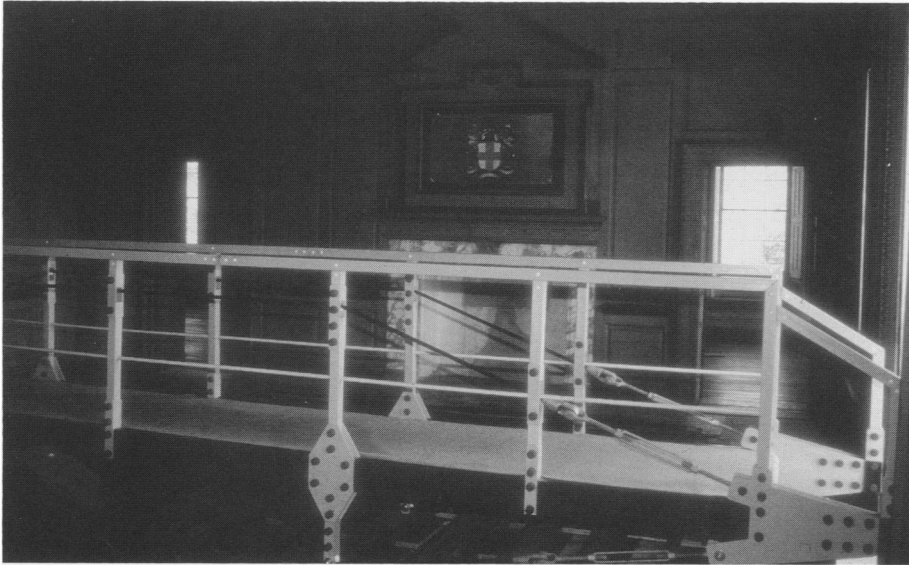
Fig. 2. Temporary suspension bridge in the room over the Great Hall to remove visitor live load from the ceiling.

- We addressed the possibility that the pedestrian bridge was causing excessive deflections of the arch at the rear of the Great Hall. We ran an experiment by loading the bridge with different-sized tour groups and logging the crack monitor readings every second. The magnitude of the displacement, while observable, was less than that due to other causes, such as temperature. It therefore does not seem as though the bridge was causing undue stress to the building.

- Stabilize the three unkeyed plaster panels that were discovered during the study.
- Reduce the deflection of the floor by stiffening two joists against the stair wall and creating a “stress-skin” system. This system would utilize plywood and screw anchors to create what are essentially “T” beams at the perimeter wall. This design will allow the original floorboards to be reinstalled in their original locations.

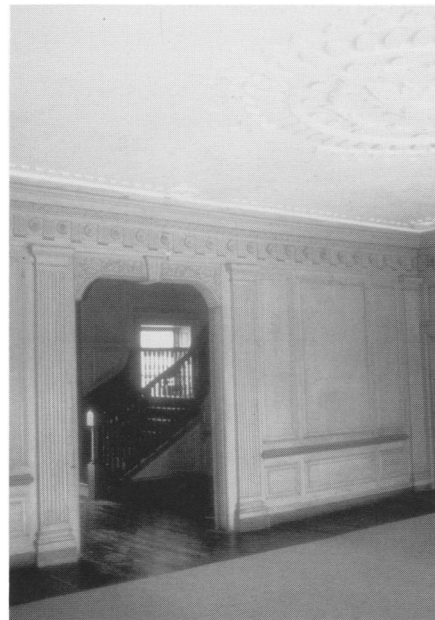
Fig. 3. The Great Hall looking north toward the archway to the stair hall.

quantity of loss decreased at higher elevations. The rooms with the most loss are the dining room and an adjoining space on the northwest side of the building. Virtually none of the painted surfaces appeared to be a continuous film. Conditions included losses following the wood grain, crazing, cracking, and losses of alligatored paint (Fig. 3).

Great Hall ceiling. The cracks in the plaster were extensive and were on regular and rectilinear patterns. Also, voids between plaster and lath could be detected by tapping softly on the surface. We had concerns that while the temporary bridge was removing live load from the ceiling, it might be concentrating loads over the arch to the stair hall (Fig. 3).

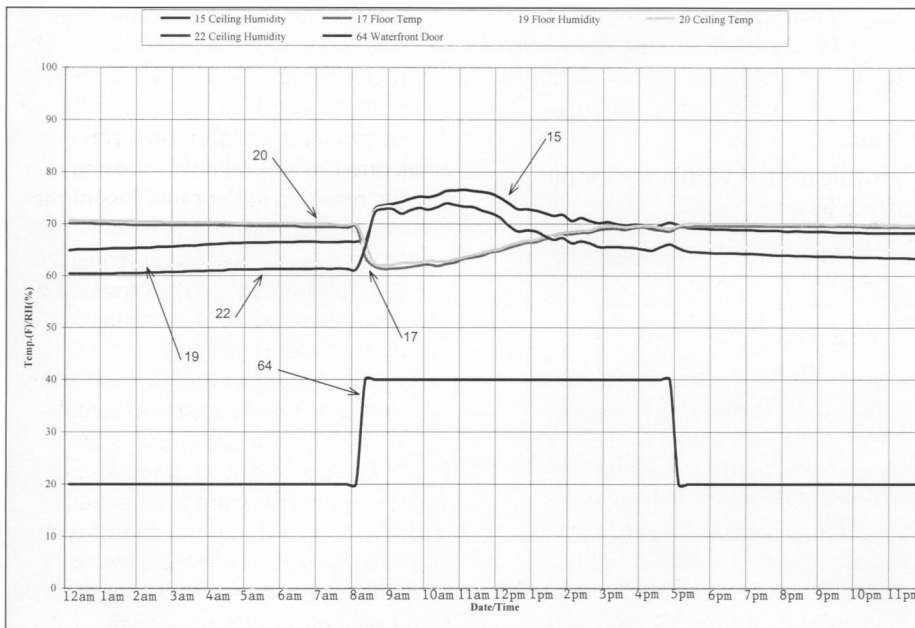
Fig. 5. Temperature and relative humidity plotted on a typical day in October against the opening and closing of the main door (Point number 64).

see that the temperature dropped and that the humidity immediately rose, which documented the cool, moist morning conditions on a given day. The building then returned to nearly the same interior temperature and humidity conditions by the next day (Fig. 5). In

- control the opening of doors on days where condensation could occur. On those days visitors may enter through the basement rather than at the first floor.
- provide natural ventilation for the damp basement area.
- provide ultraviolet shading of windows by some means: reinstallation of the nineteenth-century interior shutters, installation of ultraviolet film or storm panels, or addition of roll-down, fabric screens.
- prepare a detailed topographical map of the site around the building to document all drainage patterns. Regrade as necessary to promote better run-off. Repoint open masonry joints with the hydrated hydraulic lime mortar specified in the report.

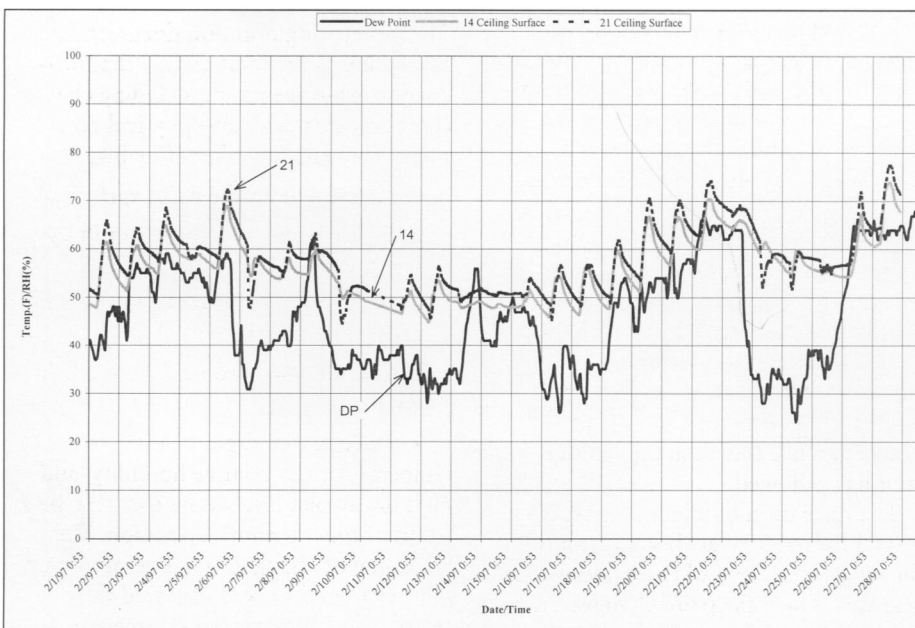
Fig. 6. Comparison of selected surface temperatures and outdoor dew points showing several instances of possible condensation.

Another principal conclusion was the fact that condensation events were occurring in the house during the course of the year. Typically, these occurred in the winter when the building surfaces were cool, the air was moist and warmer, and the doors were thrown open in the morning, as is the custom. The vapor in the warmer air would then condense as liquid on the cool surfaces. An early warning of these conditions is found by examining available weather data. If the ambient dry-bulb temperature of the air is close to the dew point, condensation can easily develop. Thus, cool outdoor overnight temperatures and high relative humidity may lead to possible condensation.

The indoor conditions on February 8, 1997, for instance, were conducive to condensation. The temperature remained low and fairly constant, while the relative-humidity spikes were very high. Condensation occurs when the surface temperature is lower than the dew-point temperature. We compared surface temperatures and outdoor dew points on this graph and discovered that the surface temperature was lower in several instances. Note that this graph shows condensation occurrence on February 8 and on other days in February as well (Fig. 6).

There were seventeen hours of possible condensation at Drayton Hall during the monitoring year, typically occurring during the winter when cool conditions were becoming warmer and more humid. That seemed to us to hold the possibility for a great deal of condensation damage. The year monitored was both cooler and drier than a typical weather year in Charleston, according to data from the weather service. Therefore, there is potential for even more condensation during more-typical years.

- continue the monitoring of temperature and humidity to ascertain when conditions are favorable to condensation.

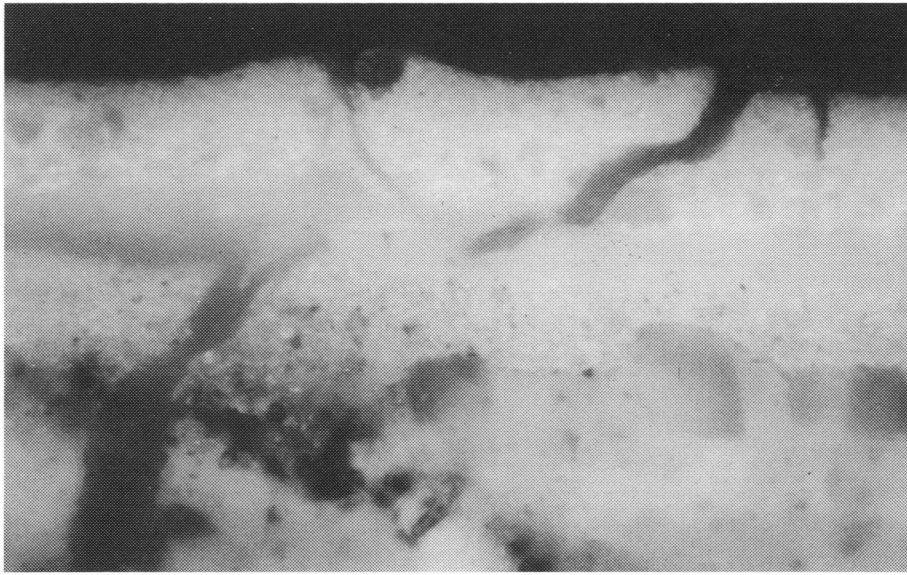
The development of surface fractures can be seen in the dining-room samples viewed with a fluorescent microscope. The cracks are widest at the exposed surface and, as the paint loses volume through oxidation, the fracture extends down through the underlying layers of paint. The pattern of paint loss on the wood is an effect produced by the differential movement between the paint film and the wood substrate as each material responds to changes in relative humidity. Both the paint and wood are hygroscopic and will absorb or lose moisture until each is in equilibrium with the moisture content of the air. As the paint film oxidizes, it shrinks and becomes less flexible, magnifying the stress between the wood and paint and accelerating the paint loss (Fig. 7).

Fig. 7. Photomicrograph showing fractures in the paint film that lead to paint loss.

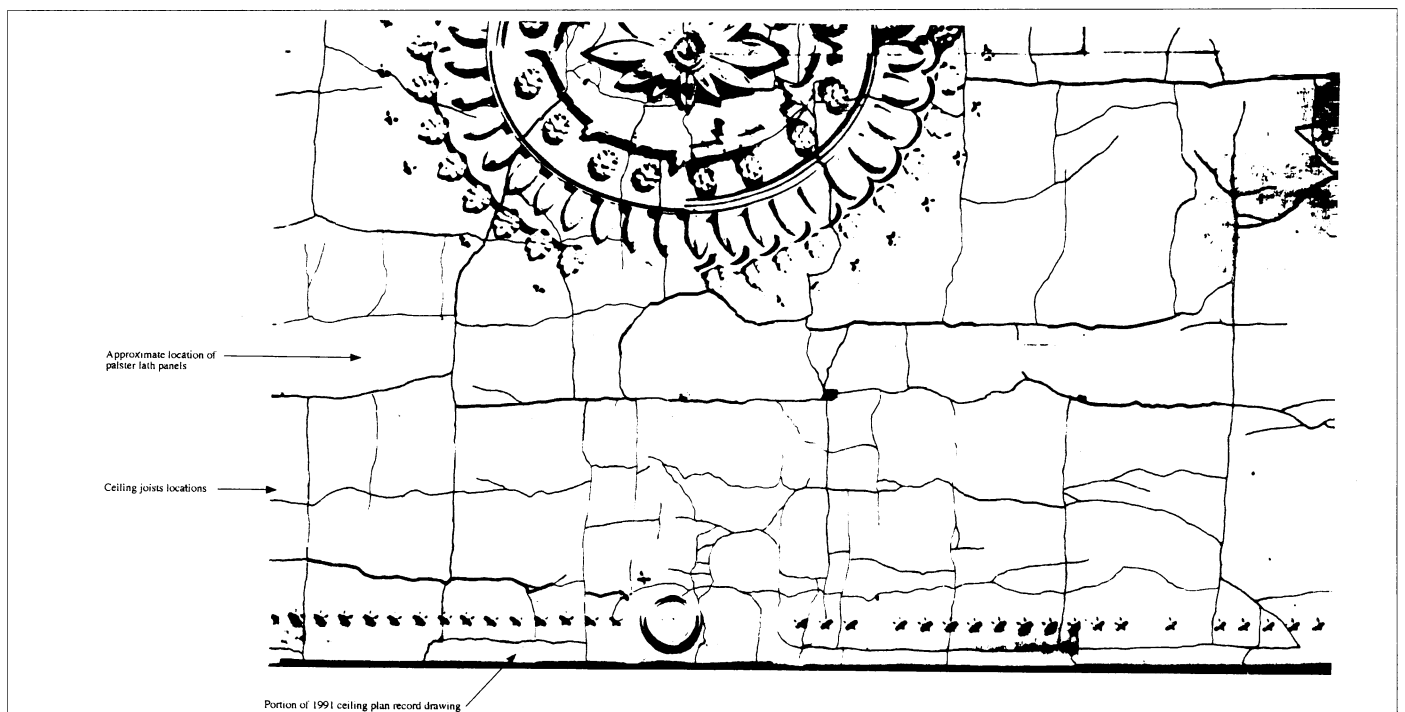
Fig. 8. Great Hall ceiling crack patterns and their relationship to staggered blocks of wood supporting lath.

Instead, our investigation found that the plaster cracks are in a pattern that corresponds both to the wood floor joists and to the staggered blocks of wood lath that support the plaster. The

pattern of the cracks and the division of the ceiling into separate panels demonstrate that the ceiling has been more affected by bending stresses than by any other factor. The relatively small panels of plaster divide the larger stresses of structural movement into small components that can be accommodated by the plaster panels without causing additional plaster damage (Fig. 8).

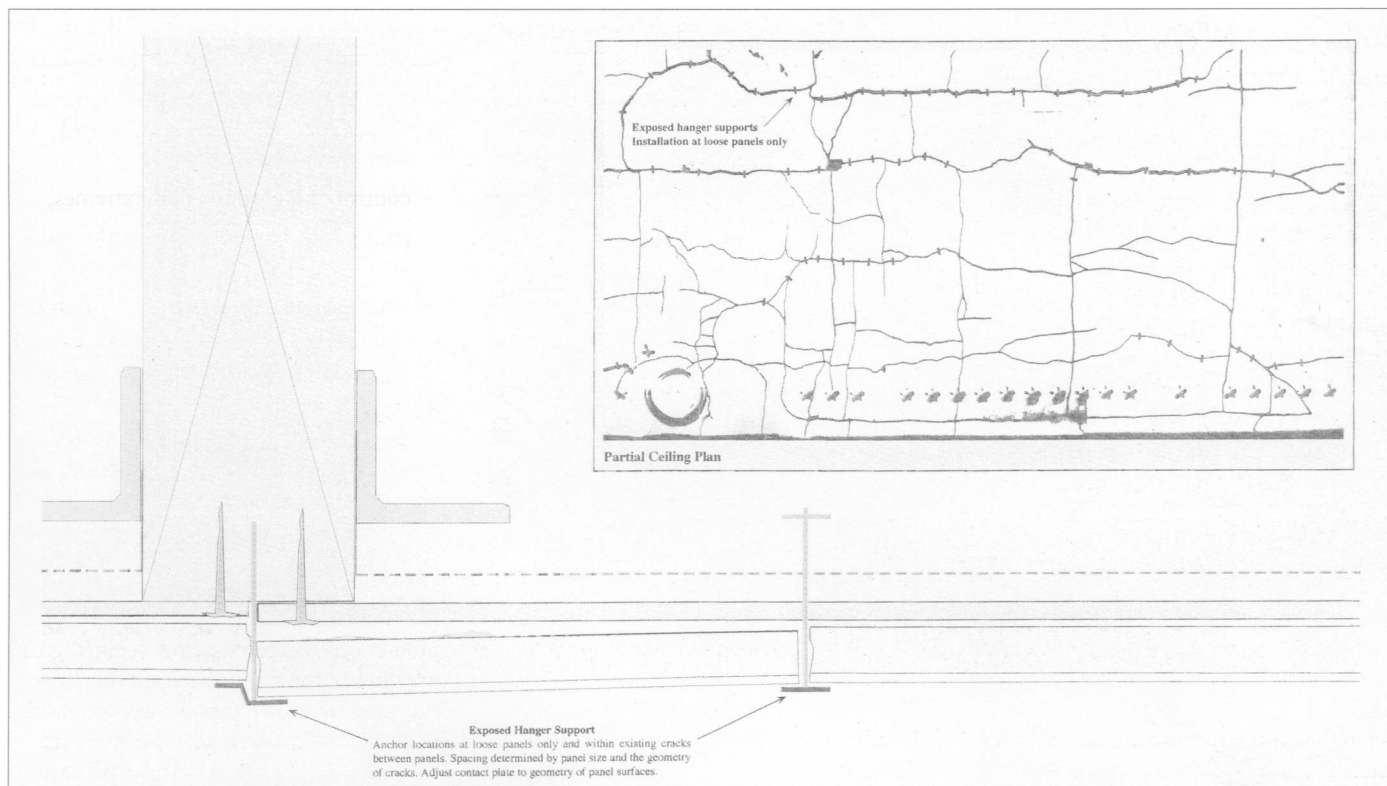
Fig. 9. Section through Great Hall ceiling showing one technique for reattachment of plaster panels.

This works well along the length of the joists, but where there is differential movement between adjacent joists, additional plaster cracking has occurred. The flexibility of the ceiling system is such that the conservation treatments must accommodate movement between the panels. Two techniques have been proposed for the reattachment of the three plaster panels: these areas can be reattached mechanically by installing flexible pins from the top of the plaster system or by installing small anchors up through the cracks between panels (Fig. 9).
