Not Just a Summer Temple: The Development of Conservation and Indoor Climate in Nationalmuseum, Sweden

Addressing the Climate in Modern Age's Construction History

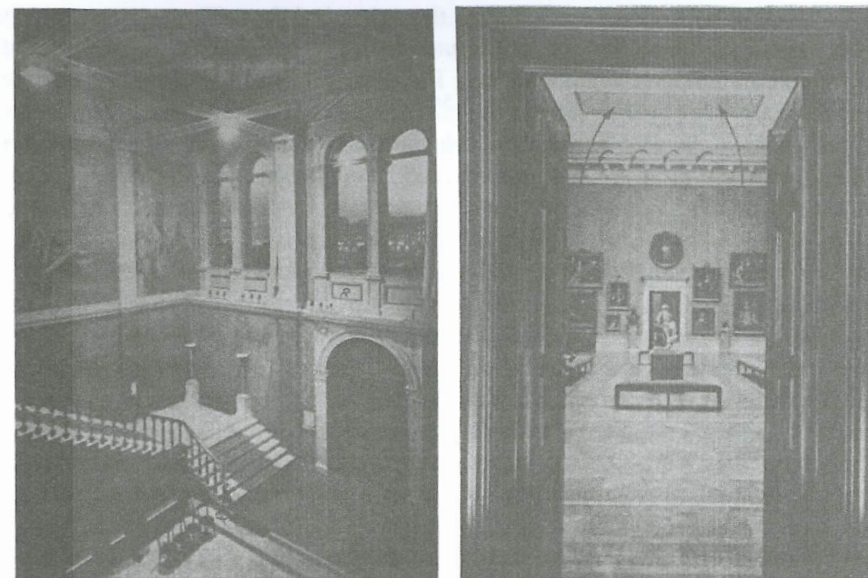
Fig. 6 The new heating and ventilation system installed in 1929–30 drew preheated air from the vestibule and upwards through the building. Inlets were placed in the cornices of the galleries and outlets were integrated in the skylights (*Museion* 1934)

In 1929–31 the extensive work of installing heating, ventilation and electricity was carried out. The hallway and the galleries would be heated by air coming from three concealed heating chambers. Air was taken in from the entrance, filtered and heated but not humidified (Fig. 6). Gauffin had worried that panels and frames of wood would run the risk of being dehydrated, but Theorell did not think this was a serious risk. In his final report, Theorell did not mention the importance of RH levels, only considering that temperature was not supposed to vary abruptly.
