Providing Safe and Practical Environments for Cultural Property in Historic Buildings... and Beyond

Richard L. Kerschner

Director of Preservation and Conservation
Shelburne Museum

From Gray Areas to Green Areas: Developing Sustainable Practices in Preservation Environments, 2007, Symposium Proceedings. (c) 2008 by The Kilgarlin Center for Preservation of the Cultural Record, School of Information, The University of Texas at Austin.

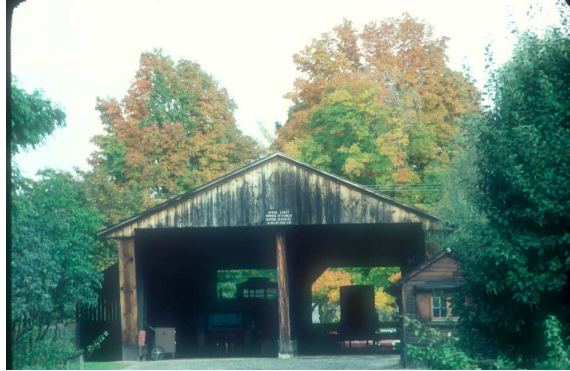
Class 1 buildings are open structures such as covered bridges or open sheds. These structures have little potential for environmental improvements, although they sometimes protect important artifacts from the harsh elements.

Figure 1. Class 1 Building, Cambridge Covered Bridge.

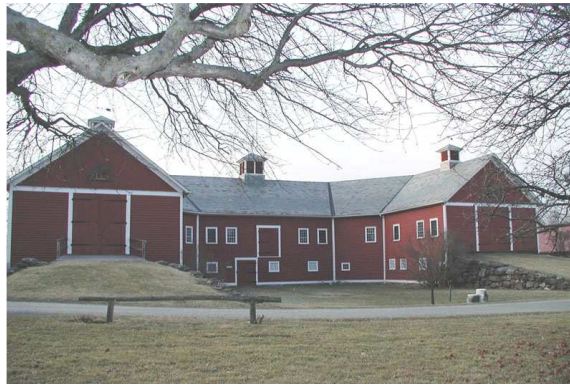
Class 2 buildings are sheathed post and beam structures such as barns. The only reasonable climate improvement for such buildings is ventilation to reduce heat and moisture accumulation.

Figure 2. Class 2 Building, Horseshoe Barn.

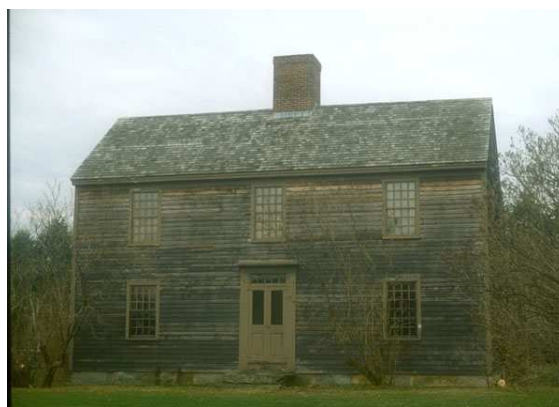
Class 3 buildings are wood structures with framed and sided walls and single glazed windows, or un-insulated masonry structures, such as the basic historic house. In these structures, one can use low level heating to reduce high humidity levels, and employ conservation ventilation to reduce humidity in the summer.

Figure 3. Class 3 Building, Prentis House.

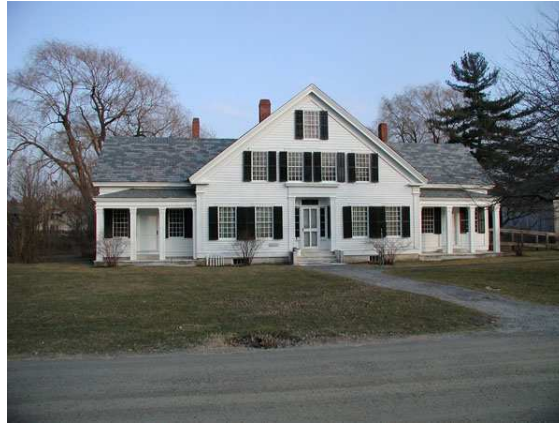
Class 4 buildings are tightly constructed wooden structures with composite, plastered walls and storm windows, or the heavy masonry structures typical of high quality historic houses. These buildings can support low-level heating and humidification in the winter and cooling and reheating for dehumidification in the summer.

Figure 4. Class 4 Building, Dorset House.

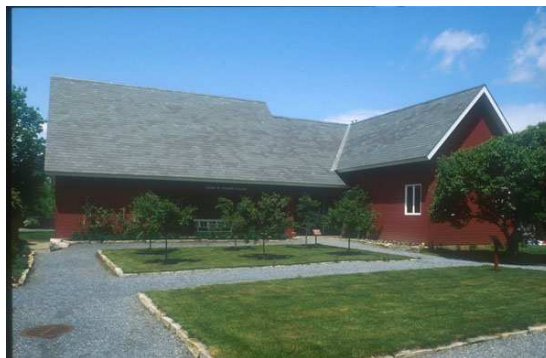
Class 5 buildings are new-built structures with insulated walls with vapor barriers and double-glazed windows. These buildings can support complete HVAC systems with winter comfort heating and humidification, and summer cooling and reheating for dehumidification.

Figure 5. Class 5 Building, Pleissner Gallery.

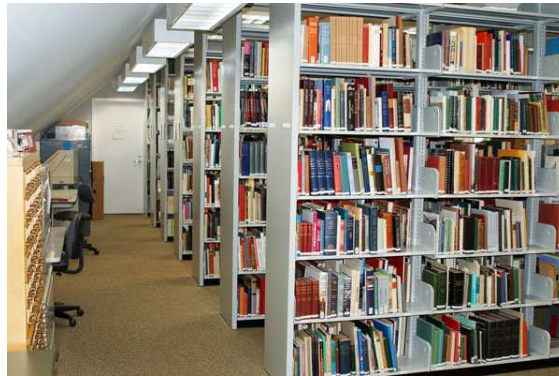
Class 6 structures are rooms-within-a-room, with double wall construction of insulated and sealed walls, such as storage vaults specially built to support precision-controlled heating, cooling, and relative humidity control systems.

Figure 6. Class 6 Building, Shelburne Museum Library.

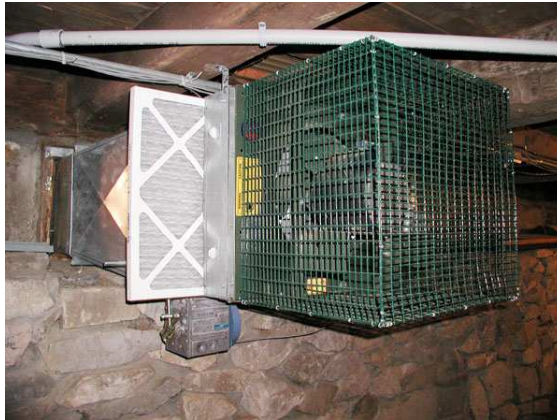
Conservation ventilation was installed in nine of our Class 2 barn-like structures, since it was apparent that, during the summer, heat and relative humidity built up inside many of our historic structures, especially on upper levels on hot afternoons. The key to Conservation Ventilation is using a humidistat to control fans rather than a thermostat. When the inside temperature exceeds 18°C/65°F and the inside relative humidity is higher than the outside relative humidity, the fans are activated and the hot, moist, interior air is replaced by cooler, drier air from outside. A consulting engineer calculated that it would require about seven air changes an hour to effectively exhaust the building and bring in outside air. However, simply installing and operating whole-house exhaust fans would solve one problem, but create another by introducing seven times as much dust into the collections areas. This problem was solved not only by exhausting air through the attic, but also by using fans to draw air into the first floor or basement of the building through filters that trap the dust.

Figure 7. Basement intake fan assembly showing dust filter pulled out.

The fans forcing air into the building are larger than the exhaust fans so that the entire building is slightly over-pressured, thereby discouraging dust from entering through open doors when visitors enter. A study conducted by the Getty Conservation Institute concluded that, on the average, conservation ventilation lowers building relative humidity levels by about 10%.⁴ In addition, moving the air prevents mold growth even when the relative humidity is above 70%.

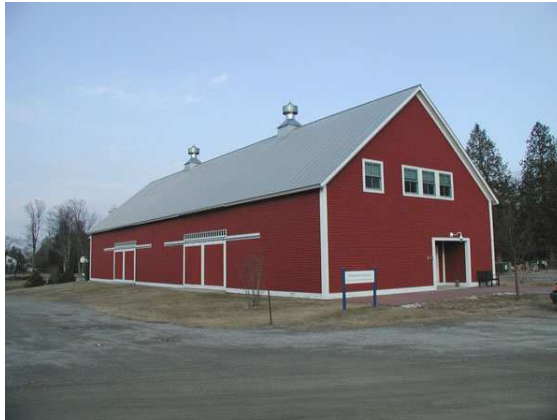
Figure 8. Collections Management Building.

A well-insulated, modern, barn-like building was proposed for construction on a well-drained site. The building was originally designed to utilize the practical environmental control principals and systems successfully employed in our historic collection buildings, such as conservation heating and ventilation. During the planning process, our director decided to include a library and collections management space on the second floor, introducing people into the structure and reducing storage space by 40%. Since conventional winter humidification and summer air conditioning was now required for the occupied space, an aluminized polyester film vapor barrier was added to the building specifications. Conservation heating and ventilation were still deemed sufficient to maintain a safe environment for the carriages, furniture, wood sculpture, metals, glass and ceramics to be stored in the 465 square meter/5,000 square foot first floor. The cost of the building doubled from \$600,000 to \$1.2 million because of the requirement of an elevator and a conventional HVAC system for the occupied second floor.

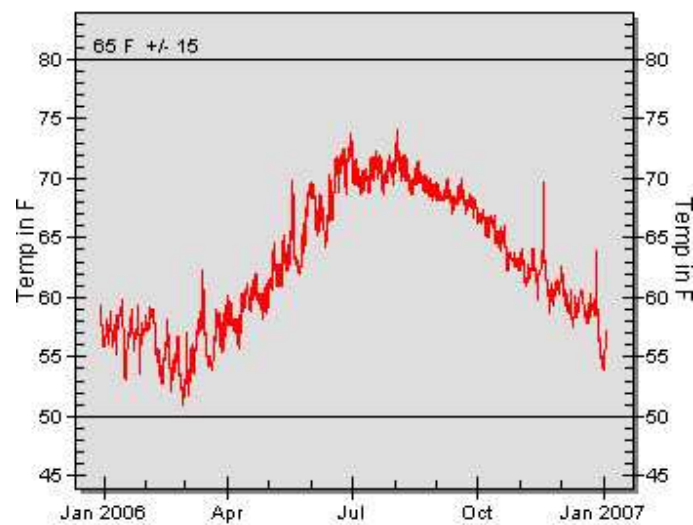
coldest winter months, we are able to maintain a safe environment that generally ranges from 45% RH in the winter to 60% RH in the summer, at temperatures ranging from 10°C/50°F in the winter to 24°C/75°F in the summer. We can maintain these favorable conditions in such an efficient manner because this well-sealed and insulated first floor storage space is sandwiched between the ground, with a year-round temperature of about 10°C/50°F, and the fully conditioned space above, and is also filled with large, wooden artifacts that act as a significant humidity buffer. The “Engineer’s Report” generated by Climate Notebook analysis software shows temperature and humidity measurements for 2006 in this storage space.

Figure 9. 2006 Climate Notebook Engineers Report for Collections Management Storage Area.

However, as the year progressed, we found that, when the conservation heating and ventilation system serving this storage area was completely shut down, the temperature and relative humidity levels were steady and safe, changing only gradually with outside conditions. The storage area relative humidity seldom exceeded 60% during the winter, spring and fall, and summer temperatures remained below 24°C/75°F with summer relative humidity levels topping out at 65%. By installing a steam humidifier to introduce some moisture into the space during the

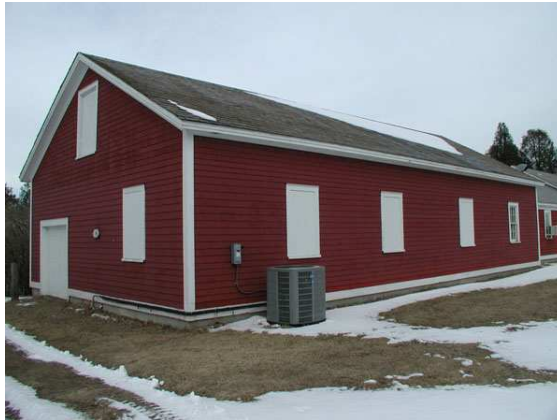
Another recent innovation is controlling relative humidity in a 300 square meter/3,200 square foot, infrequently accessed storage building using only conservation heating and direct refrigerant expansion (DX) cooling, as opposed to expensive super-cooling and reheating that requires running air conditioning and heating at the same time for three seasons of the year.

Figure 10. Decorative Arts Storage Building.

We began by super-insulating a 30-year-old frame structure using blown-in, densely packed cellulose insulation. This hygroscopic material has a better insulating value than fiberglass battens and stops all air movement, and hence most moisture movement, within the wall and roof cavities. The cellulose is treated with a fireproofing agent, so enveloping the structure with densely-packed cellulose effectively fire-proofs the building. The cellulose is treated with borates to prevent mold growth and insect infestation in the insulation. The building was insulated during the winter, and, on completion, the building interior warmed from -12°C/10°F to 5°C/40°F simply by retaining heat from the ground.

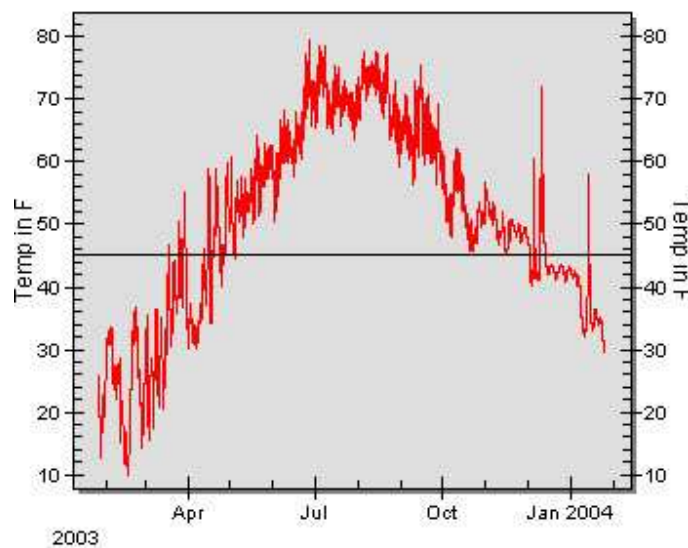
The Climate Notebook Engineer’s Report shows the temperature and relative humidity in Decorative Arts Storage for 2003, the year before environmental improvements were made. The histograms show the temperature and relative humidity measurements that fall within the established “safe” zones. Note the high relative humidity, indicated in blue on the right chart, especially during the summer.

Figure 11. 2003 Climate Notebook Engineers Report for Decorative Arts Storage prior to environmental improvements.

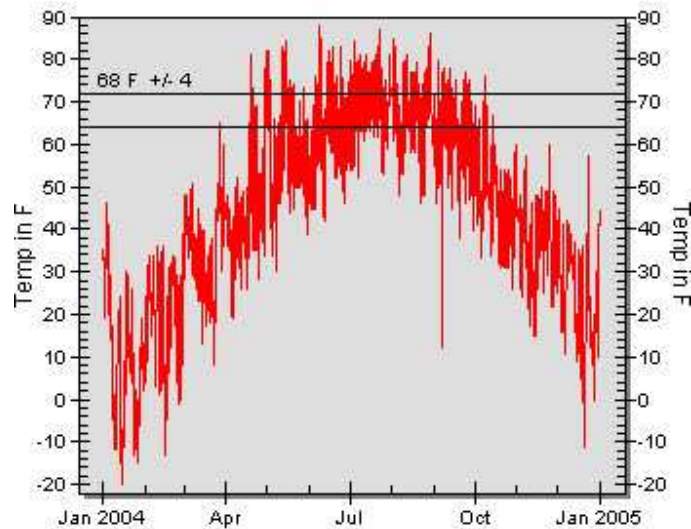
The equipment failure during April of 2005 is a good reminder that even practical climate control systems require constant and careful monitoring to insure that safe conditions are maintained. Outside temperature and humidity conditions for 2004 are included for comparison.

Figure 13. 2004 Climate Notebook Engineers Report for Outside Environment, Burlington, Vermont.
