## Condensation in the walls of humidified buildings - 2

### Preventing air movement through the structure of old buildings used as museums

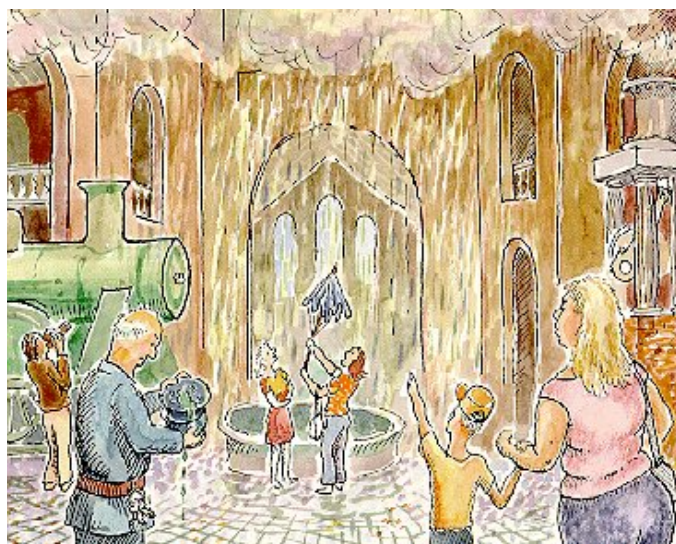
This picture is based on an eyewitness account of the scene within the rotunda of the Arts and Industries Museum in Washington D.C on a warm, clear, spring morning. The clouds dispersed, metaphorically at least, when an analysis of the liquid on the guard's hat revealed a cocktail of exotic ions: borate, ammonium, potassium and phosphate; all constituents of fireproofing treatment of plywood. For help in the subsequent investigation I thank my colleague on several such forensic adventures, David Erhardt of the Conservation Analytical Laboratory of the Smithsonian Institution.

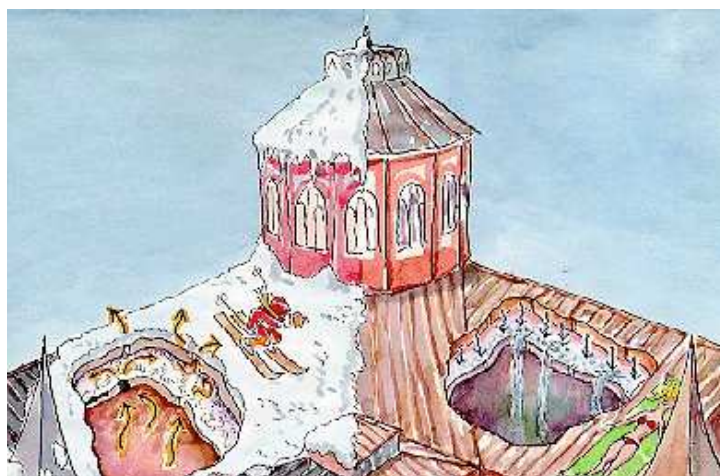
The prefabricated roof panels are boxes made of two layers of plywood enclosing glass fibre insulation and a polyester moisture barrier.

During the winter, air penetrated from the museum into the boxes and water condensed into the cold upper plywood panel. The process was aided by the hygroscopicity of the fireproofing salts. Drying to the outside was prevented by the lead-coated copper roof. The process continued without symptoms throughout the winter, as shown on the left side of the picture below.

On a warm spring day (the right half of the picture) bright sunlight warmed the dark lead roof to over 80C. Water evaporated from the saturated upper plywood. The vapour diffused through the insulation and condensed on the vapour barrier. The hydrophobic vapour barrier collected the water in drops on its gently sloping surface. At a critical moment two drops coalesced, collected a third and started a little stream down the surface of the polyester. The stream

became a flood and cascaded through the joints in the metal ceiling to surprise the museum guests below.
