Condensation in the walls of humidified buildings - 3

It is very often only some unusual weather that reveals the magnitude of processes that are continuing invisibly in less extreme weather. My last example is from the building next to the Arts and Industries Museum: the Hirshhorn Museum of Modern Art.

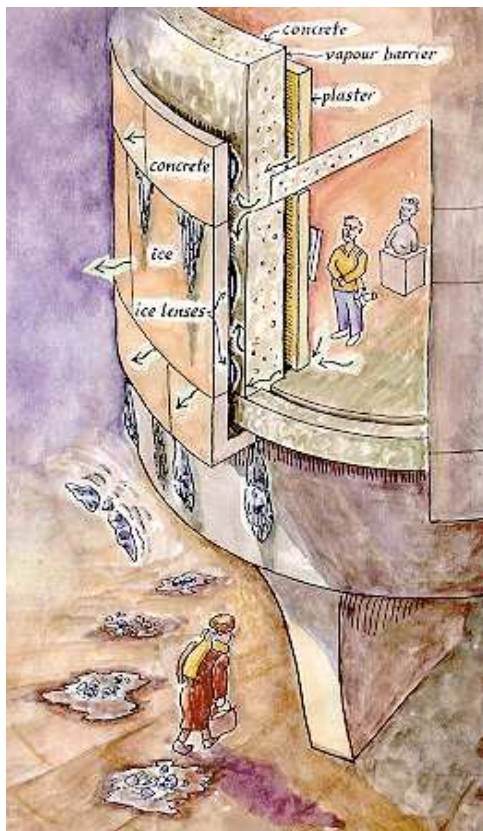
This is a much more modern structure, with a moisture barrier built in from the start, and probably leaky from the start.

I was passing by on a cool but bright spring morning and witnessed the building dropping lumps of ice on innocent workers hurrying to their duties in the Federal service.

The museum is a large cylinder on legs. The humidified, filtered and pressurised air that is attempting to compensate for the doubtful durability of much of the art, leaks out through defects in the sealing. Water often condenses behind the concrete outer skin. On the previous night the water condensed as ice. When the morning sun warmed the grey concrete walls the ice melted and flowed through the joints to the outside of the wall where it froze again by evaporative cooling from the strong breeze and the low relative humidity in the air.

As the sun grew stronger its radiation melted first the ice in contact with the wall, so large chunks fell away and littered the pavement below.
