Influence of New External Protective Glazing on Historic Painted Windowpanes in Medieval Churches

Georg-Wilhelm Mainka, DrIng

Heiko Winkler, DrIng

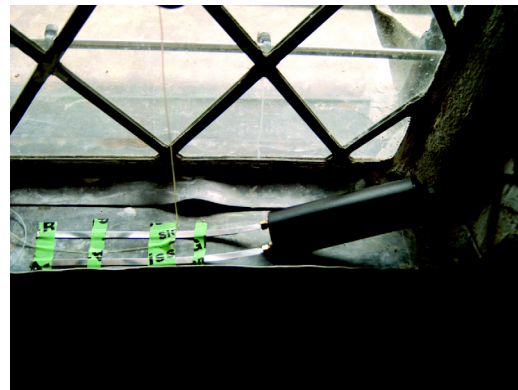
Figure 5 Sensor for humidity on the lead tray.

of the clearance, a flat lead tray collects incoming rain and conducts it through a tiny opening to the outside (Figure 5).

- Gaps between window and wall. These were tightened traditionally by a hemp rope and were closed inside and outside by mortar. Pieces of mortar have dropped out within the last 20 years, so on top of the new mortar outside a new flashing of lead tin was developed, which was soldered to the window frame and pressed to the wall, as shown in Figure 5.

(w) was fixed in the lead tray and insulated against the metal. (see Figures 4, 5, and 7).

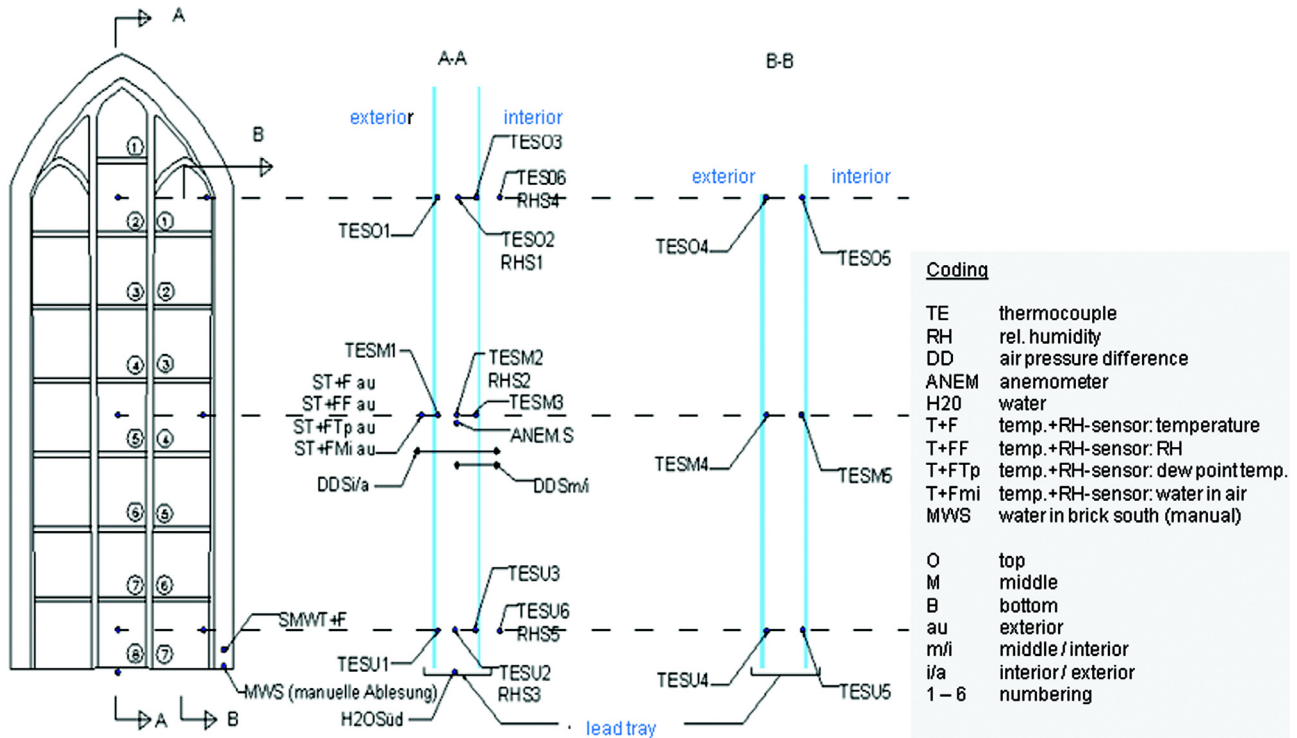
Figure 6 Locations for sensors.

At the northern and southern choir windows, the following sensors were installed (see Table 1 and Figure 6).

The exterior and interior air sensors (θ , Φ) were installed 100 mm (4 in.) in front of the windows on iron rods. Sensors in the middle of the clearance (air) (θ , Φ , v , Δp) were fixed on vertical nylon strings. Thermocouples (θ) were coated on glass surfaces with water-resistant tape. The water detector

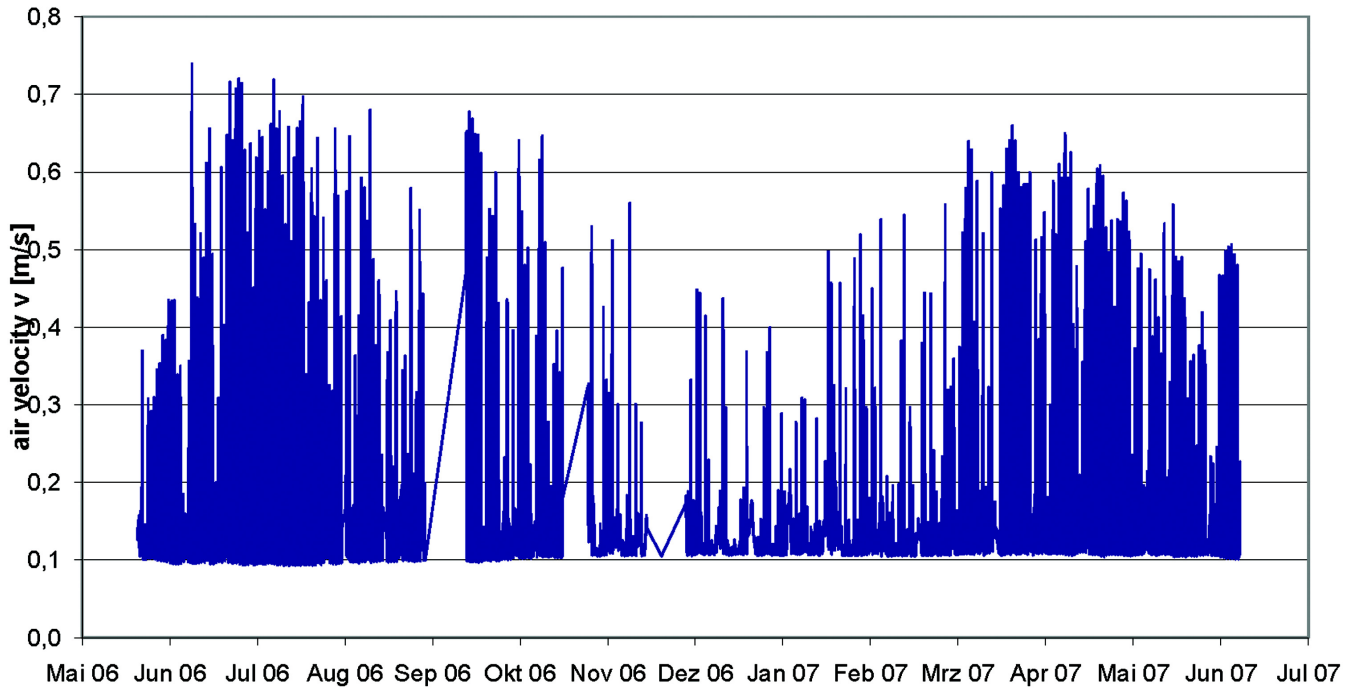
Figure 8 Time variation curve for air speed within southern clearance for 1 year. Top: ordinary graph of hourly data. Bottom: graphs for speeds at 0 h, 6 h, 12 h, and 18 h.

Because some of the measured data oscillated daily, the yearly time variation graph shows a broad band in which only the peaks can be recognized. For better interpretation, the time-dependent data were separated into groups for each hour of the day. Values for 00:00 h, 06:00 h, 12:00 h, and 18:00 h were plotted in their own graphs. Figure 8 shows the effect for ventilation in the clearance.

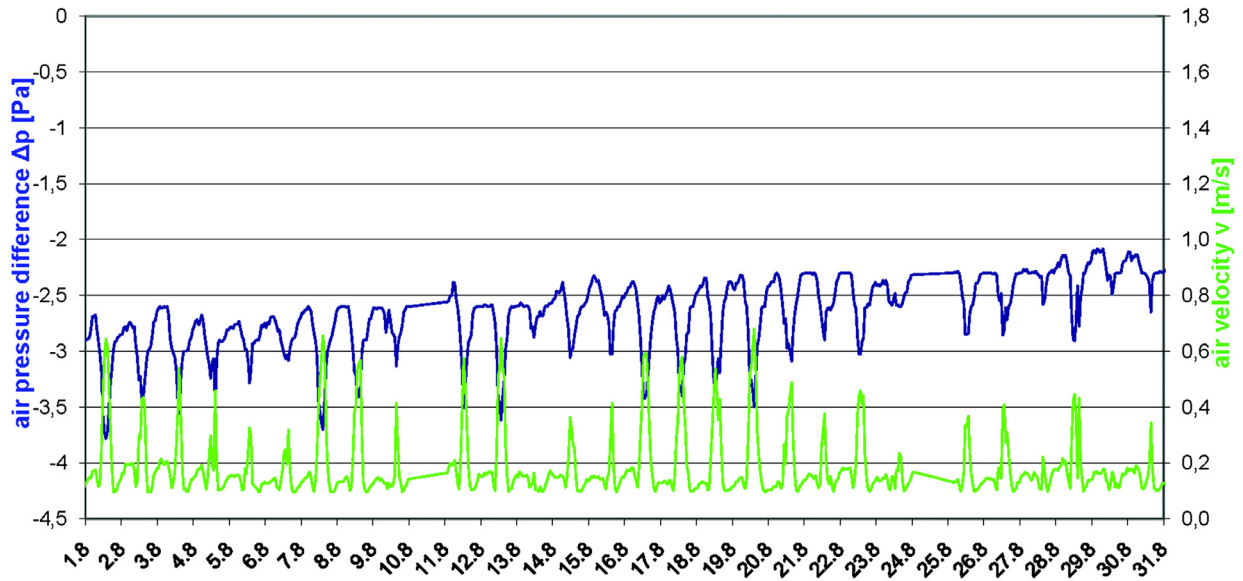
Figure 9 Time variation curves for air speed and air pressure within southern clearance for one month: August 2006.

- Air pressure differences: wind directions and speed
- Air velocity in the clearance: solar radiation from the nearby weather station, as shown in Figure 9
- Air temperature inside, at the clearance, and outside at different heights

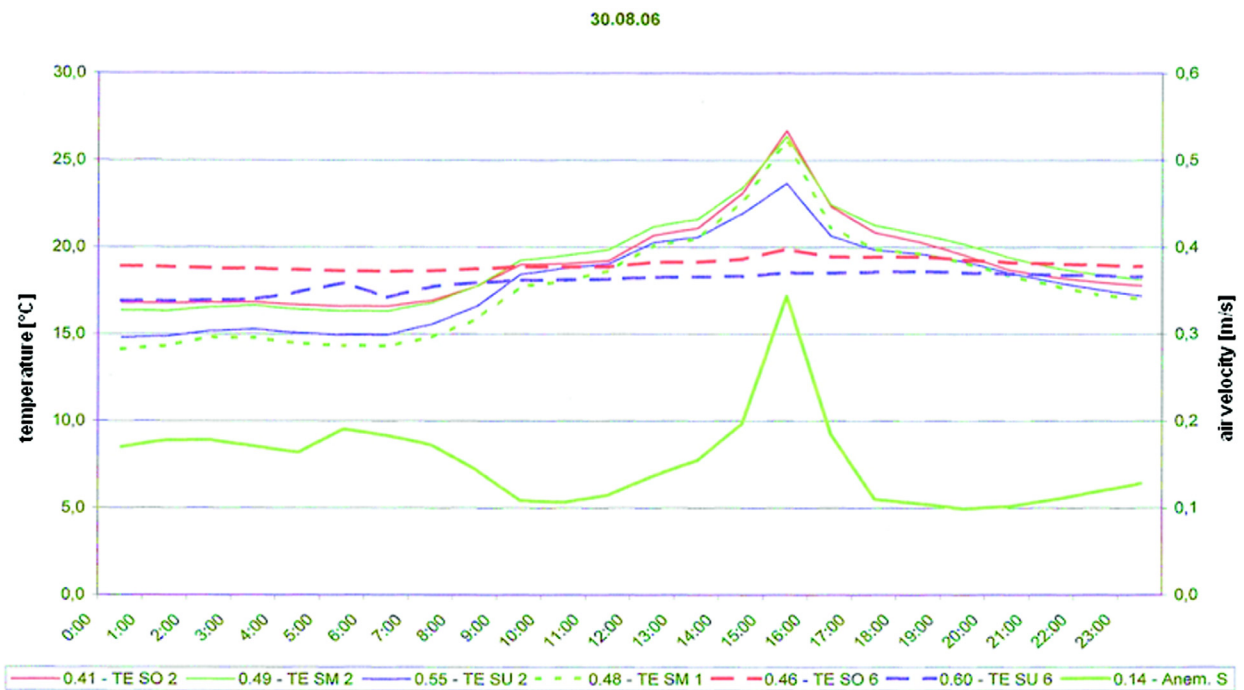
Figure 10 Time variation curves for air speed within southern clearance (green) and temperatures for one day: August 30, 2006. Code for lines: red = top; blue = bottom; continuous: outside; dashed: inside; dotted: clearance.

The wind speed in the clearance and the different temperatures for 2006-08-30 are shown in Figure 10.

- Air temperatures between exterior and clearance. “Partly” means synchronous for some hours, disturbed by radiation.
- Temperatures in the clearance at three different heights to interpret the impetus for buoyancy
- Interior temperatures at the bottom and top of the window
- Valuation of buoyancy compared to temperature differences in the clearance (see Figure 10).

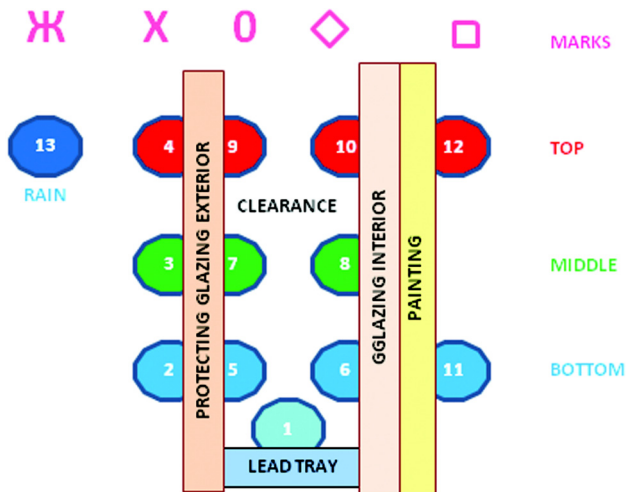
Figure 12 Allocation of rows in Figure 11 to places on the glazings.

Condensation on glazings may occur when the measured surface temperature is lower than the dew-point temperature of the air, which can be calculated from the air temperature and relative humidity. For the different surfaces of both windows, the time condensation risk is plotted in Figure 11. Figure 12 shows the location of measurement and the code for Figure 11.
