Short Guide

CLIMATE CHANGE
ADAPTATION FOR
TRADITIONAL
BUILDINGS

1st Edition

First Edition October 2016

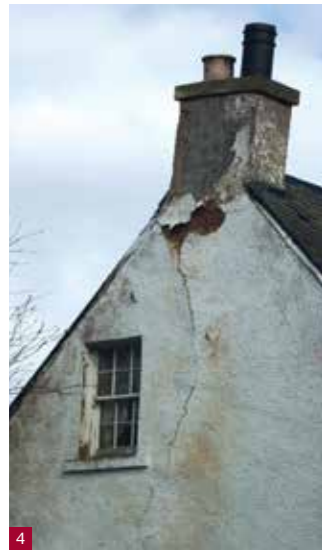
Fig. 4 Water ingress has led to progressive failure of the chimney and masonry below.

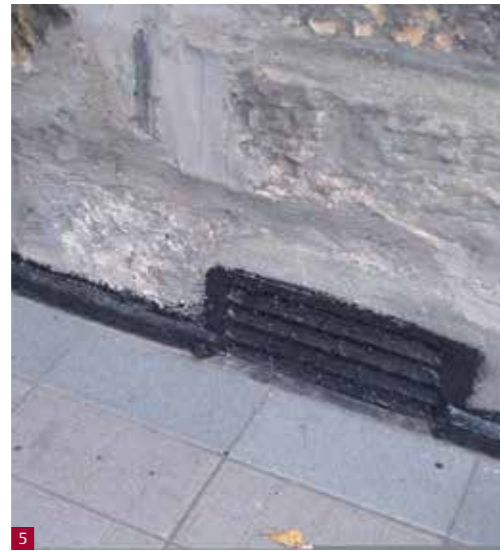
Fig. 5 Poorly designed hard landscaping close to building, partially obscuring the wall vent, inhibiting ventilation and concentrating moisture.

Alterations, such as hard landscaping close to buildings and development leading to loss of gardens, have inadvertently led to increased water run-off and splash back, resulting in high moisture levels in external walls or adjacent areas. Ground levels can become raised over time from natural deposition of organic materials or from poorly designed landscaping work (Fig. 5). Increased levels of water in the soil and impermeable materials next to buildings increase the risk of damp and associated problems. In some areas a rising water table or poor drainage will also have an impact on footings and foundations. Moisture from soils can contaminate porous masonry with damaging salts which can cause or accelerate stone decay.

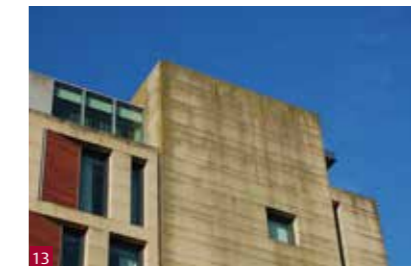
Fig. 13 Poor detailing on a modern building in Edinburgh has led to staining of the masonry.

External details on traditional buildings such as *string courses*, *hood mouldings* and *cornices* exist primarily as functional elements to shed water and protect the building façade, although they can also be decorative (Fig. 10, Fig. 11 and Fig. 12). The rapid weathering and staining sometimes seen on buildings of modern design, often with flat roofs and unembellished *curtain wall* façades, illustrates the purpose of traditional detailing and the need to understand the micro-climate in which a building sits. Buildings which may perform well in a dry, southern European climate are typically poorly suited to Scottish weather conditions (Fig. 13).

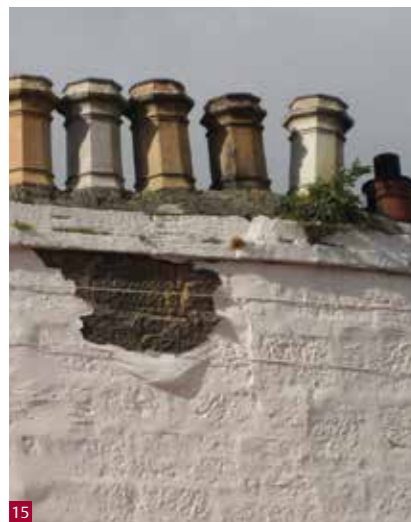
Fig. 15 A poorly maintained chimney stack.

Chimneys are generally the most exposed element of a building, and by their nature are typically hard to access; consequently they are often neglected (Fig. 15). Not only are chimneys exposed to wind and rain, but flue gasses and combustion products deposited within the masonry from decades of solid fuel fires can accelerate the decay of stonework, particularly if the flues are no longer in use. Mortar joints can wash out over time or degrade, allowing water to penetrate the fabric and encourage vegetation, all of which can compromise structural integrity. In order to protect the chimney stack from water run-off and penetration through the chimney cope, additional lead detailing may be required (Fig. 16).

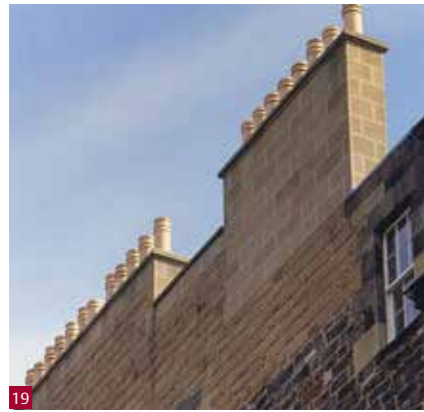
Fig. 19 Repaired chimney using matching stone and good detailing. Note reinstated drip mould details to copes, and lead flashing to protect vulnerable areas of original stone.

In some cases, a chimney may need to be taken down and rebuilt. If the stone is in good condition, it can be reused and any new stone carefully matched to the existing (Fig. 19). Ceramic flue liners will make construction easier and will increase the durability of the re-built chimney. The chimney cope should normally be of natural stone, possibly composed of two or three sections if weight for handling is a consideration. The opportunity should be taken, where appropriate, to modify or improve the detailing on the chimney stack, *haunching* and junctions to allow adequate shedding of water. This should include a correct drip mould detail under the outer edge of the cope. If this is not present or is damaged such a detail can be incorporated into any new work. Alternatively, a drip detail can be formed with the use of a lead strip set into the cope edge (Fig. 20), or for a more complete cover a lead apron can be formed around the chimney cans to the edge of the cope.

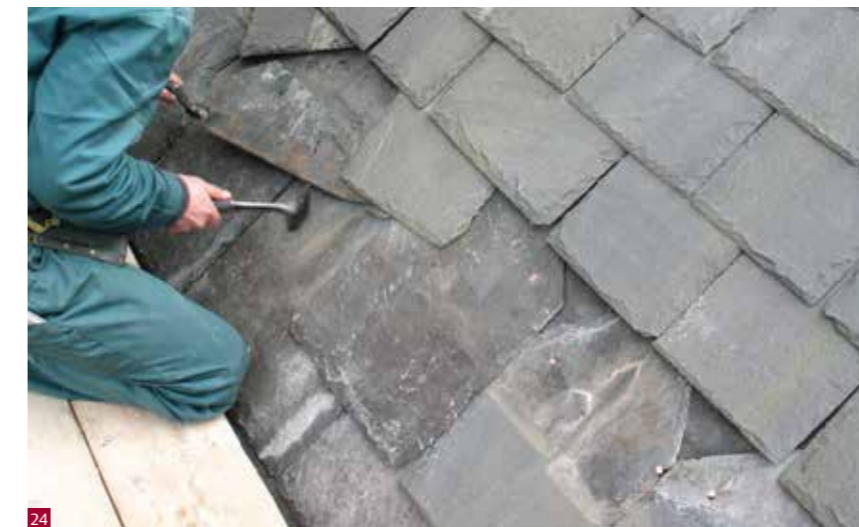
Fig. 24 Fixing slates with additional fastenings to prevent wind lift.

In Scotland the majority of roof coverings on traditional buildings are slates, plain clay tiles or *pantiles*. In particularly exposed areas and in high winds there is a tendency for water to be blown up under the slates, even where they are correctly laid. To address this issue the use of an underlay might be necessary to ensure the roof remains watertight during bad weather. To prevent excessive movement or rattling of slates in high winds, slates can be secured with additional nails to the sides, known as *cheek nailing*, every third or sixth course (Fig. 24). On turrets and exposed areas cheek nailing is sometimes necessary for every course. In some parts of Scotland where larger slates are used they are fastened with two nails on each slate, in the English way. In this case additional nailing is not normally required.

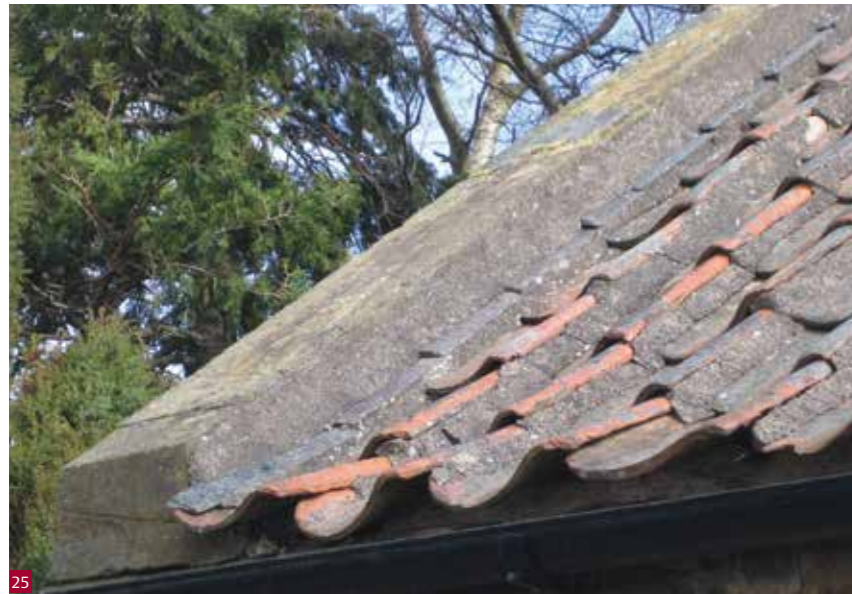
Fig. 25 Mortar torching on pantiles to prevent wind lift.

With pantiles there is little variation possible in fitting or overlap; however, they tend to be more open to ventilation and subject to wind lift, especially at the eaves. This may be the reason for the narrow courses of slates at eaves level (called an *easing course*) which is a common feature of pantiled roofs in Scotland. In some locations lime mortar is used to close gaps in a pantiled roof (Fig. 25). The addition of lime mortar torching or bedding might be necessary where wind driven rain or wind lift is causing problems.

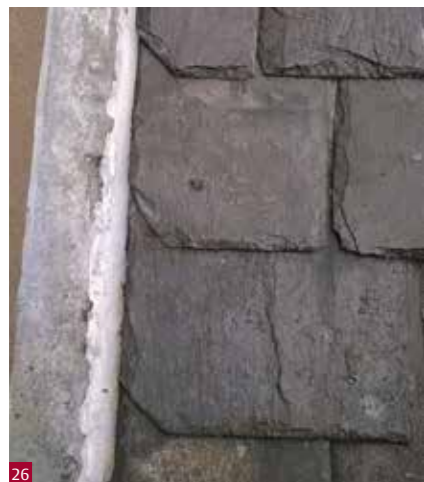
Fig. 26 Edge of slate cut to drive water away from the junction and minimise run off onto the gable.

Where the roof junction with the gable (the verge) is flush, with no overhang, the edge slate is cut with an angle on the edge corner, to drive water onto the middle of the next slate, away from the junction (Fig. 26). This minimises run off onto the gable wall, reducing the chances of saturation and accelerated weathering. Sometimes the verge is secured with a cement *fillet*, but where exposure is more extreme, a zinc or lead ridge roll can be fixed onto the verge (Fig. 27) to give better protection against damage from wind lift and prevent wind driven rain reaching the *sarking* and roof timbers behind.

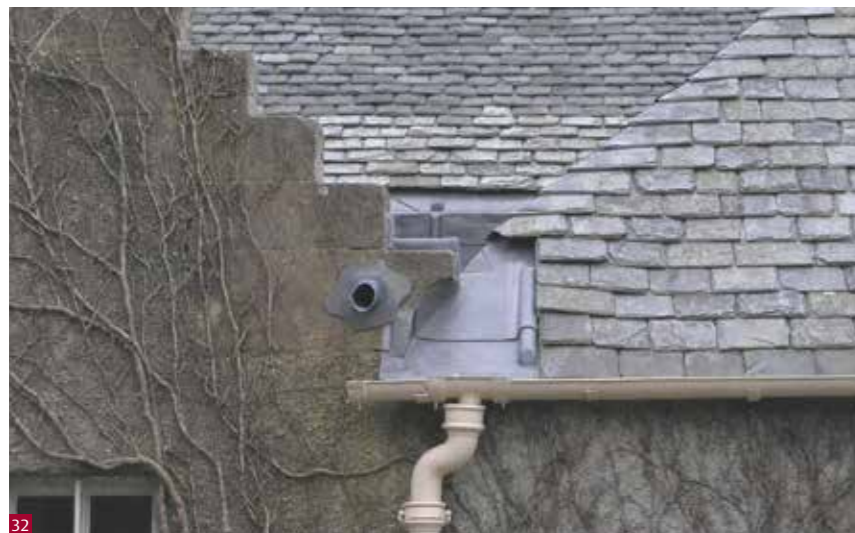
Fig. 32 Enhanced lead detailing, such as the use of a storm roll, can be conspicuous, but is an effective way to improve rainwater disposal in areas of high water flow.

Where water flow at certain points is very high, the use of a *storm roll*, formed from lead dressed over a wooden roll, can be used to ensure deflection of water into the rhone or gutter. While sometimes necessary, they can be visually intrusive, and adoption of this detail must be considered carefully, particularly on prominent roofscapes (Fig. 32).

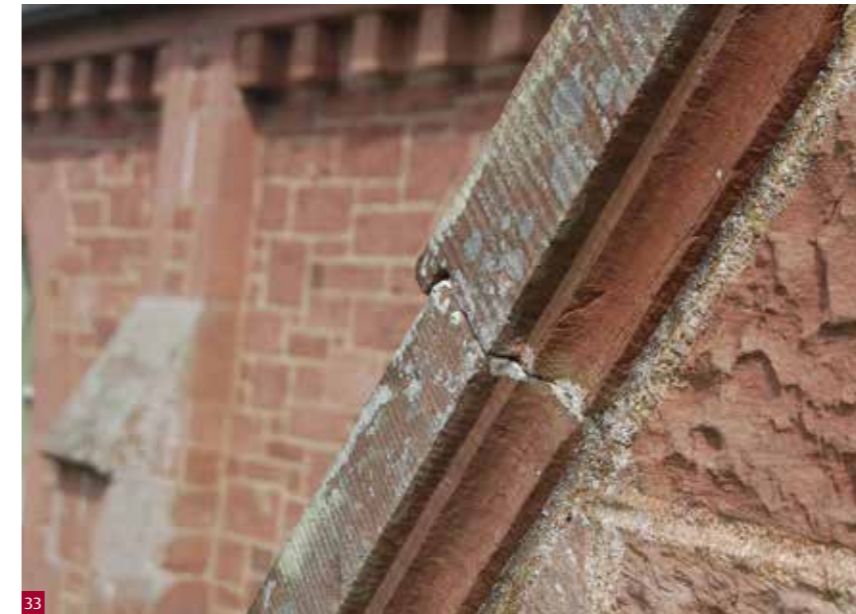
Fig. 33 Raised moulding on upper skew copes to ensure effective water run-off and prevent water ingress.

The stone slabs that are generally used to cover gable end wallheads are often vulnerable to water ingress. The joints between the stone copes should be narrow, less than 5mm, and therefore need a fine ashlar-type pointing. Historically there have been various ways of forming these junctions: plain butt joints, stepped joints with an overlap, or a raised mould on the upper cope to shed water to the sides (Fig. 33). While requiring additional stonemasonry work, such weathering details are particularly applicable today, as increasing rainfall and wind driven rain puts a strain on exposed areas.

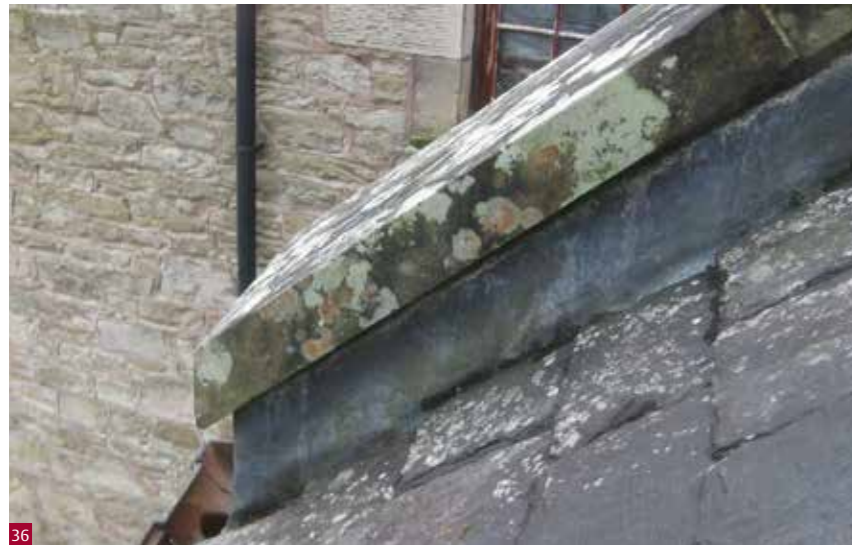
Fig. 36 Bedding of a skew cope with a lead DPC underneath.

In some cases defective skew copes can be re-bedded onto a lead damp proof course (DPC), to provide extra protection against water ingress (Fig. 36). If this approach is taken, the copes will need to be secured in place by additional fixings, to avoid slippage. The edges of the DPC should extend out from the gable wall by about two inches as a drip detail to shed water clear of the wall.

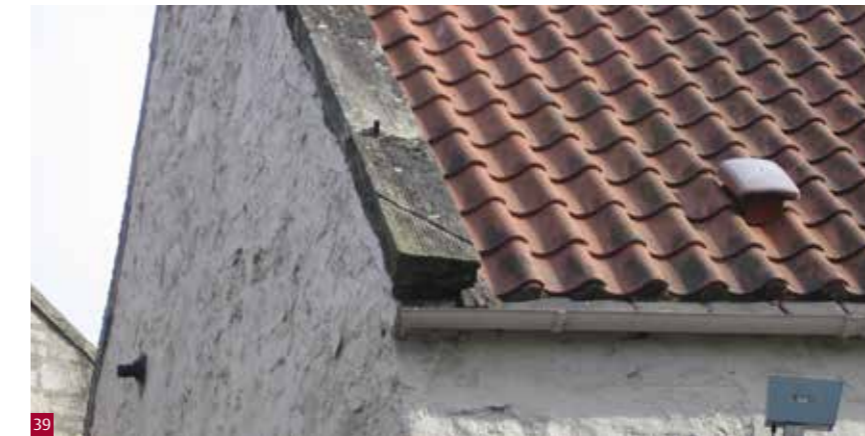
Fig. 39 Small channel detail on a skew cope to keep water off the corner.

An additional detail on a flat stone cope at eaves level is the formation of a small channel, approximately 5 mm deep, that runs at 45 degrees across the lower skew cope towards the slate side (Fig. 39). This traditional detail is seldom seen in new work, but for a small amount of additional labour it ensures that water from the surface of the cope is directed onto the slates, preventing staining and progressive saturation of the *skew putt* and the adjacent gable masonry and mortar.

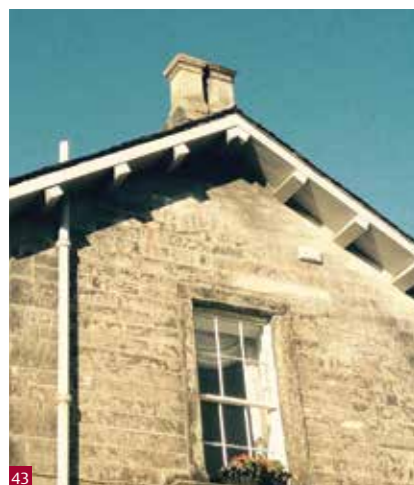
Fig. 43 Oversailing eaves to protect gable.

In parts of Scotland where high precipitation has been an issue for a long time, local architectural styles developed in response to the conditions. Additional detailing was often incorporated in a decorative way and adapted to prevailing fashions. Details might include oversailing eaves (Fig. 43) and extended verges on gables, often finished with decorative bargeboards (Fig. 44). If significant works to the roof are being planned, increasing the protection to the underlying walls by the addition of such details may be an option, where it is compatible with the overall design and appearance of the building.

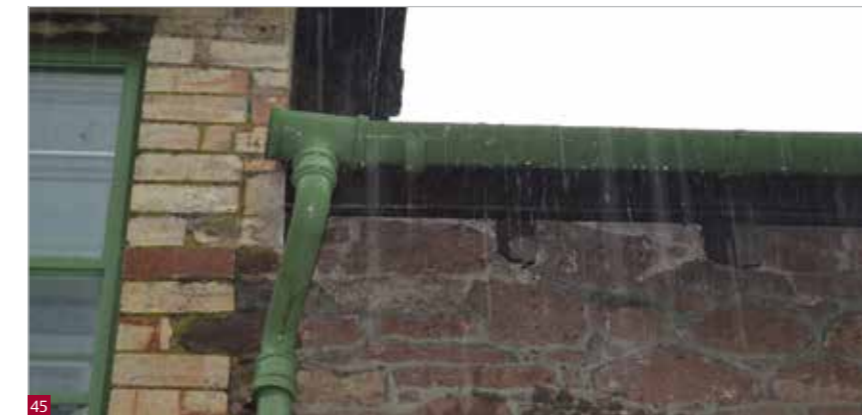
Fig. 45 Overflowing rhones in an area of high water flow.

Generally in Scotland rainwater is collected from the edge of the roof, at the eaves, into rhones or gutters. These carry the water into vertical downpipes. This system forms the roof drainage, with components being referred to generally as *rainwater goods*. Rhones are set at a shallow angle to give a run which allows the water to move along at a suitable rate. Over time the run or height of the rhone can become distorted, causing water to back up or overflow (Fig. 45). Poor detailing can also cause rhones to discharge onto the masonry, leading to persistent damp problems. Increased water flow can cause movement of debris, leading to blockages. Warmer temperatures and wetter winters may result in increased vegetation growth (e.g. moss on roofs, overhanging trees etc.) with potential to block rainwater goods. Regular inspection and cleaning, at least twice a year, is required to keep rainwater goods in working order. In some circumstances a larger width rhone may need to be installed. Rhones normally route water into the downpipes through a small spigot, sometimes called a *drop*, into the downpipe. However, in some cases the drop flows into a cast iron or lead *hopperhead*. The outlets for these can be undersized and may need adaptation.

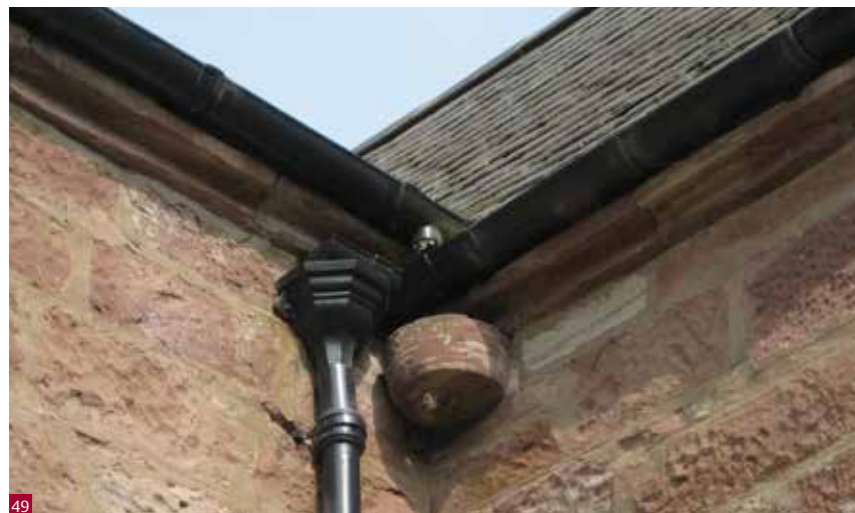
Fig. 49 Works to this building have neglected to reuse the original stone rainwater bracket, resulting in an overly complex arrangement.

In some cases modern repair works have resulted in rainwater goods, particularly downpipes, being installed which have a smaller diameter than the original. This can occasionally be seen very obviously where the downpipe passes through the string course (Fig. 49). Inadequately sized rainwater goods often result in blockages and overflow. On some elevations additional downpipes may be needed, especially where there are turns and corners that make the run of the rhone shallow. Where this is not possible, replacement of the downpipes with those of a similar pattern but larger diameter may be required. Complex roof drainage arrangements may not be able to cope with intense rainfall.

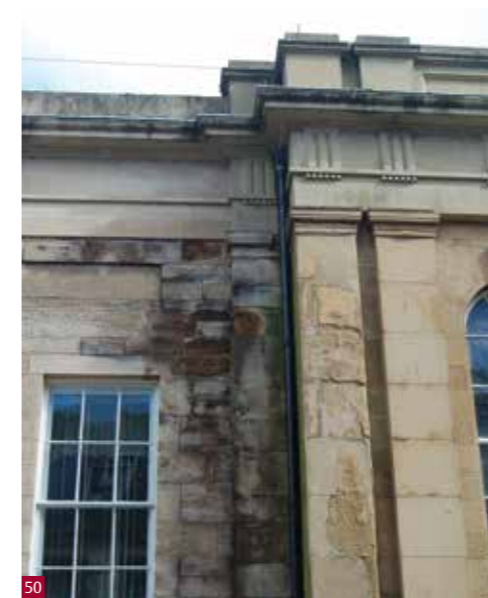
Fig. 50 Staining and decay of masonry resulting from a blocked parapet gutter.

While many parapets have overflow spouts, parapet gutters are always over wallheads and therefore any overspill leads inevitably to water penetration into the masonry below (Fig. 50). While traditional building fabric can cope with a certain degree of occasional wetting and drying, frequent saturation and water flow into a building from such a drainage failure can result in damage to internal finishes and contents. Extended saturation can lead to staining, algal growth and the decay of stone and timber elements, while the leaching out of binders from the masonry can cause progressive weakening of the structure.

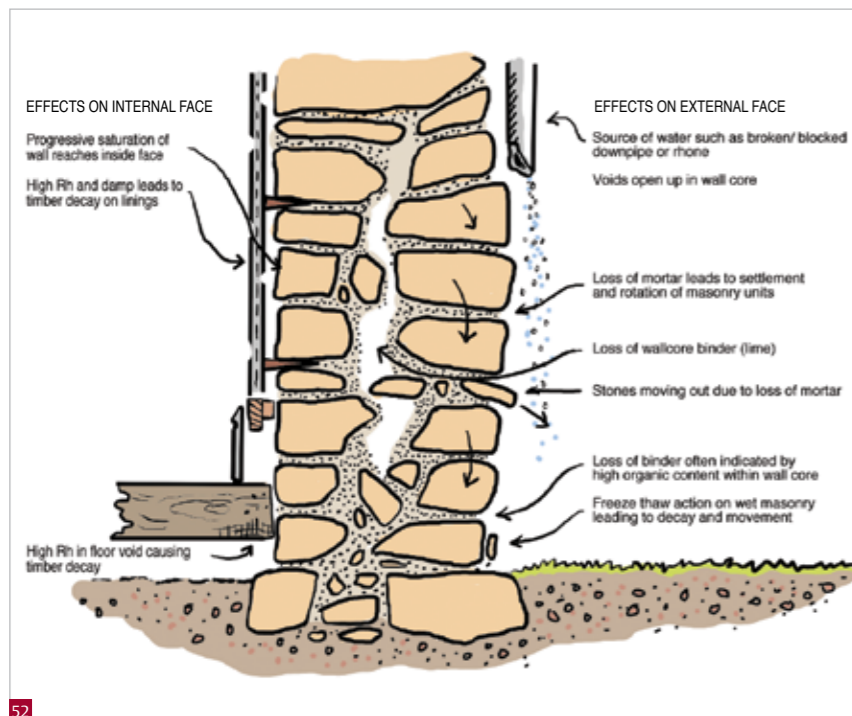
Fig. 52 Diagram showing a cross section of a weakened mass wall.

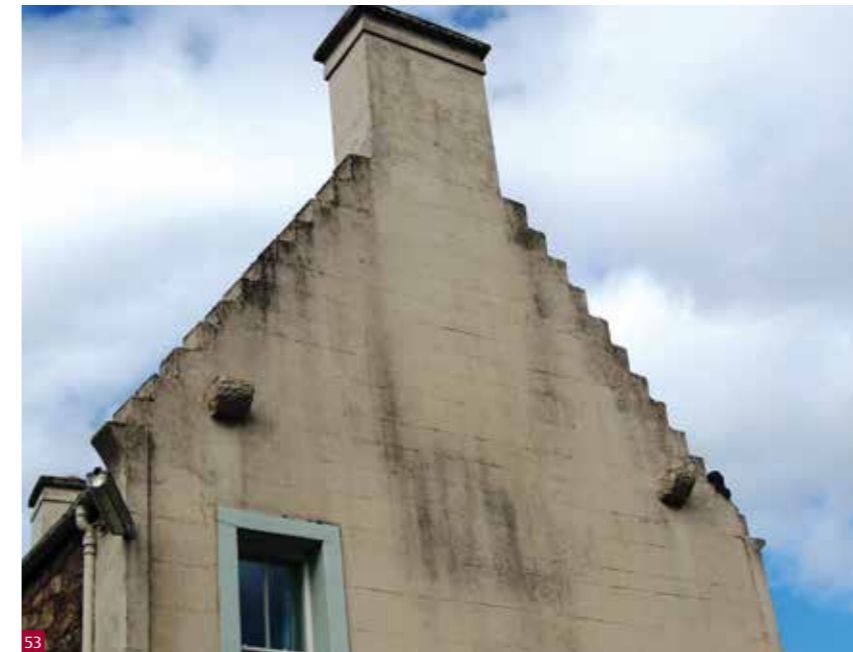
Fig. 53 A lack of protective water shedding detailing has led to staining, and progressive crazing of this cement-rendered gable.

Dampness in gable walls is most commonly due to a combination of defects in the chimney, the skews, the masonry pointing and frequently blocked rhones and downpipes. Often cement pointing or renders can exacerbate the problem as cement can be vulnerable to cracking and crazing, allowing water to be drawn in and become trapped (Fig. 53). Chimney flues within the masonry of gables can be prone to decay due to weather damage from the outside and corrosive flue gases on the inside, both accelerated by the presence of moisture. Thus the masonry is being attacked both externally and internally, with greater potential for problems arising.

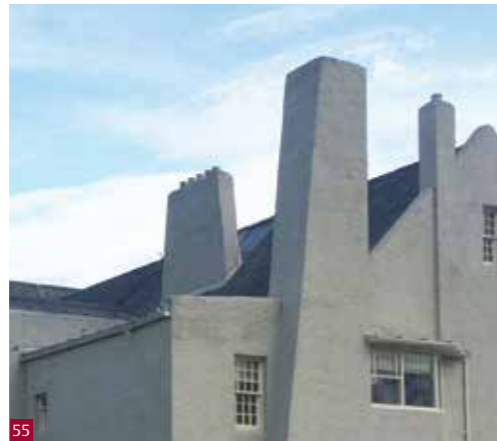
Fig. 55 An early 20th century building in the west of Scotland. The lack of weathering detail contributes to saturation of the underlying masonry.

Some early 20th century buildings feature parapets with no protective drip detailing. This invariably causes problems in all but the most sheltered locations (Fig. 55). The absence of such details may be acceptable for buildings in areas with low rainfall, but is ill-suited to most parts of Scotland.

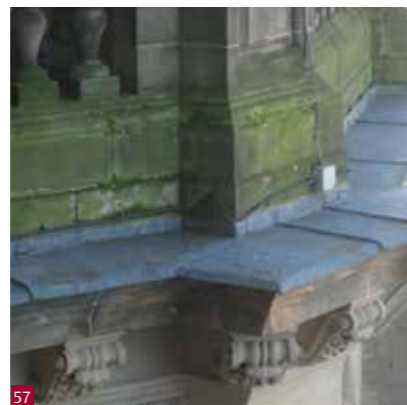
Fig. 57 Even the careful use of lead will have visual effects.

In areas of high exposure, the remodelling of parapet or cornice details may be required to ensure the protection of the masonry below if on-going long term damage is to be avoided; this can often be done with the careful use of sheet lead or zinc (Fig. 56). Such alterations will affect the appearance of the building, and will need careful consideration to minimise the visual impact (Fig. 57).

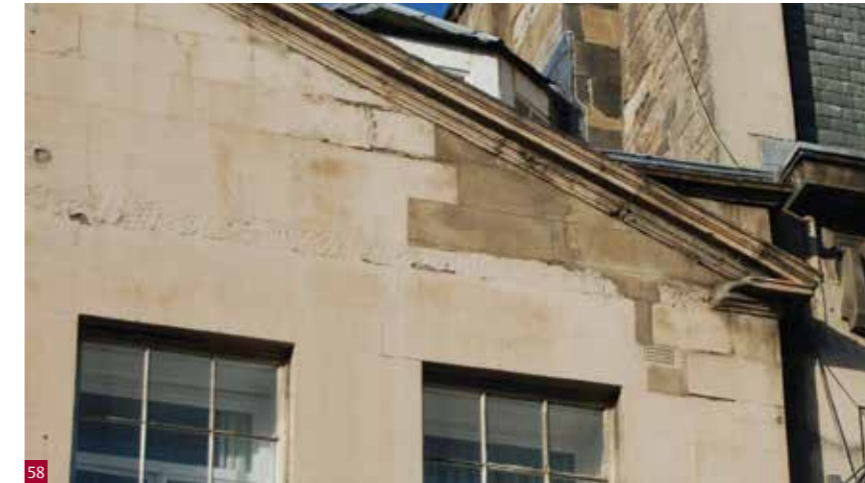
Fig. 58 A traditional masonry elevation where the cornice has been removed.

Often the importance of the details on parapets and cornices is not appreciated; sometimes they are thought to be purely decorative and in a misguided attempt to save money on repair work they are poorly repaired, allowed to decay or even removed (Fig. 58). In addition to the architectural damage, there is a technical penalty as well; the upper parts of a wall become wetter and consequent internal and external defects can develop.

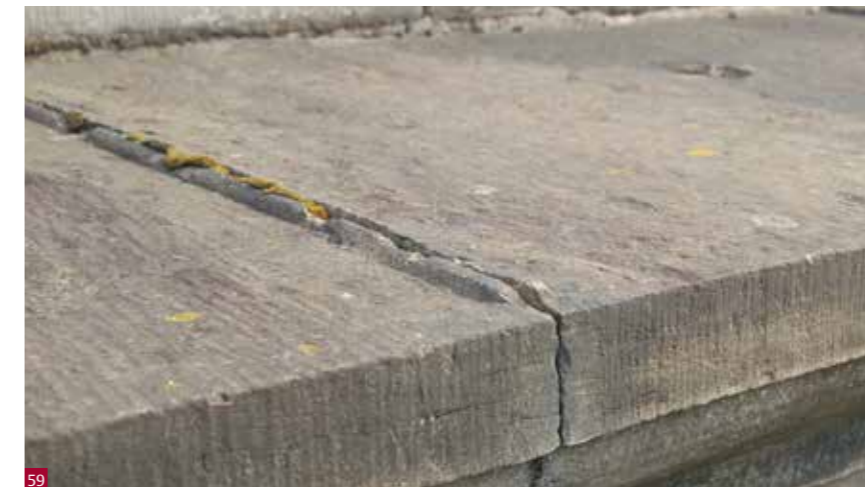
Fig. 59 A raised margin on a parapet to minimise water loading on the mortar joint.

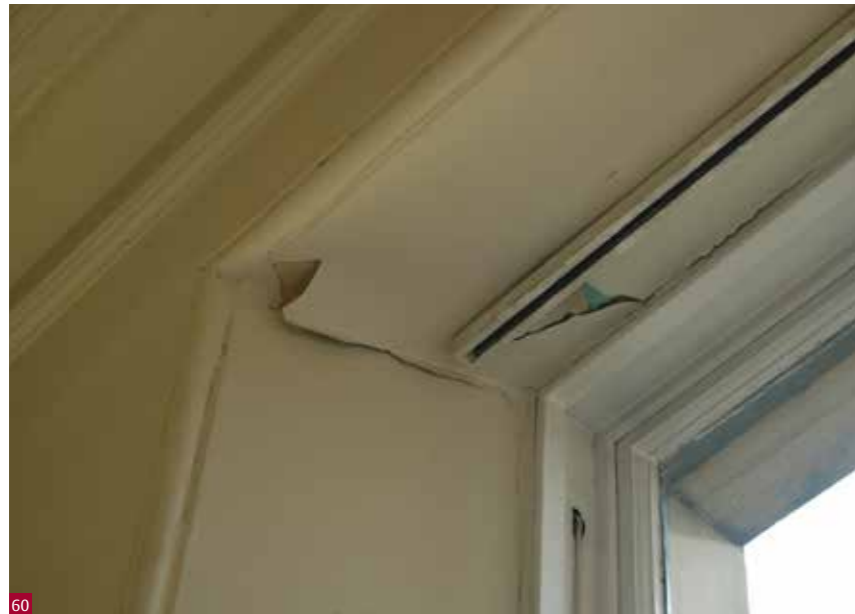
Fig. 60 Internal decorative damage, caused by water ingress.

Masonry parapets and cornices without such subtle detailing are not necessarily inadequate, but they will be more vulnerable to weathering of the mortar joints, leading to water ingress (Fig. 60). Careful attention to maintenance and appropriately specified ashlar repointing where necessary will adequately manage this risk.

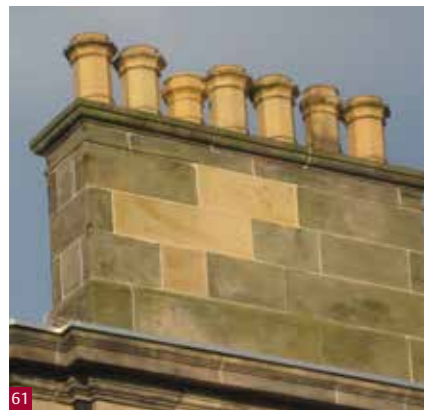
Fig. 61 Zinc protection to cornice and parapet below a repaired chimney.

Works to parapets and cornices should include the repair, reinstatement or introduction of new drip moulds and associated details to ensure water run-off (Fig. 61). Specialist repair mortars may be suitable in small areas of masonry damage, as they can be moulded and dressed to match the existing material, and are sufficiently durable (Fig. 62). For larger defects a new stone indent will be required (Fig. 63).

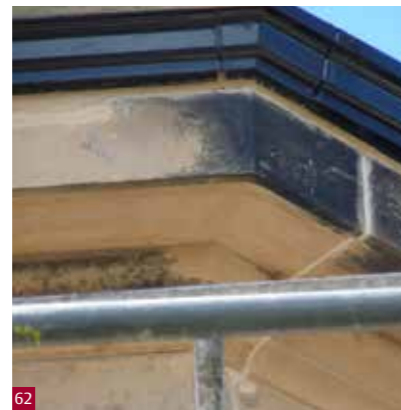
Fig. 62 An eroded cornice detail repaired with a restoration mortar.

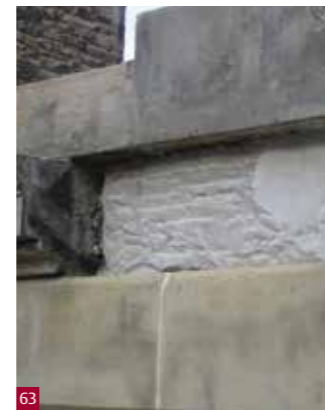
Fig. 63 Missing section of cornice awaiting replacement with a new section of masonry.

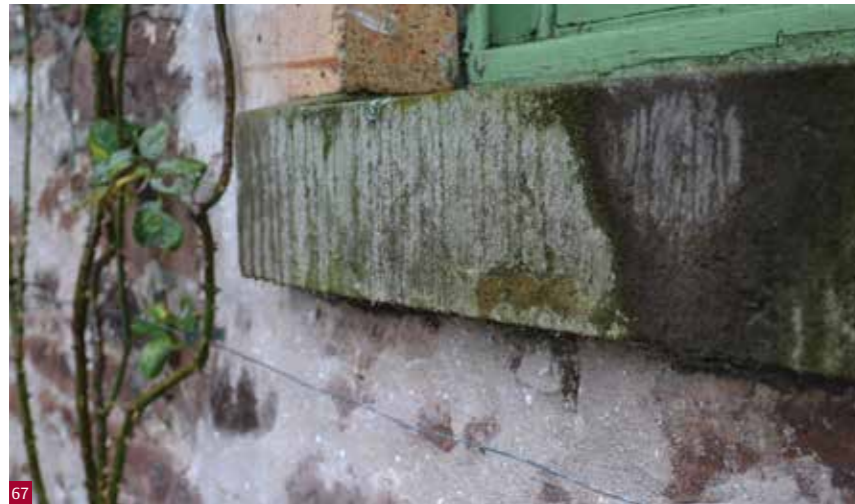
Fig. 67 Water being shed from a projecting window cill.

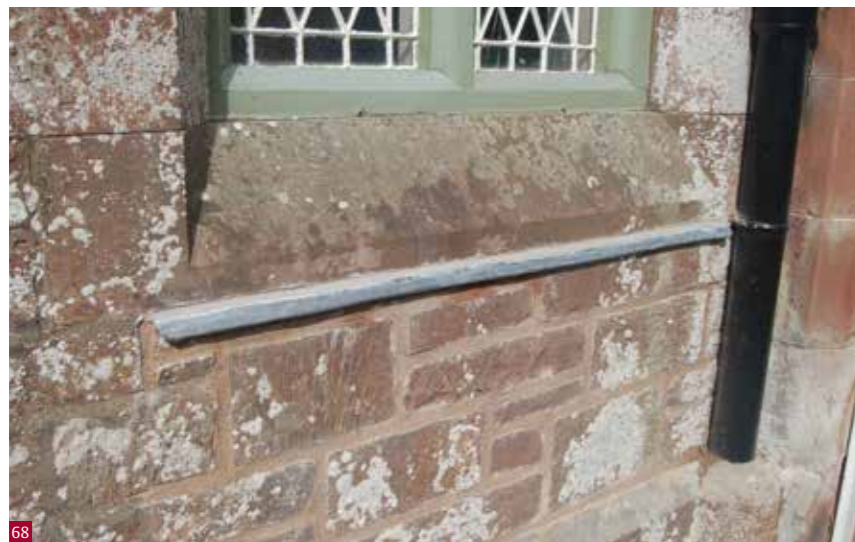
Fig. 68 New drip detail on a 19th century cill.

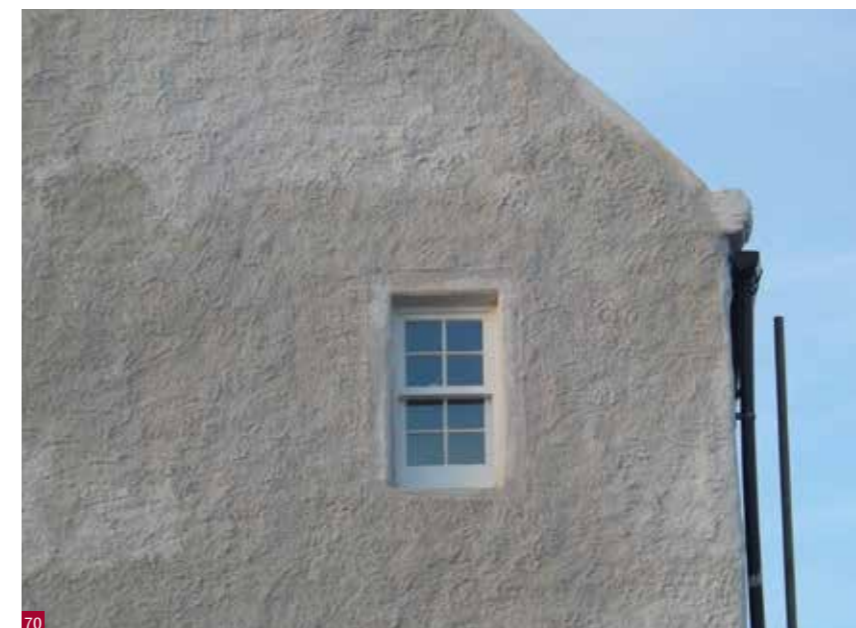
Fig. 70 The condition of this exposed 18th century building in Shetland was significantly improved by the use of a lime harl and lime wash.

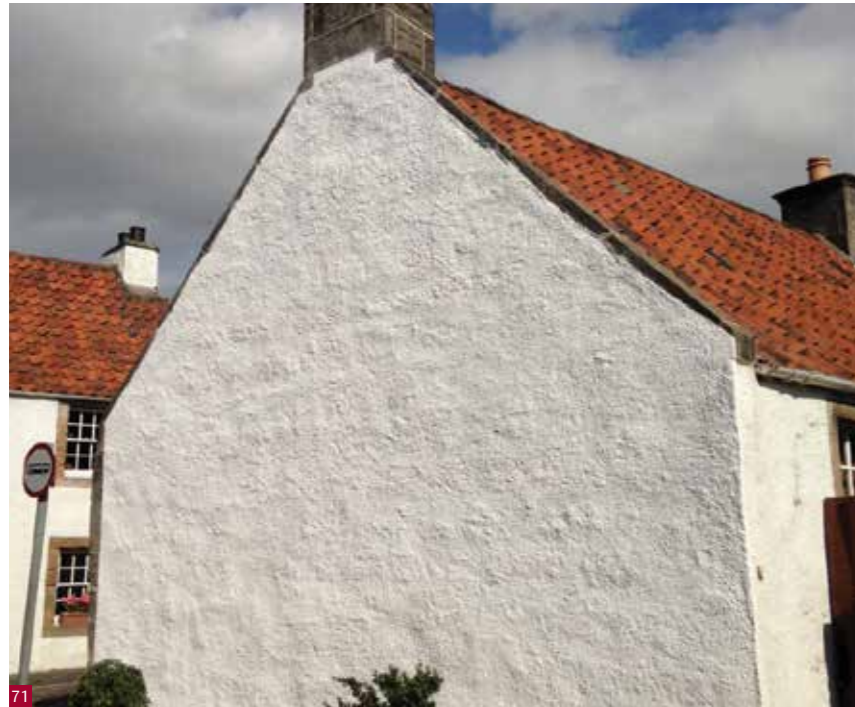
Fig. 71 Limewashing of masonry elevations consolidates the masonry units and the mortar.

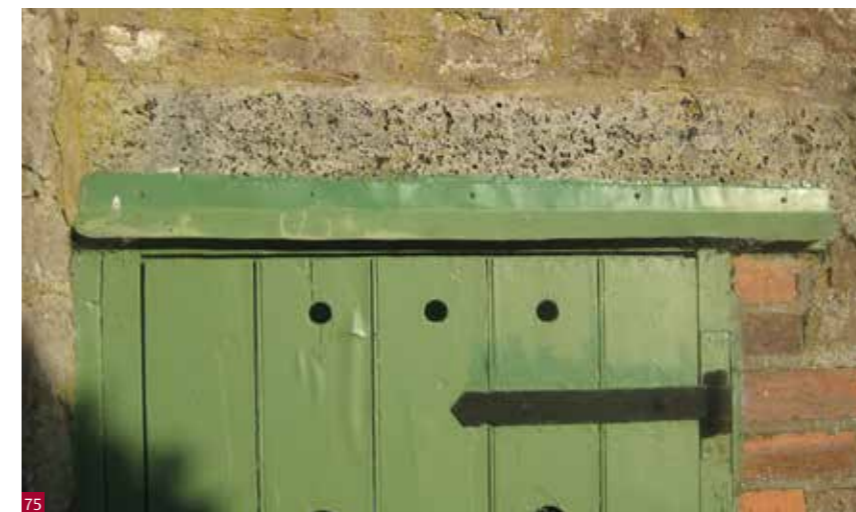
Fig. 75 The addition of a small hood over this flush mounted storeroom door has kept water off the top of the frame and the door.

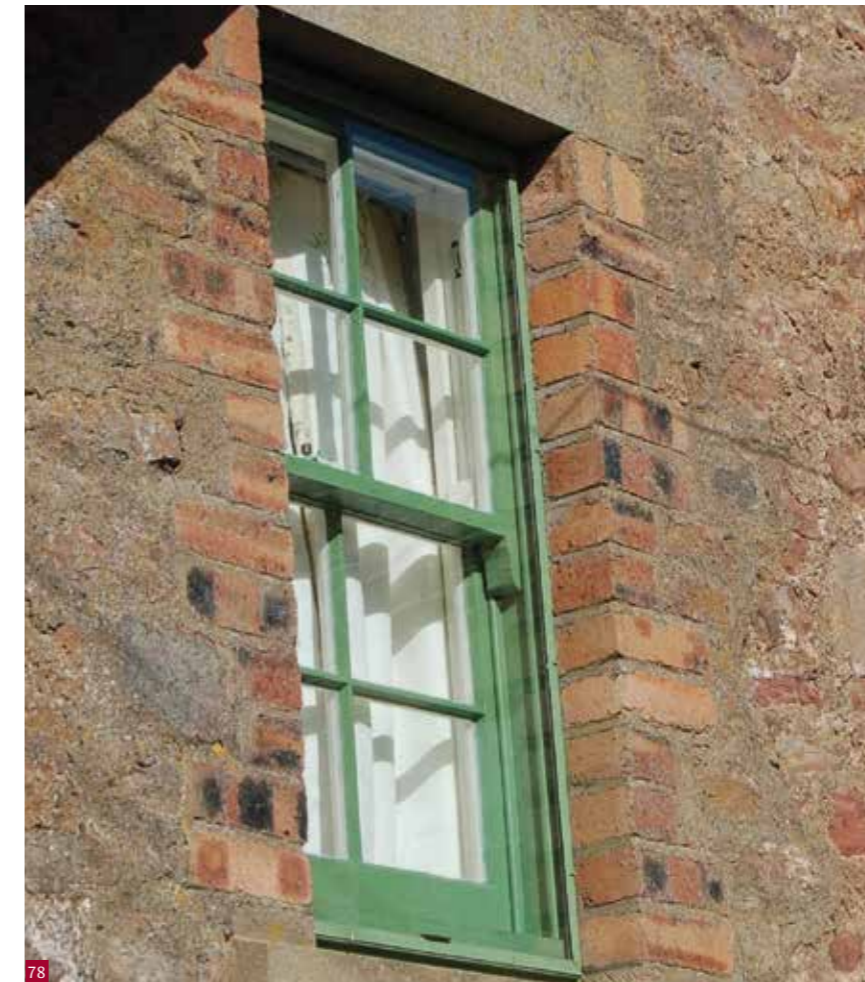
Fig. 78 Storm type external secondary glazing providing weather protection to a traditional window.

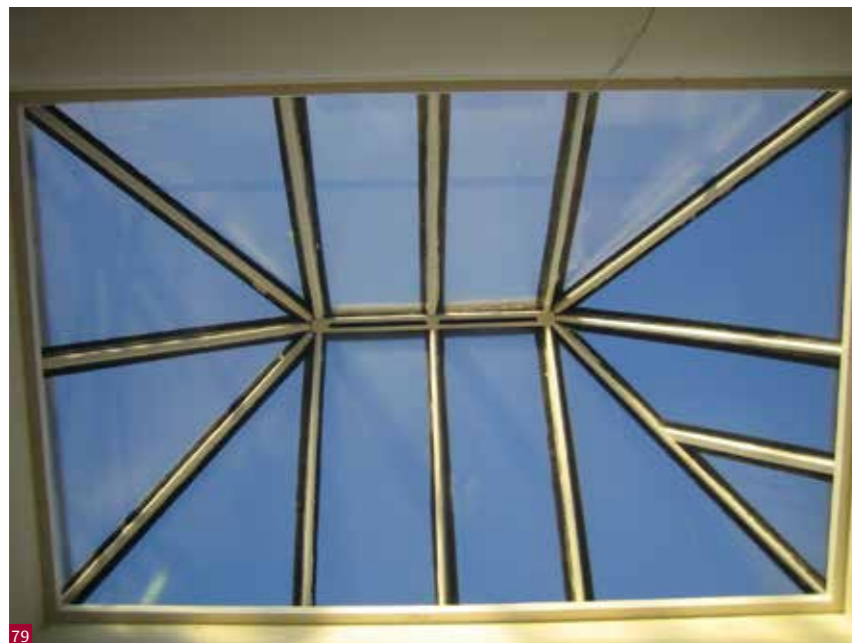
Fig. 79 A discreetly placed vent at the apex of a lightwell in an Edinburgh tenement stair.

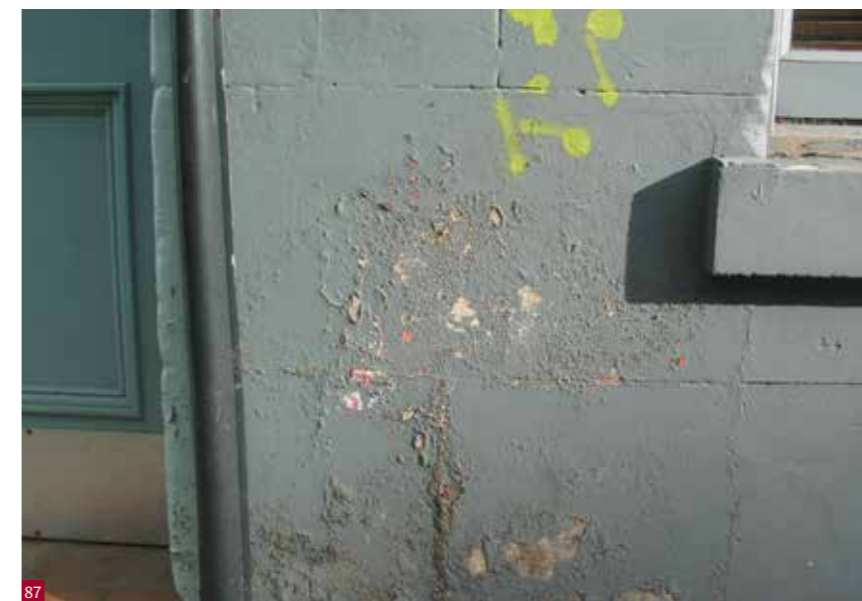
Fig. 87 Blistering external paint due to trapped moisture behind.

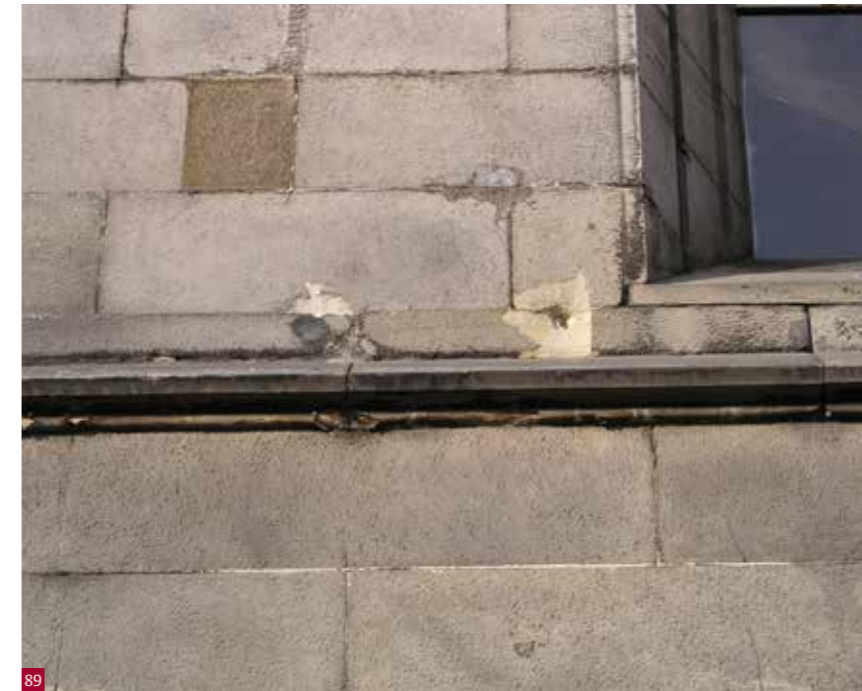
Fig. 89 Open joints in masonry have allowed water to penetrate, leading to corrosion of embedded iron cramps and fracturing of stone.
