# Energy Efficiency in Historic Buildings

Visby, February 9–11, 2011

## **Gotland University Press 15**

**Editors:** Tor Broström and Lisa Nilsen

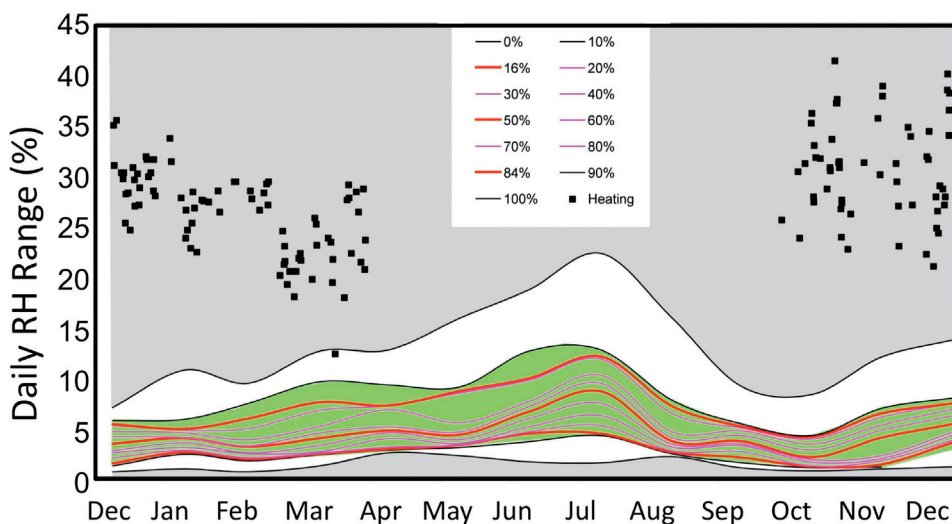
Fig. 3. An example of percentile distribution of Daily RH Range in a church in the Italian Alps in which warm-air-heating is occasionally operated. Green Area: the “safe” variability band, lying between the 7<sup>th</sup> and 93<sup>rd</sup> percentiles of the RH variability in the absence of heating operations (EN 15757). When heating is operated, the RH levels fall within the risk area; wooden statues and paintings on canvas are suffering damage.

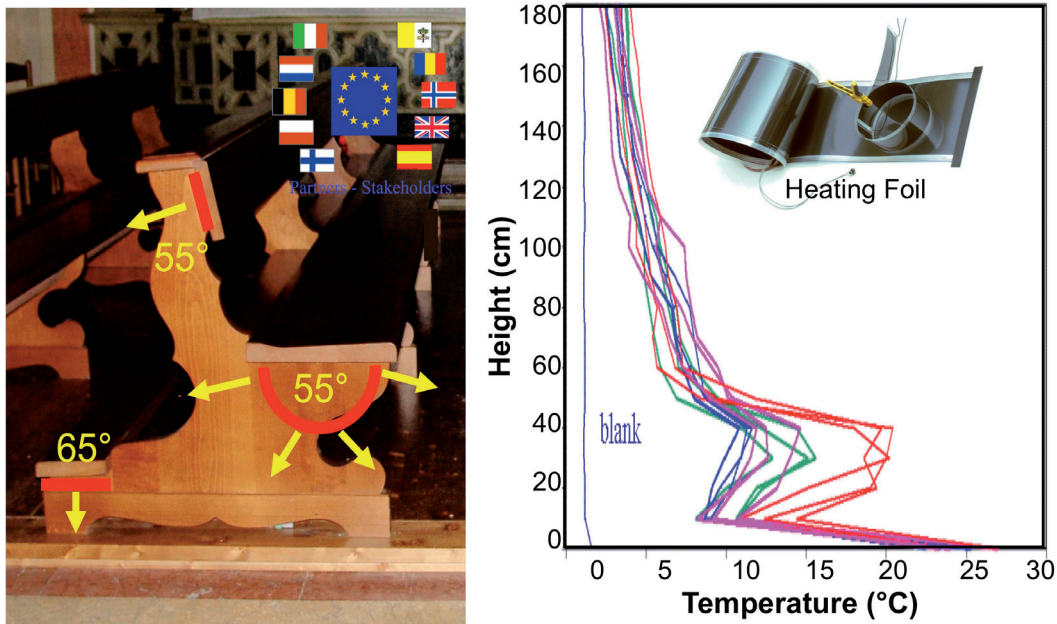
Fig. 6. Location and temperature of the heaters in the EU Friendly-Heating Project studied to preserve artwork in its natural microclimate and, at the same time, to warm people at a thermal comfort level compatible with conservation. On the right side, temperature profiles in the pew area, and a picture of the heating foils used to produce IR radiation.

The heating foils are made of an electrically heated layer of graphite microgranules deposited on fibreglass and sealed between two plastic foils. For their electrical resistance, the graphite granules are heated up when electric power is supplied. A positive fact is that the electrical resistance increases with granule temperature and reduces the current intensity. Consequently, the maximum temperature of the foil is self-regulated at levels specifically selected for various

parts of the body – in our case between 40 ° and 70 °C. This self-regulation provides a natural cut-out for the system and eliminates the risk of ignition or burning skin. A thermostat is added for further fine regulation and safety. Thermal comfort was improved with an ergonomic combination of heat sources distributed in the manned area below the kneeling pad to heat feet from the top, the seats to heat legs and calf, and the back of seats to heat hands and/or back (Fig. 6).

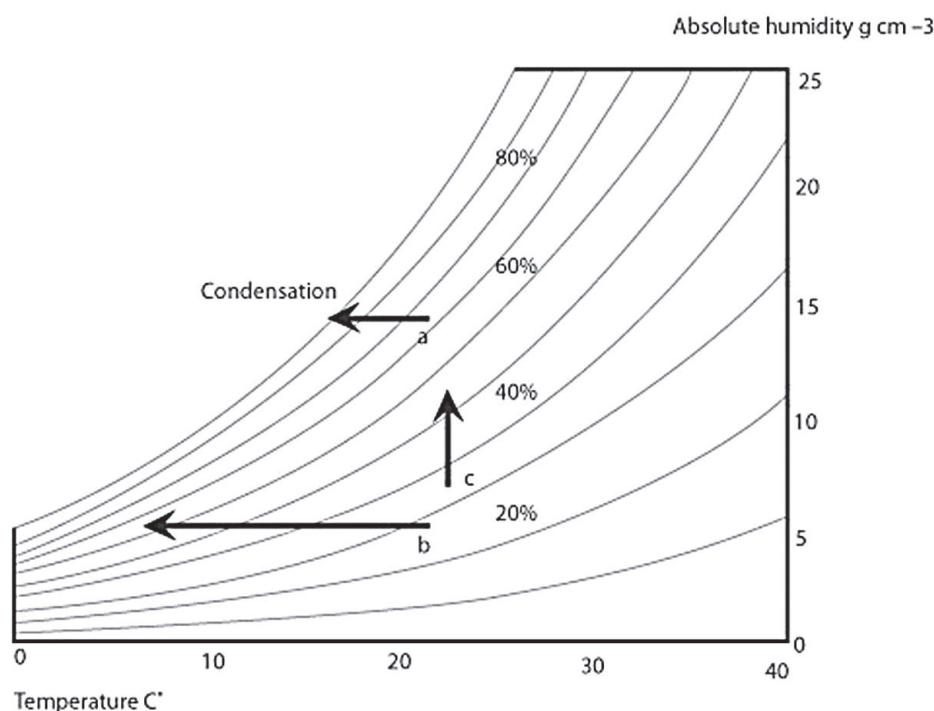
Fig. 1. A schematic illustration of the effect of a decreased temperature in the summer, e.g. on a colder wall, when the absolute humidity is high (arrow a), in the winter when the absolute humidity is low and there is no moisture addition indoors, e.g. in an unused church (arrow b) and the effect of moisture addition during services leading to higher RH and lower tolerance to temperature decrease (arrow c).

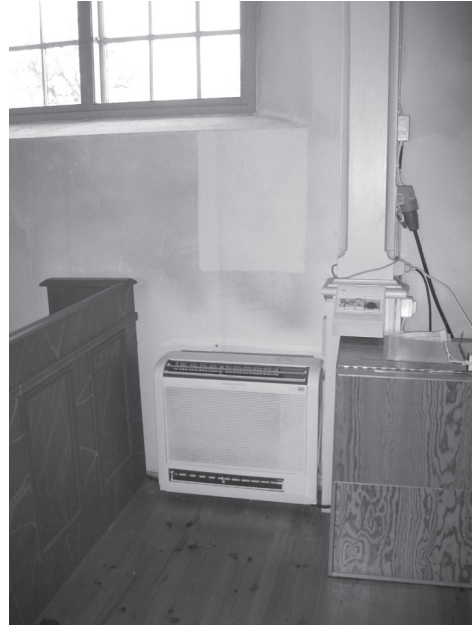
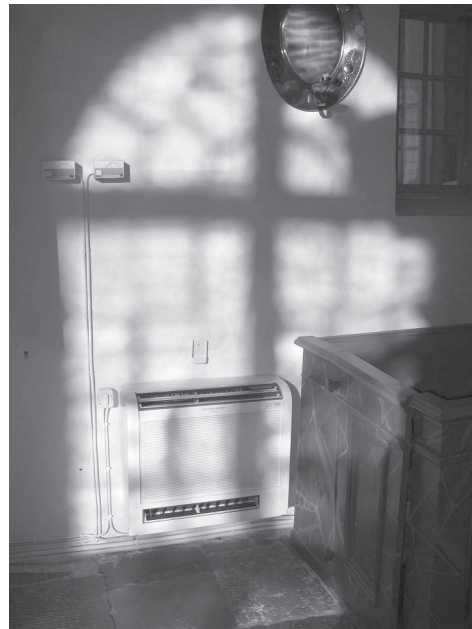
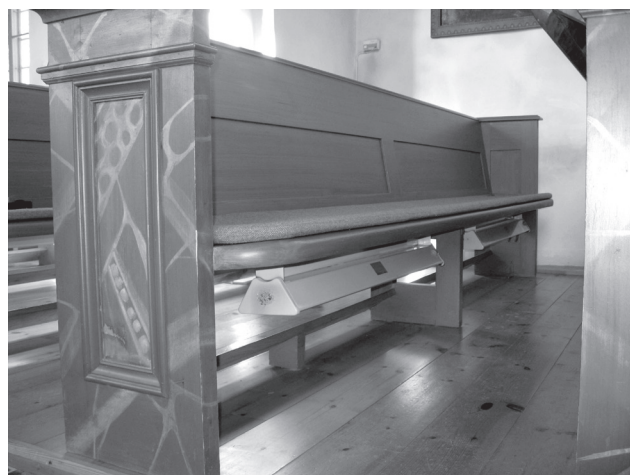
Fig. 3. Three photos showing heat pumps HP1 and HP2 and bench heaters.

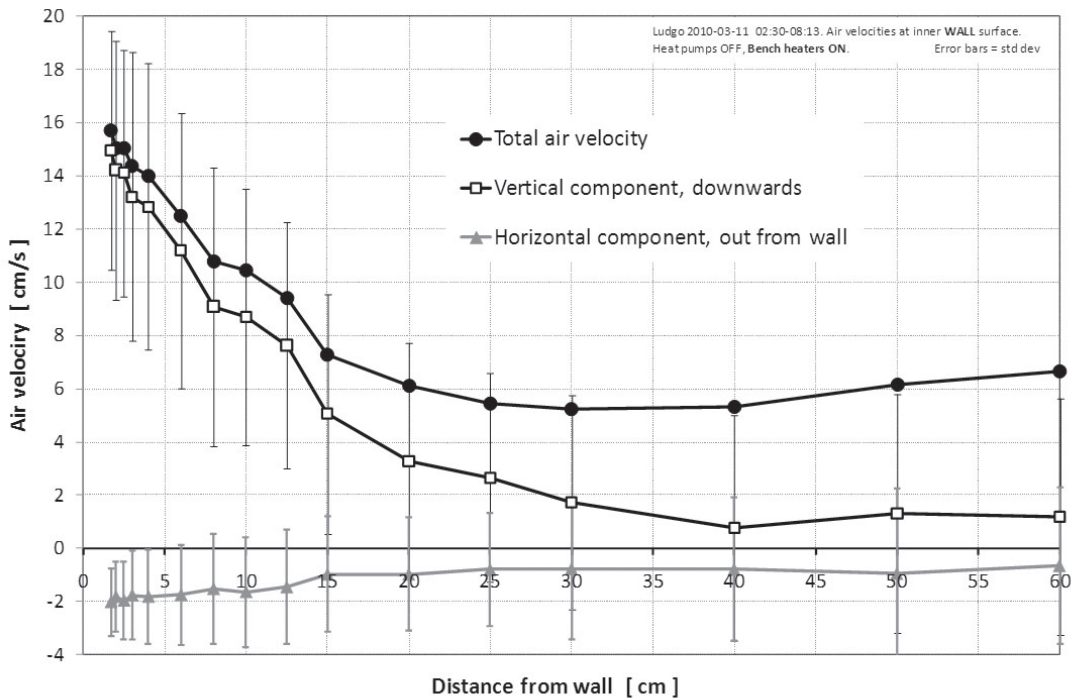
Fig. 8. Horizontal air velocity profiles at **wall** surface. **Bench heaters & Radiators active.** Error bars for the components = standard deviation.

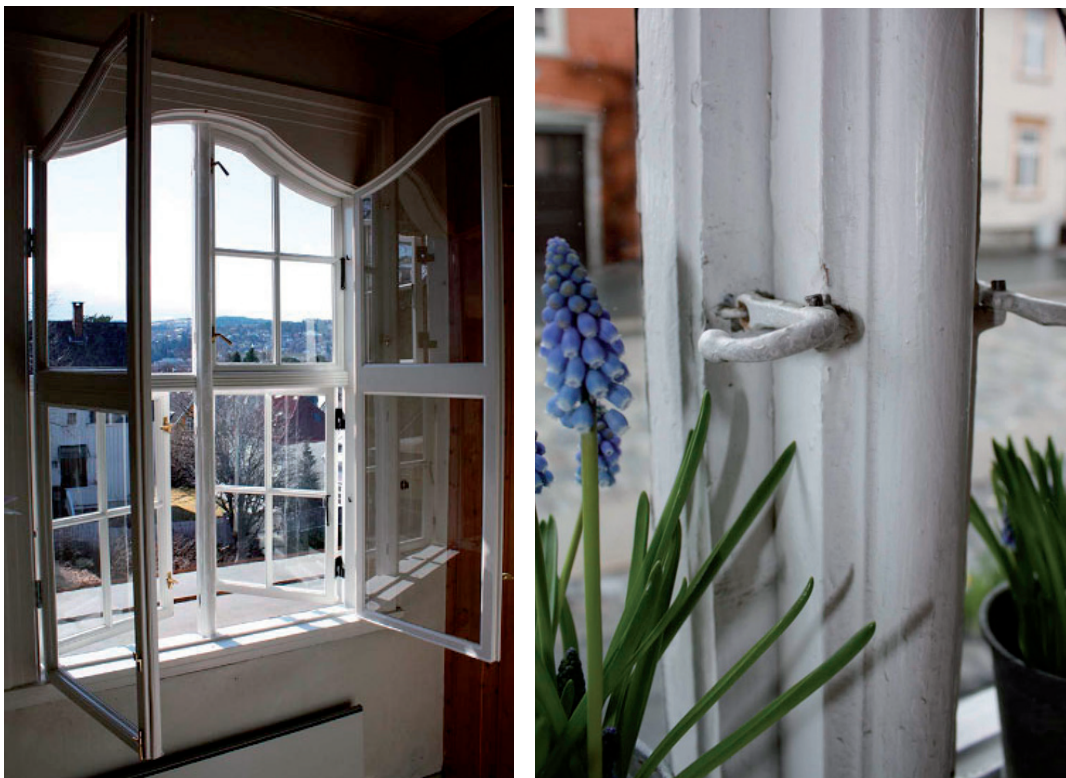
Fig. 3. Original windows are significant architectural elements, often with high-quality materials and excellent detailing. Secondary glazing systems are often part of the original window.

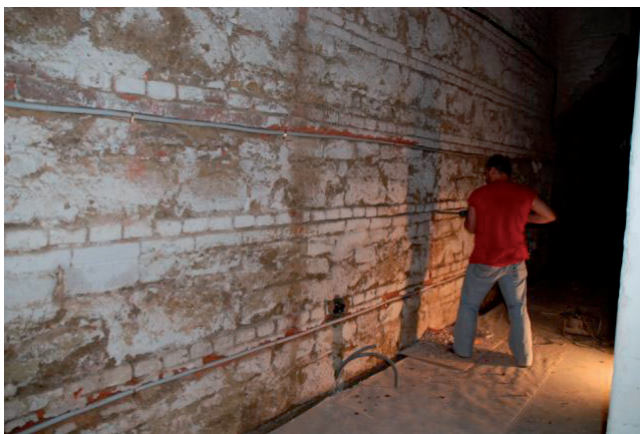
Fig. 8. Simple wall heating in the depot against humidity and for climate stability.

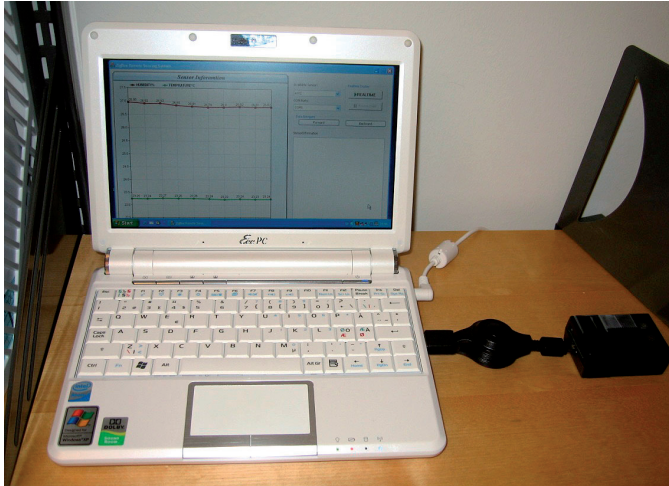
Fig. 13. Local server set-up in Linköping cathedral.

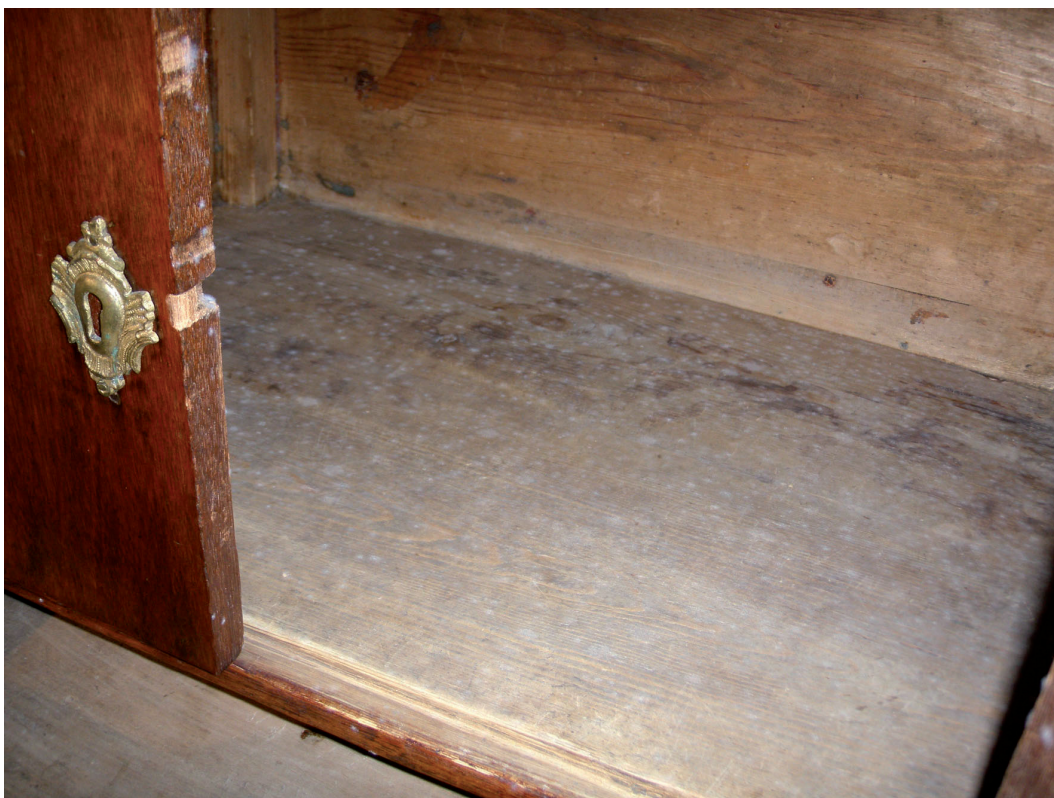
Fig. 2. Mould growth in a cupboard. *Photo: J. Bjurman.*
