Environmental Monitoring and Conservation Study of Drayton Hall in Charleston, South Carolina

MICHAEL J. MILLS and GEORGE FORE

Beset by the deterioration of architectural fabric at one of America's great historic houses, the National Trust completed an environmental monitoring and conservation study to serve as the basis for future treatment of the building.

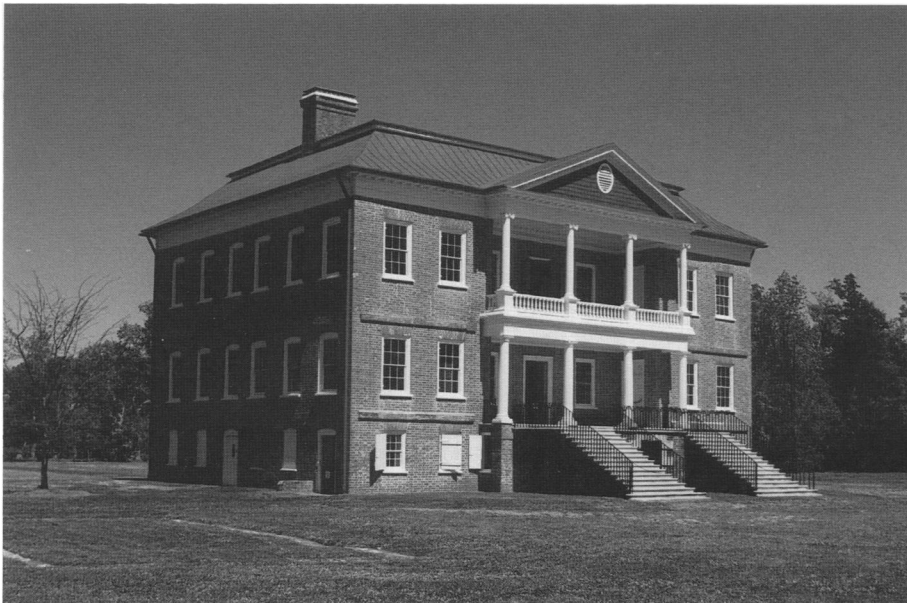
Fig. 1. Drayton Hall from the south and west showing the double portico. All photographs courtesy of Ford Farewell Mills and Gatsch, Architects.
