The challenge of rehabilitating relocated listed heritage Buildings: Requirements and opportunities

Malin Pedersen^{a,1}, Helga Margaretha Hognestad^{a,1}, Ronja Helle^{a,1,*}, Bjørn Petter Jelle^a

^a Norwegian University of Science and Technology (NTNU), Department of Civil and Environmental Engineering, NO-7491 Trondheim, Norway

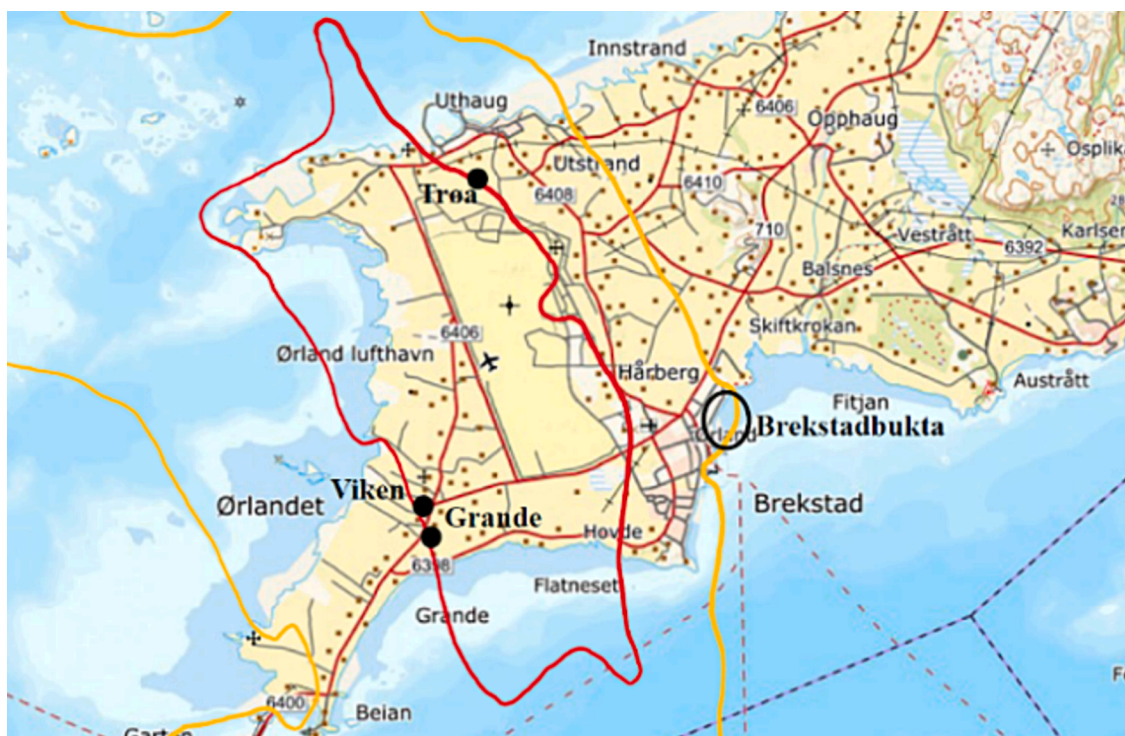
Fig. 2.1. Part of Ørlandet Municipality, showing Ørlandet and Brekstad. The red line represents the red noise zone, and the yellow line represents the yellow noise zone. The current location of the three assessed farmhouses (Trøa, Grande and Viken) and the recently designated Brekstad Bay (Brekstadbukta) area are also indicated. Drawn on the map from norgeskart.no. (For interpretation of the references to colour in this figure legend, the reader is referred to the web version of this article.)

Ørland Municipality is located at Fosenhalvøya in Trøndelag County [45]. Most of the population in Ørland Municipality lives near the northern coastline, in Brekstad and on the outer west peninsula, called Ørlandet. Ørlandet is a flat area characterized by agriculture and a military airport. In 2012 it was decided to establish a main combat aircraft base at Ørlandet for The Royal Norwegian Airforce [109]. This development will not only expand the existing base but also bring new aeroplanes. The increased noise levels from these aeroplanes will have an impact on the environment, including potential harm to both people and animals living in the area. As a result, The Norwegian Defence Estates Agency has designated a "red zone" around the base that will be most affected by noise, see Fig. 2.1.

Today, the three selected farmhouses are rurally located at some distance from the coast. Trøa is located near Uthaug, north of Ørlandet, while both Grande and Viken are situated in the southern part of Ørlandet, see Fig. 2.1. In the new residential area, the buildings' orientations and climate stresses will change. For instance, the proposed site for Viken is situated along the coast, resulting in significant alterations in the weather exposure the building will be subjected to. The farmhouse will be rotated approximately 220° based on cardinal directions (north being 0° and east being 90° etc.). Trøa will be somewhat protected from climate stresses by surrounding buildings, and the proposed orientation remains roughly the same. Grande will be situated farthest away from the coast but close to the road, causing issues concerning noise. Grande will be rotated about 50° from its original orientation. Fig. 2.2 shows the new locations of the buildings in Brekstad Bay.

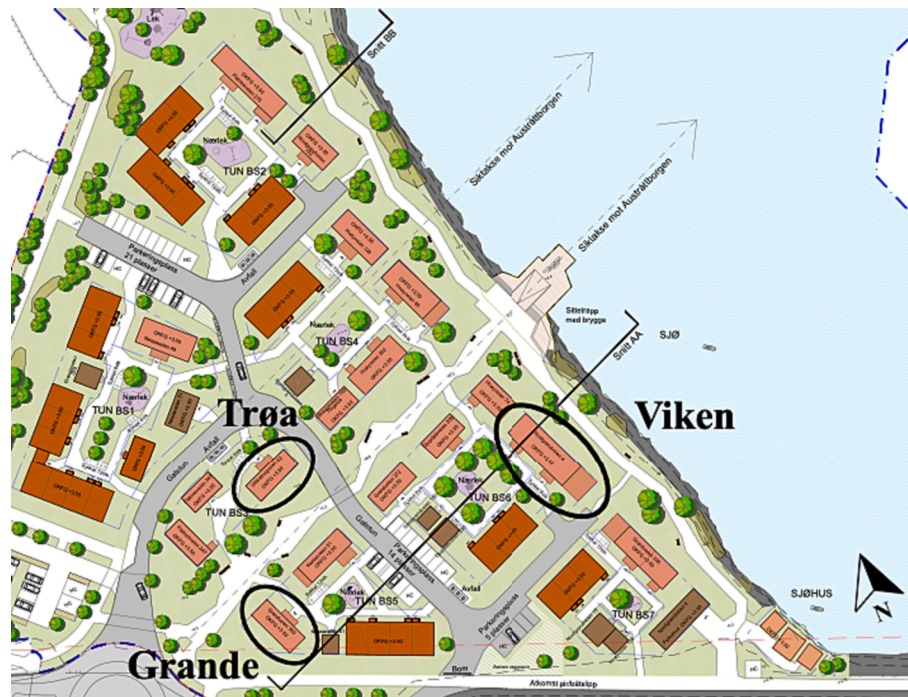
Fig. 2.2. Placement of Trøa, Grande and Viken in Brekstad Bay (Brekstadbukta) after relocation. Drawn on site plan received from Ørland Municipality.

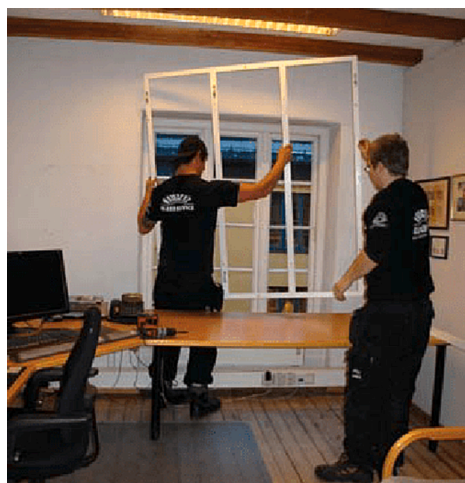
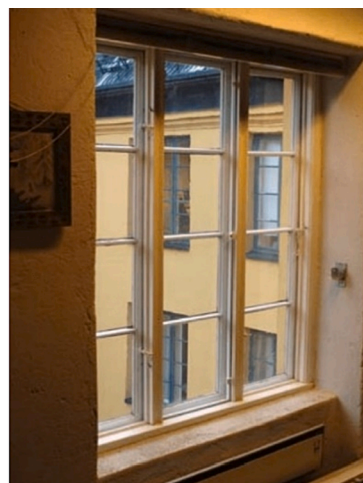
Fig. 3.1. Installation of a secondary glazing improving the window's U-value from 4.6 W/(m²K) to 1.6 W/(m²K). Photo: Marte Boro [125].

Restoration and/or installation of internal secondary glazing may lead to similar or more energy savings, according to Litti et al. [63]. Illustrating this point is a study conducted by Chandel and Aggarwal [20], where they found that the installation of a secondary glazing contributed to significant reductions in heat losses. Moreover, replacement of windows is not always compatible with preservation of heritage buildings and their cultural value. This is applicable for the case in Ørland Municipality, where there are regulatory requirements about preserving the exterior façades, something that must be accounted for when considering fenestration renovation. The original windows in listed buildings are an important part of building history and traditional craftsmanship [59]. Also, there are multiple reasons to preserve old

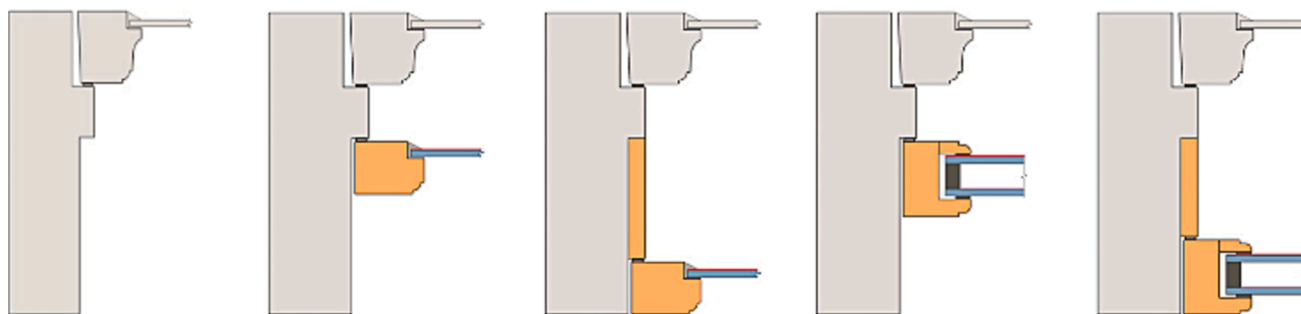
Fig. 3.2. Possible solutions for upgrading an old single-glazed window with an internal storm window of single or double glazed windowpane [50].

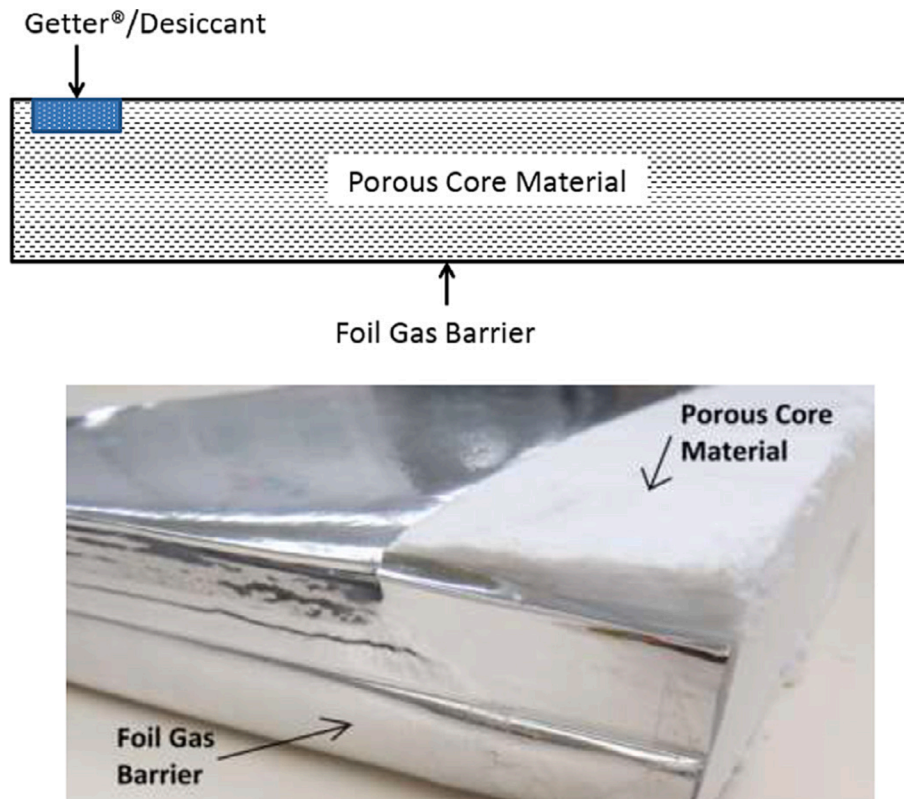
Fig. 4.1. VIP components [67].

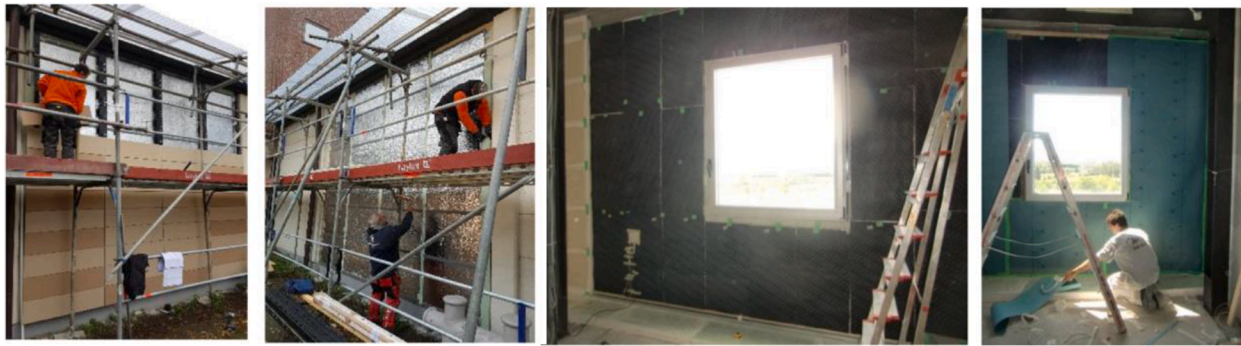
Fig. 4.2. External ventilated façade retrofitting with VIPs in Malmö (two left photos) and internal installation of VIPs in KUBIK by TecNALIA (two right photos) [116].

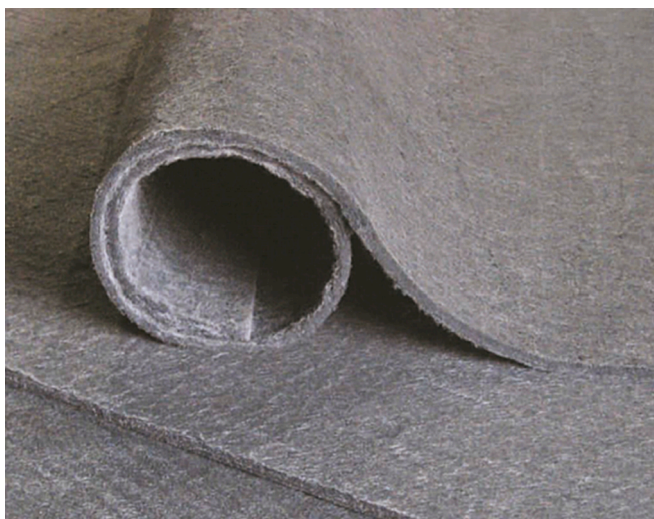
Fig. 4.3. Spaceloft® Aerogel insulation blanket developed by Aspen Aerogels, Inc. [39].

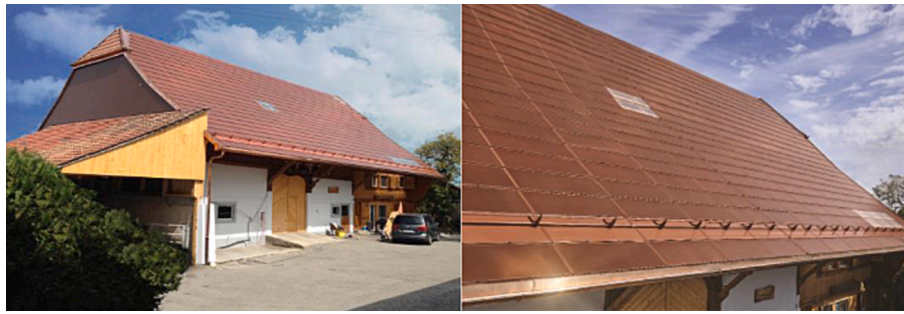
Fig. 5.1. Rural farmhouse in Switzerland from 1859 with terracotta coloured BIPV (right photo). The left photo shows the building before the energy upgrade. Photos from [75].

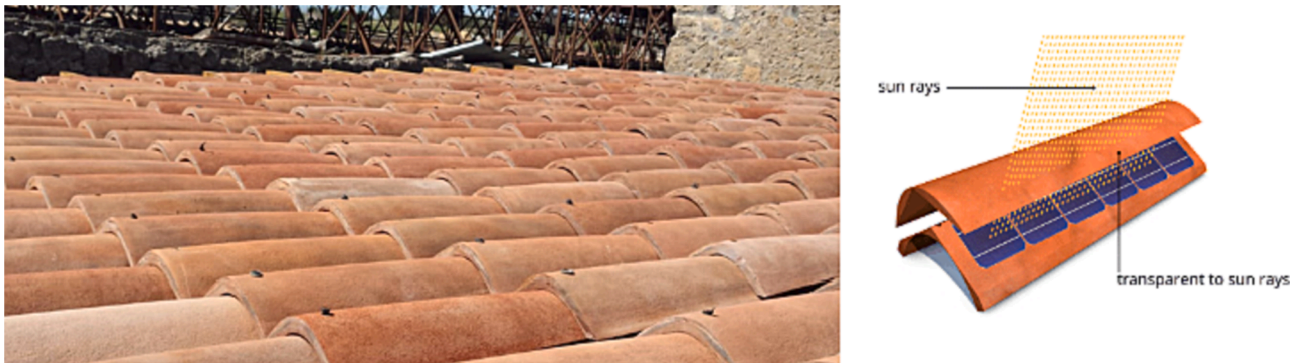
Fig. 5.2. Dyaqua Invisible Solar terracotta roofing tile [26].

The Italian company Dyaqua Invisible Solar has taken it one step further and recently launched an invisible solar roofing tile that realistically resembles a traditional terracotta roofing tile [26], as shown in Fig. 5.2. The PV cells are hidden underneath a low molecular polymeric compound surface which is opaque to human eyes, but transparent for sun rays. These tiles have a peak power of 7.5 Wp and weigh 2 kg per tile. The same company are also developing PVs that realistically look like other building materials, such as wood, stone and concrete, see Fig. 5.3, which can be applied to roofs, walls and pavements. However, the three last-mentioned products are not on the market yet. Still, they are worth a mention to show where the development of PV and BIPV technology is headed. Such realistic PV tiles could be of great importance for the integration and acceptance of PV in general, and especially for cultural heritage buildings and areas.

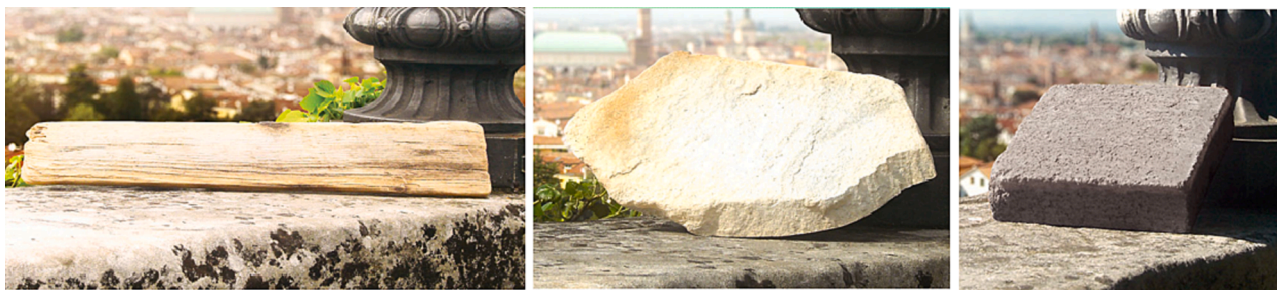
Fig. 5.3. PV-technology under development from Dyaqua [26]. PV with realistic-looking wood (left), stone (middle) and concrete (right) surface.

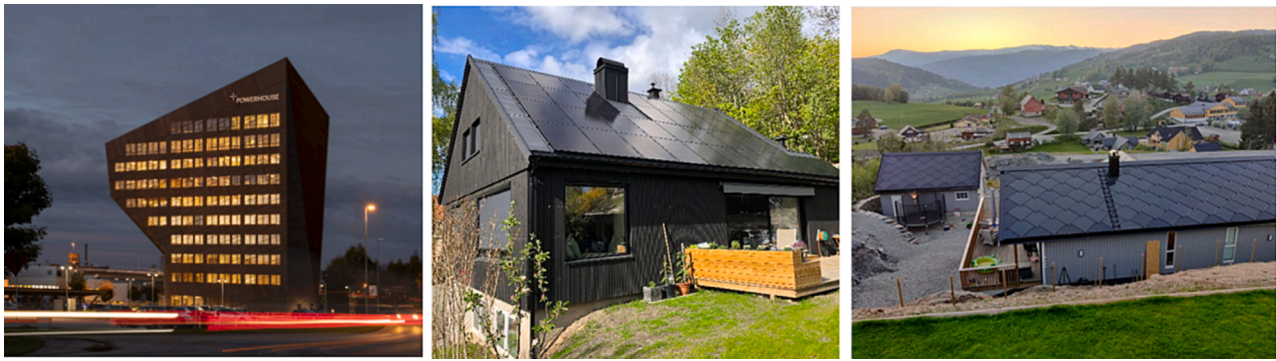
Fig. 5.4. Powerhouse Telemark (left) [77]. Two Norwegian houses with BIPV roofs (middle and right) [16].

Over the past few years, the accumulated capacity of solar power plants has increased in Norway [60]. Typical for Norway is to apply the PV panels to existing buildings as BAPV, and not installed as ground-mounted systems or BIPV. Nevertheless, the country has a growing interest for BIPV [16], and they are highly applicable due to low temperatures and low sun angle, especially on south-facing façades [60]. However, there are few agreed-upon and recommended solutions for building structures with BIPV, and this is not yet included in the “SINTEF Building Research Design Guides” (Byggeforskserien) [16], which is an important national information channel, knowledge base and quality standard used by builders, contractors, engineers, and architects [94]. Still, BIPV can be found in several Norwegian buildings, e.g., Powerhouse Brattørkaia, Telemark and Kjørbo [77], ZEB Laboratory in Trondheim (ZEB [124]), and several others shown in the studies by Bunkholt et al. [16] and Kvalbein & Stensrud Marstein [60]. Some of the aforementioned buildings with BIPV are depicted in Fig. 5.4.

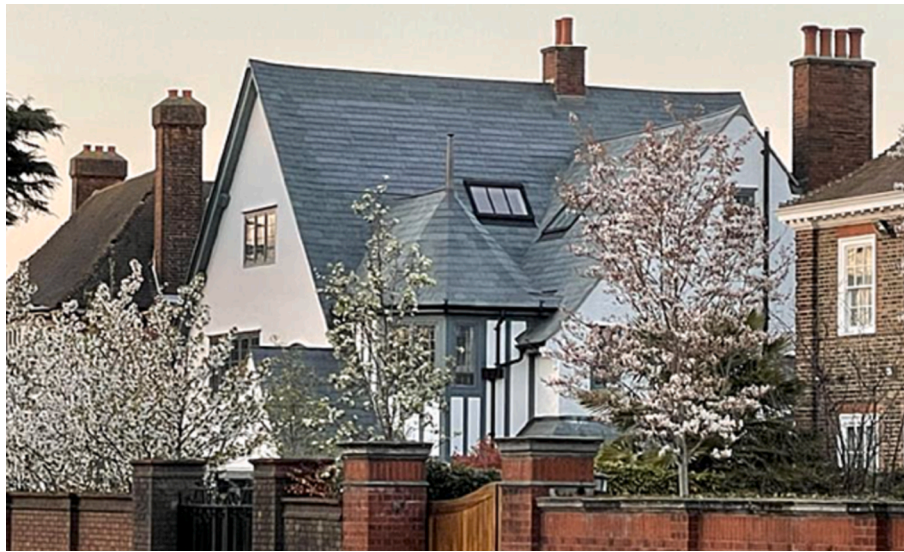
Fig. 5.5. PV Slates from GB-Sol [38].

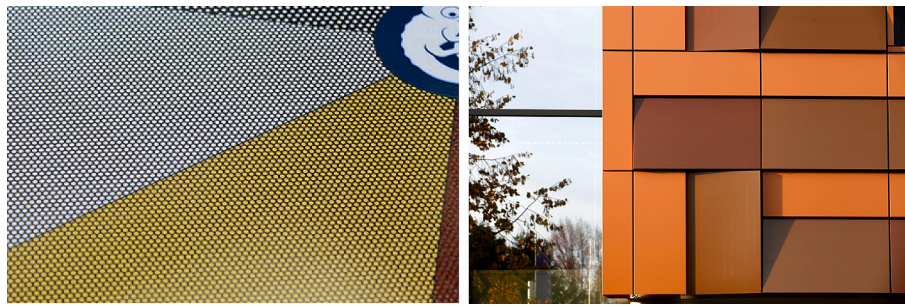
Fig. 5.6. Hexagon coloured pattern on ColorBlast PVs (left). Kuijpers - Helmond with ColorBlast PVs in orange shades from a distance, appearing as homogenous colours (right). Both images are retrieved from [96]. (For interpretation of the references to colour in this figure legend, the reader is referred to the web version of this article.)

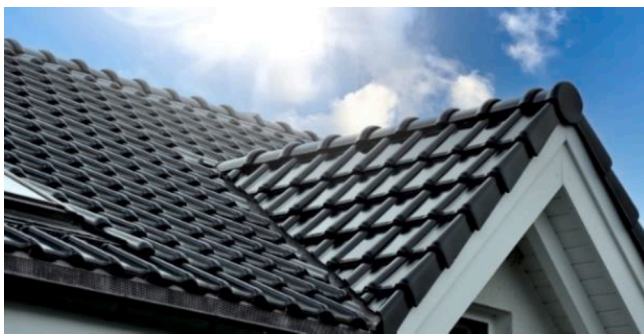
Fig. 5.7. Alegra 10 Wevolt solar roofing tiles by Wienerberger [121,120].

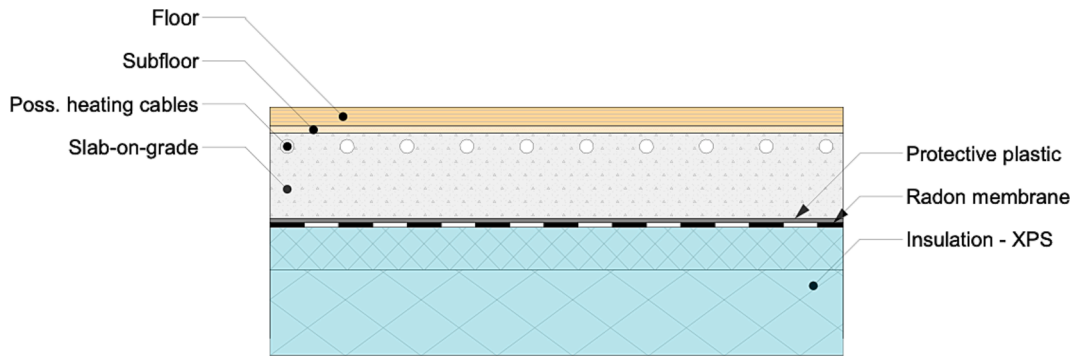
Fig. 6.1. Illustration of suggested new floor composition.

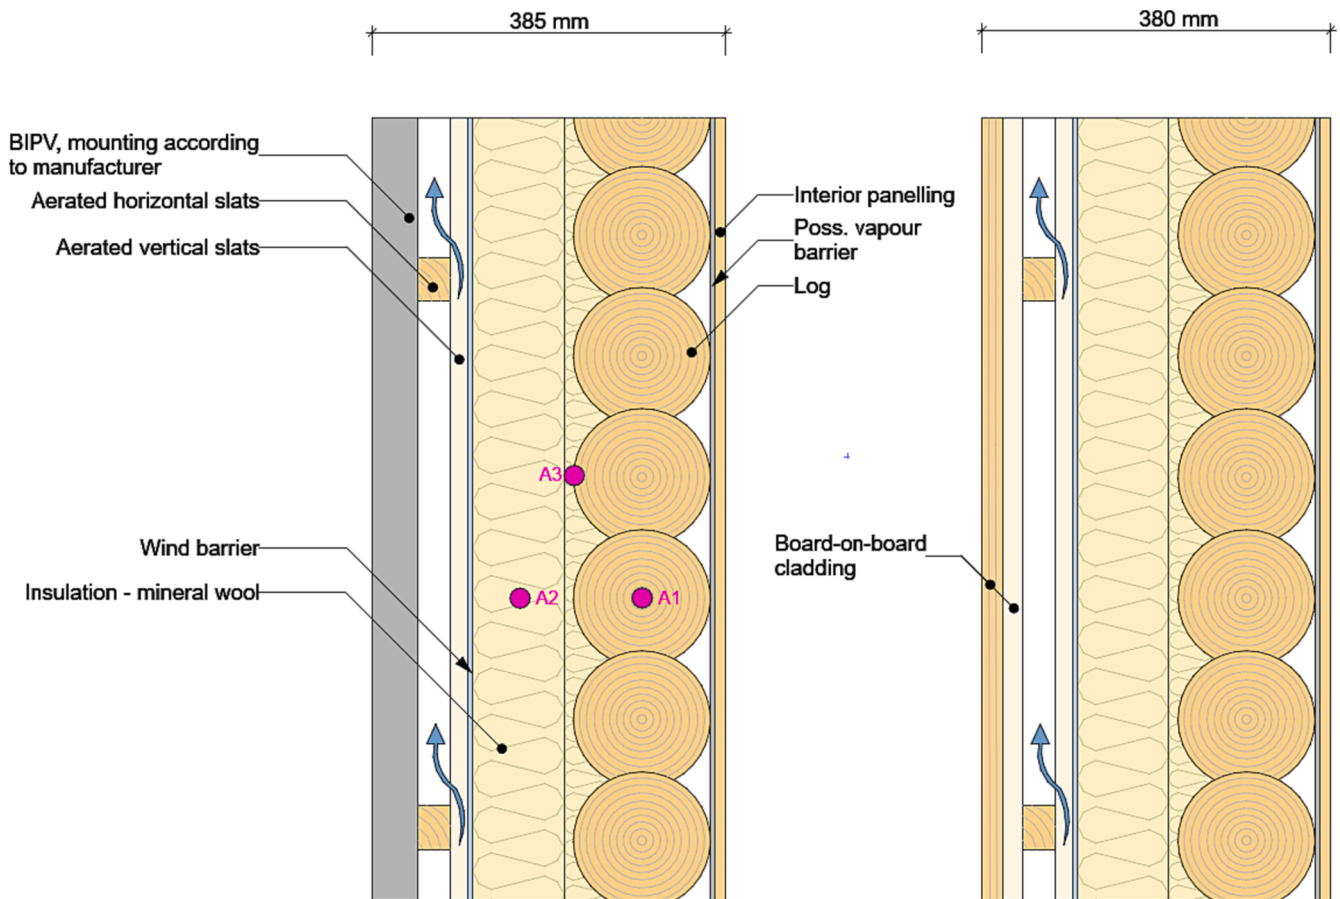
Fig. 6.2. Wall construction post-insulated with external mineral wool. The left wall suggests BIPV as exterior cladding, and the right wall illustrates traditional board-on-board cladding. Monitor positions and names for WUFI simulations are shown as pink dots. (For interpretation of the references to colour in this figure legend, the reader is referred to the web version of this article.)

insulated with 150 mm mineral wool (solution A), which gives a U-value of 0.26 W/(m²K). The mineral wool is placed in a framework and fills the gaps in the logs. While obtaining an adequate U-value, the

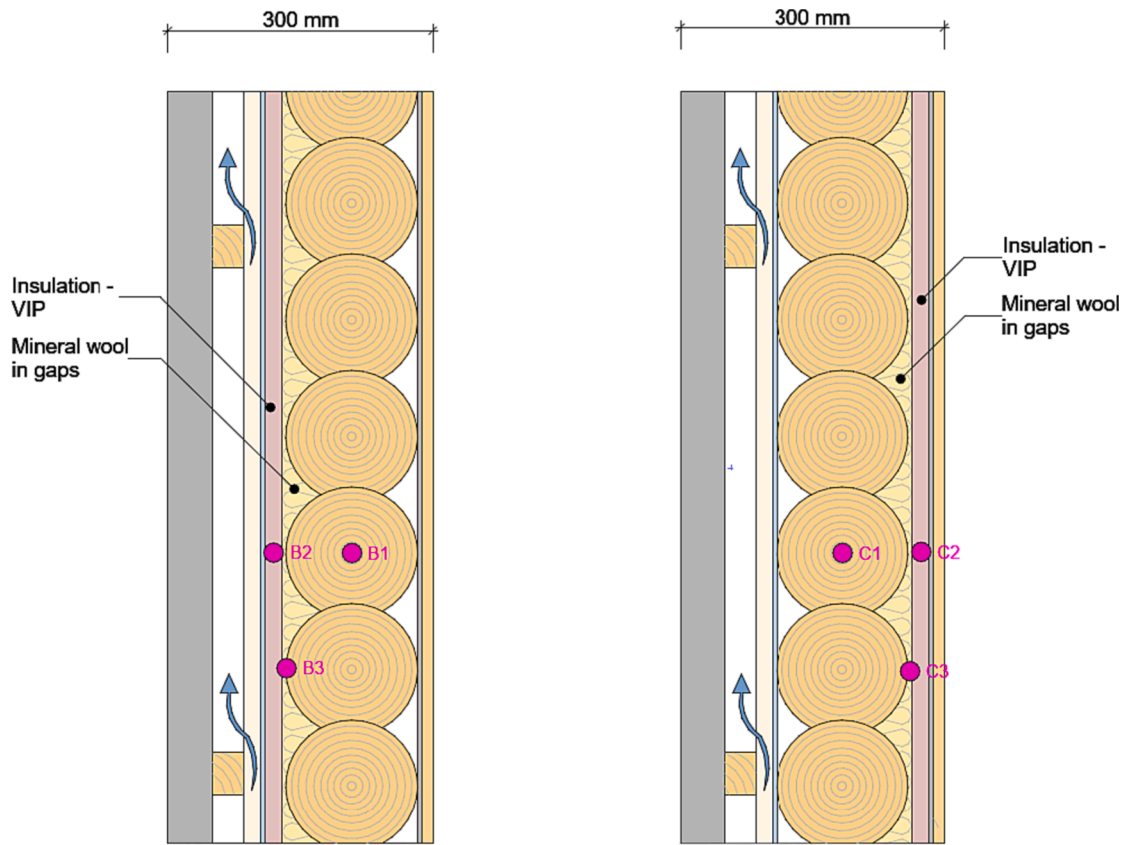
Fig. 6.3. Wall construction post-insulated with external VIP (B), and internal VIP (C). Monitor positions and names for WUFI simulations are shown as pink dots. (For interpretation of the references to colour in this figure legend, the reader is referred to the web version of this article.)

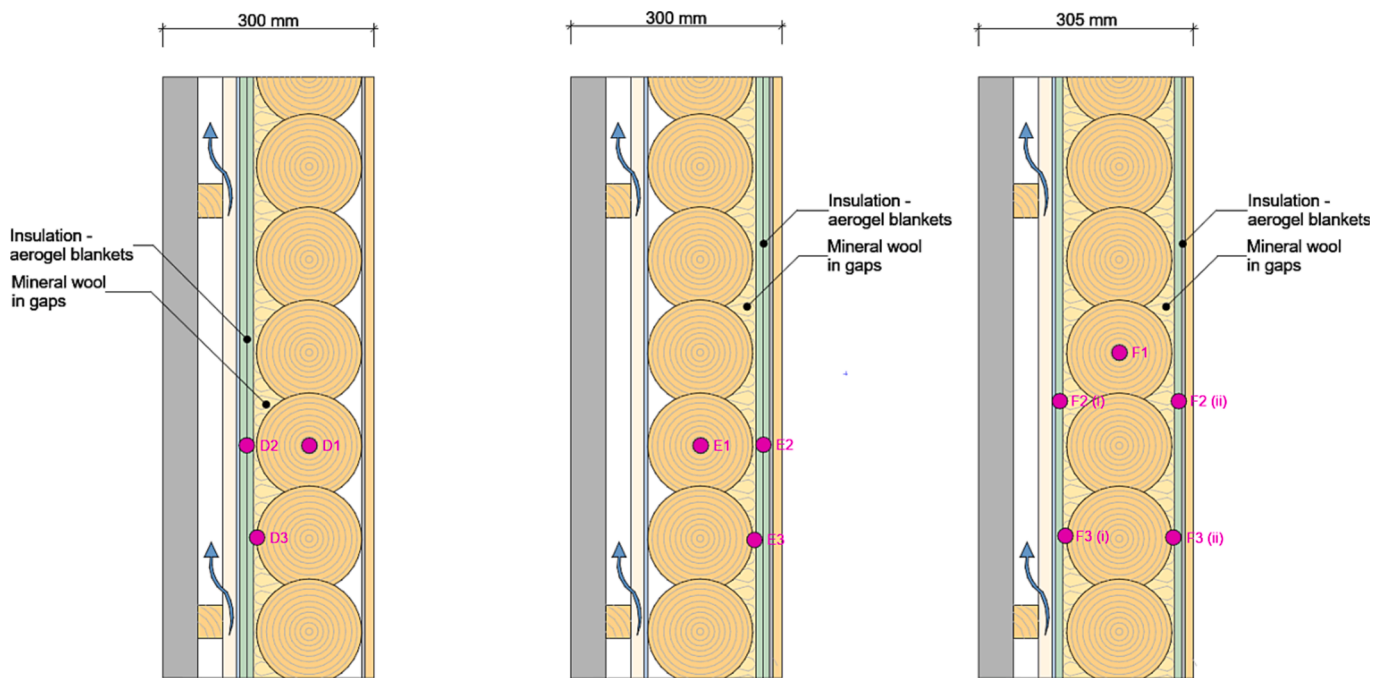
Fig. 6.4. Wall construction post-insulated with external aerogel insulation (D), internal aerogel insulation (E), and both (F). Monitor positions and names for WUFI simulations are shown as pink dots. (For interpretation of the references to colour in this figure legend, the reader is referred to the web version of this article.)

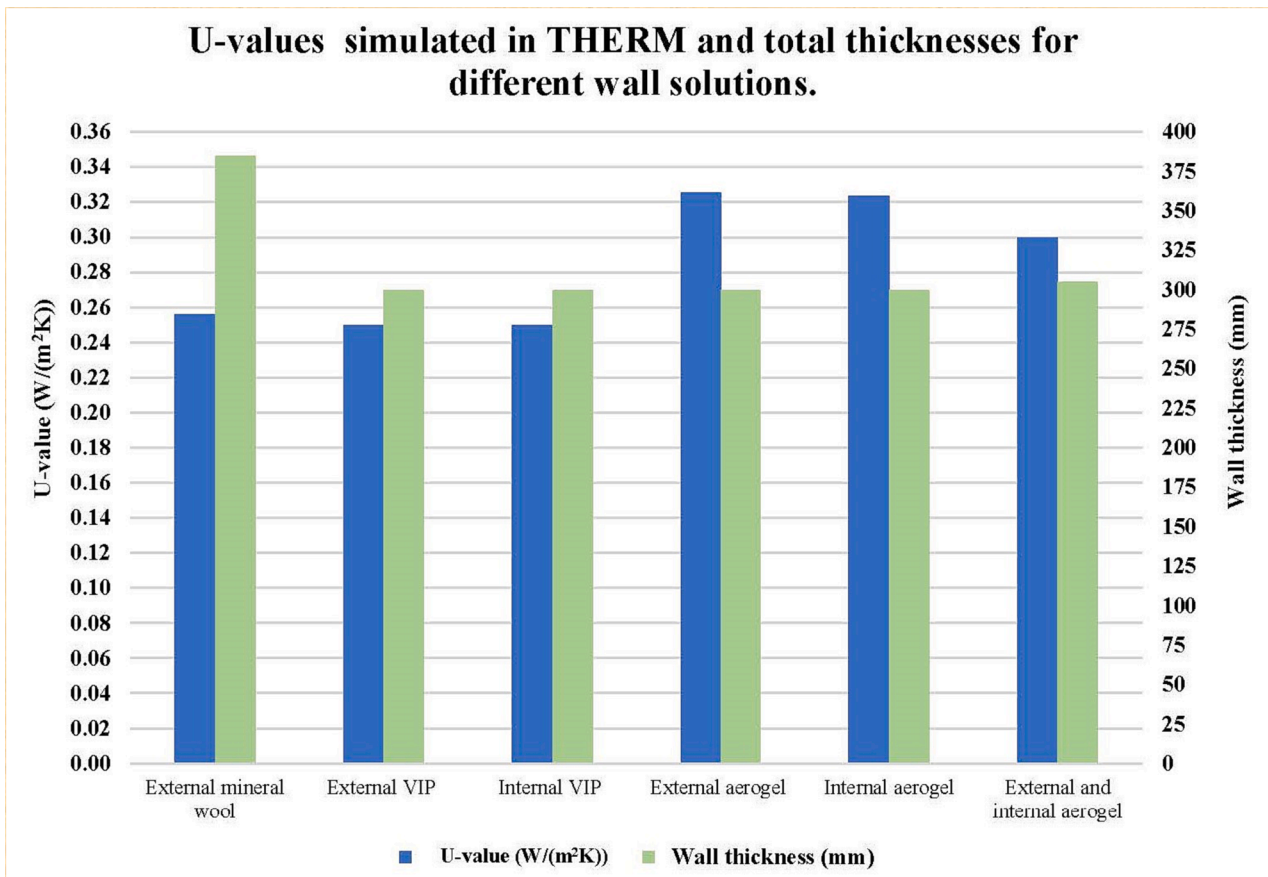
Fig. 6.5. U-values simulated in THERM and total thicknesses for different wall solutions.

solutions, but traditional board-on-board cladding is still an option. Fig. 6.5 shows a summary of the simulated U-values from THERM and the total wall thicknesses. Fig. 6.6, Fig. 6.7 and Fig. 6.8 illustrate the

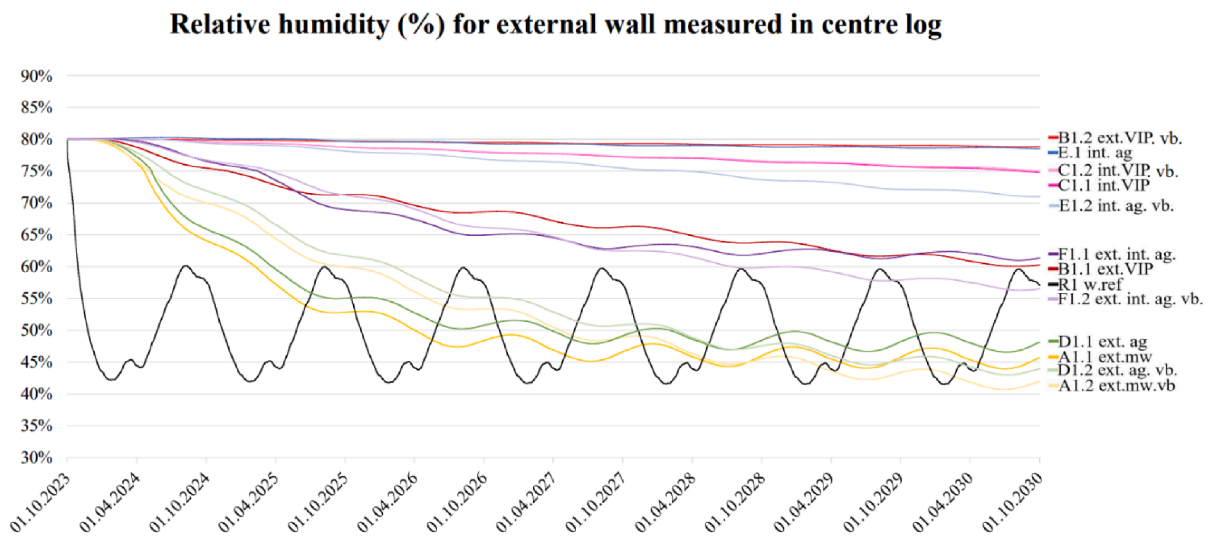
VIP. vb.: Solution C internal VIP with vapour barrier; D1.1. ext. ag.: Solution D external aerogel; D1.2. ext. ag. vb.: Solution D external aerogel with vapour barrier; E1. 1. int. ag.: Solution E internal aerogel; E1.2. int. ag. vb.: Solution E internal aerogel with vapour barrier; F1.1. ext. int. ag.: Solution F external and internal aerogel; F1.2. ext. int. ag. vb.: Solution F external and internal aerogel with vapour barrier; R1.w. ref.: Wall reference measured on interior surface.

Fig. 6.6. Relative humidity (%) for external wall measured in centre log (monitor position 1) for solution A-F.

logs (A1) will dry out well with this solution, see Fig. 6.6. In the centre of the mineral wool (A2), the graph (Fig. 6.7) demonstrates that the relative humidity (RH) fluctuates stably and gradually downward sloping. The peaks are during autumn and the troughs are during spring,

Measurements from the log centre (Fig. 6.6) and between the logs and the insulation (Fig. 6.8) show that external aerogel gives the best result out of the three solutions, where this solution both with and without vapour barrier results in low RH in the log, but over time the solution with vapour barrier will be the best by decreasing the most. Combined external and internal aerogel gives tolerable results by reducing the RH in the centre log (F1, Fig. 6.6) both with and without vapour barrier. In the junction between logs and insulation (F2 (i) and

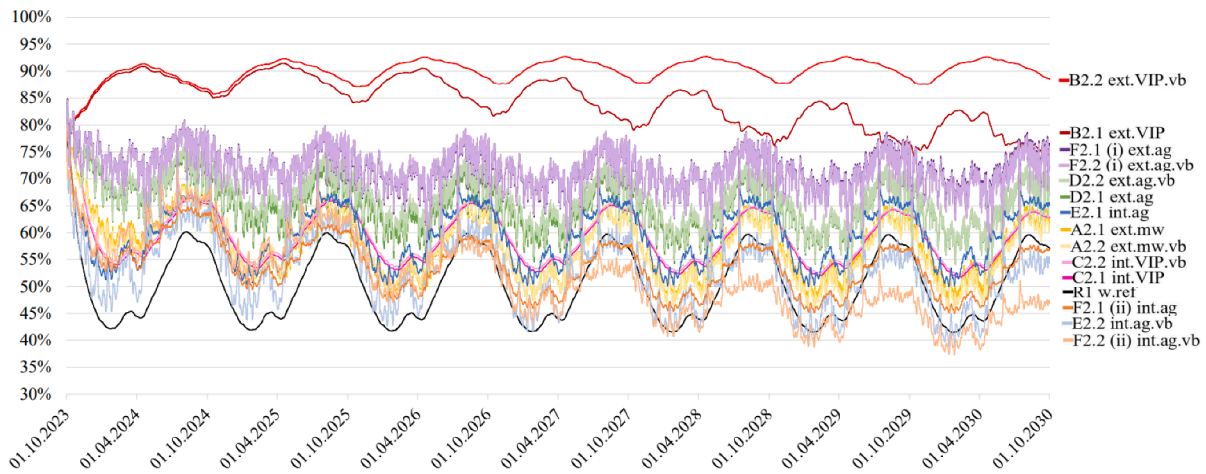
A2.1. ext. mw.: Solution A external mineral wool; A2.2. ext. mw. vb.: Solution A external mineral wool with vapour barrier; B2.1. ext. VIP.: Solution B external VIP; B2.2. ext. VIP. vb.: Solution B external VIP with vapour barrier; C2.1. int. VIP: Solution C internal VIP; C2.2 int. VIP. vb.: Solution C internal VIP with vapour barrier; D2.1. ext. ag.: Solution D external aerogel; D2.2. ext. ag. vb.: Solution D external aerogel with vapour barrier; E2.1. int. ag.: Solution E internal aerogel; E2.2. int. ag. vb.: Solution E internal aerogel with vapour barrier; F2.1.(i) ext. ag.: Solution F external aerogel; F2.2. (i) ext. ag. vb.: Solution F external aerogel with vapour barrier; F2.1. (ii) int. ag.: Solution F internal aerogel; F2.2. (ii) int. ag. vb.: Solution F internal aerogel with vapour barrier; R1. w. ref.: Wall reference measured on interior surface.

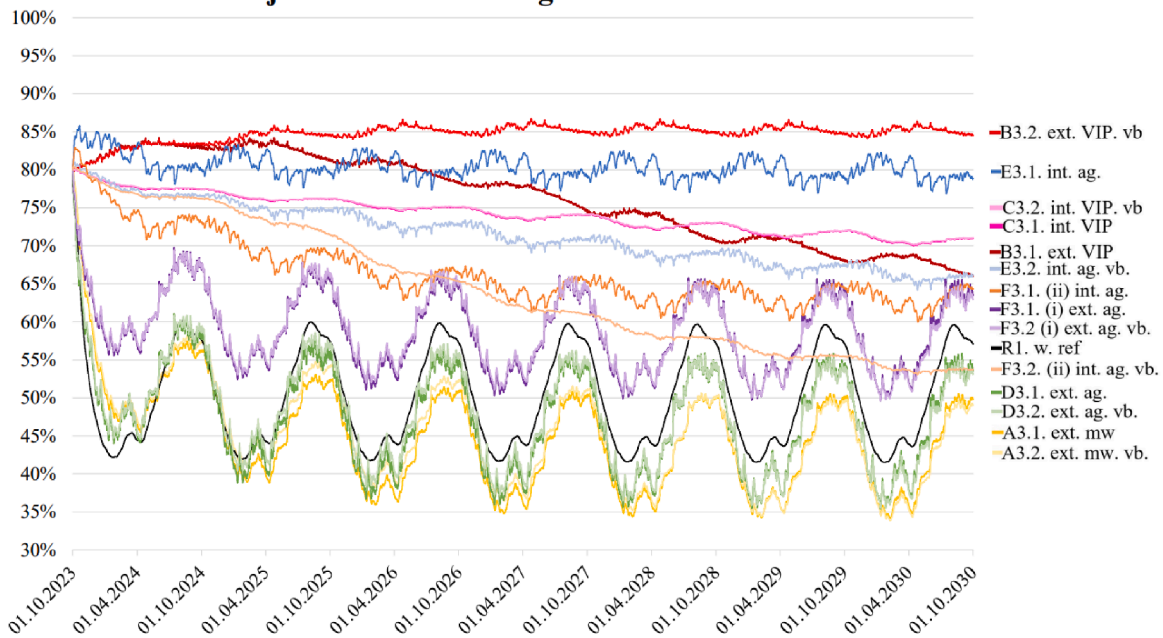
Relative humidity (%) for external wall measured in junction between log and insulation

A3.1. ext. mw.: Solution A external mineral wool; A3.2. ext. mw. vb.: Solution A external mineral wool with vapour barrier; B3.1. ext. VIP.: Solution B external VIP; B3.2 ext. VIP. Vb.: Solution B external VIP with vapour barrier; C3.1. int. VIP.: Solution C internal VIP; C3.2. int. VIP. Vb.: Solution C internal VIP with vapour barrier; D3.1. ext. ag.: Solution D external aerogel; D3.2 ext. ag. vb.: Solution D external aerogel with vapour barrier; E3.1 int. ag.: Solution E internal aerogel; E3.2. int. ag. vb.: Solution E internal aerogel with vapour barrier; F3.1. (i) ext. ag.: Solution F external aerogel; F3.1. (ii) int. ag.: Solution F internal aerogel; F3.2 (i) ext. ag. vb.: Solution F external aerogel with vapour barrier; F3.2. (ii) int. ag. vb.: Solution F internal aerogel with vapour barrier; R1. w. ref.: Wall reference measured on interior surface.

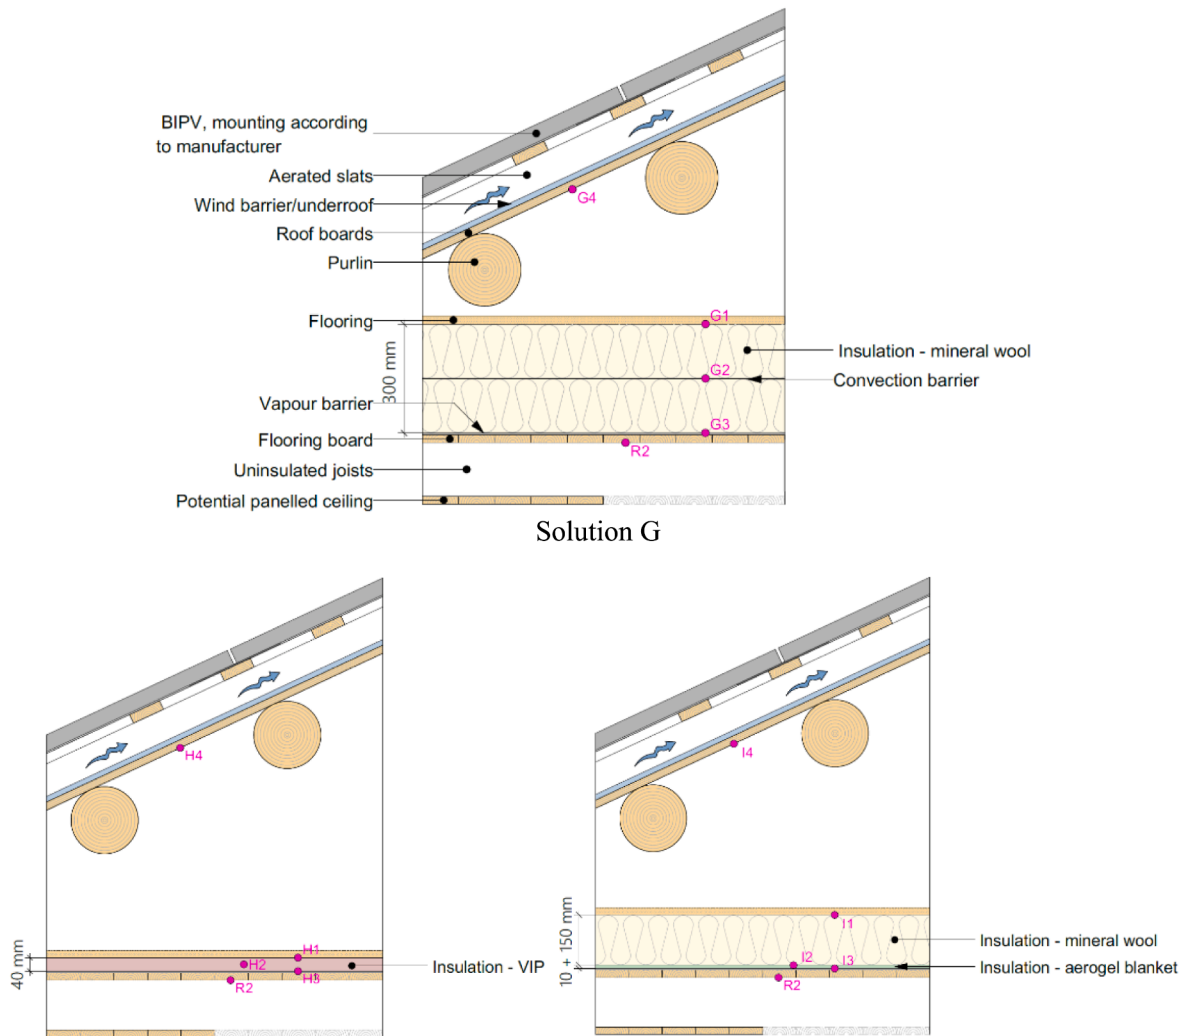
Fig. 6.9. Three possible solutions for post-insulating above the joists against the cold attic: Solution G with mineral wool, Solution H with VIPs, and Solution I with aerogel and mineral wool. Monitor positions and names for WUFI simulations are shown as pink dots. (For interpretation of the references to colour in this figure legend, the reader is referred to the web version of this article.)

The proposed solutions (G-I) are illustrated in Fig. 6.9, and the only difference between them is the insulation layer. All the studied solutions satisfy the maximum U-value requirement of 0.18 W/(m²K), see Fig. 6.10. Solution G has a thick layer of mineral wool, hence more of the attic space is used but the obtained U-value is relatively low; 0.11 W/(m²K). The large thickness could be a disadvantage if the space is limited and are going to be used for storage, e.g., for ventilation and BIPV equipment. In this case, solution H using VIPs may be more suitable

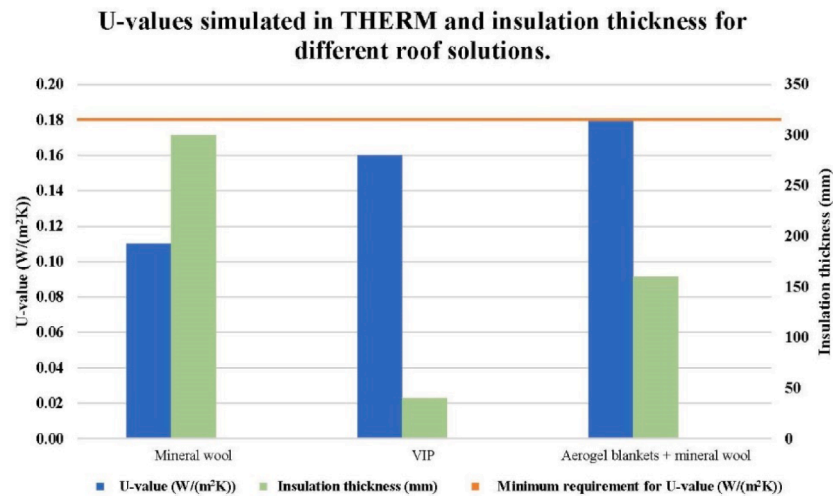
Fig. 6.10. U-values and insulation thickness for three different roof solutions for post-insulation above the joists against the cold attic simulated in THERM.

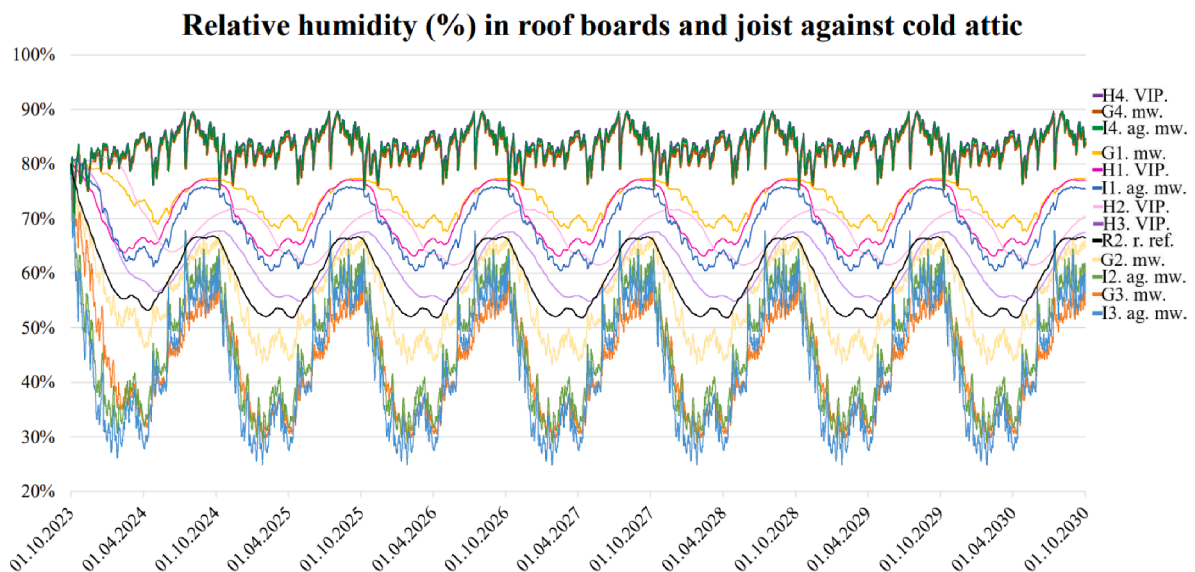
G1-4. mw.: Solution G, monitor position 1-4, mineral wool; H1-4. VIP.: Solution H, monitor position 1-4, VIP; I1-4. ag. mw.: Solution I, monitor position 1-4, aerogel and mineral wool; R2. r. ref.: Roof reference measured on interior panelled ceiling.

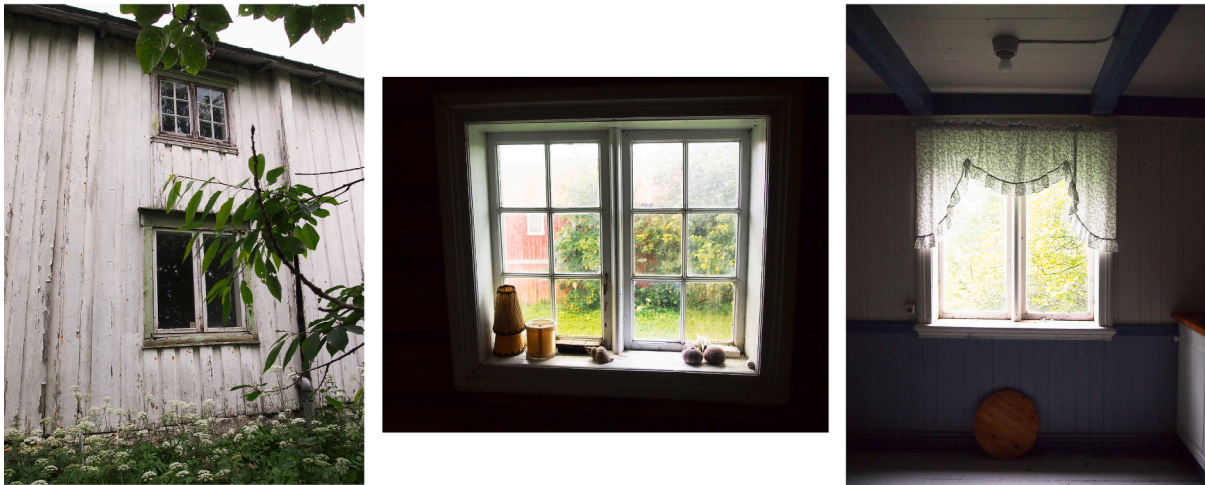
Fig. 6.12. The pictures show an old original slatted window on the first floor and a newer two-section window on ground floor of Trøa. Photos: [106].

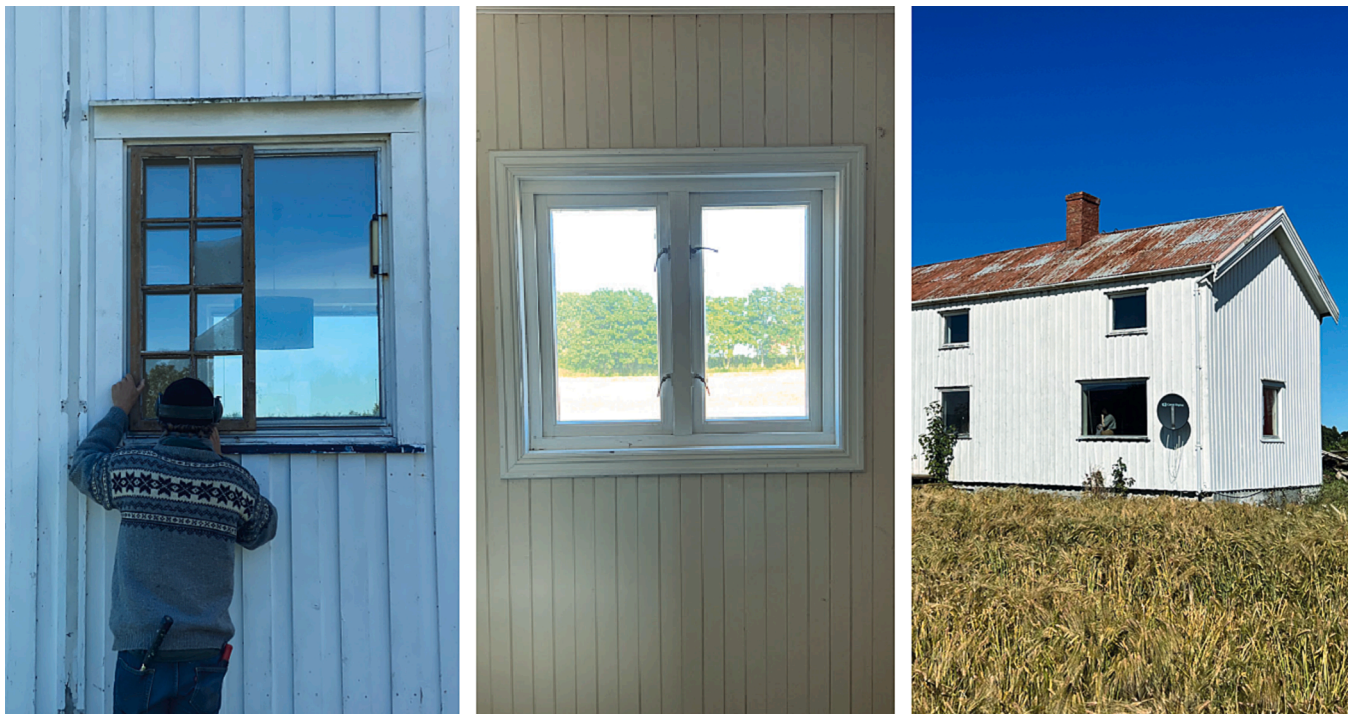
Fig. 6.13. Left: Old slatted window found at the farm held over an awning window of Grande. Middle: two-section casement window of Grande. Right: Awning windows on the southwest and southeast façades of Grande. Photos: [49].

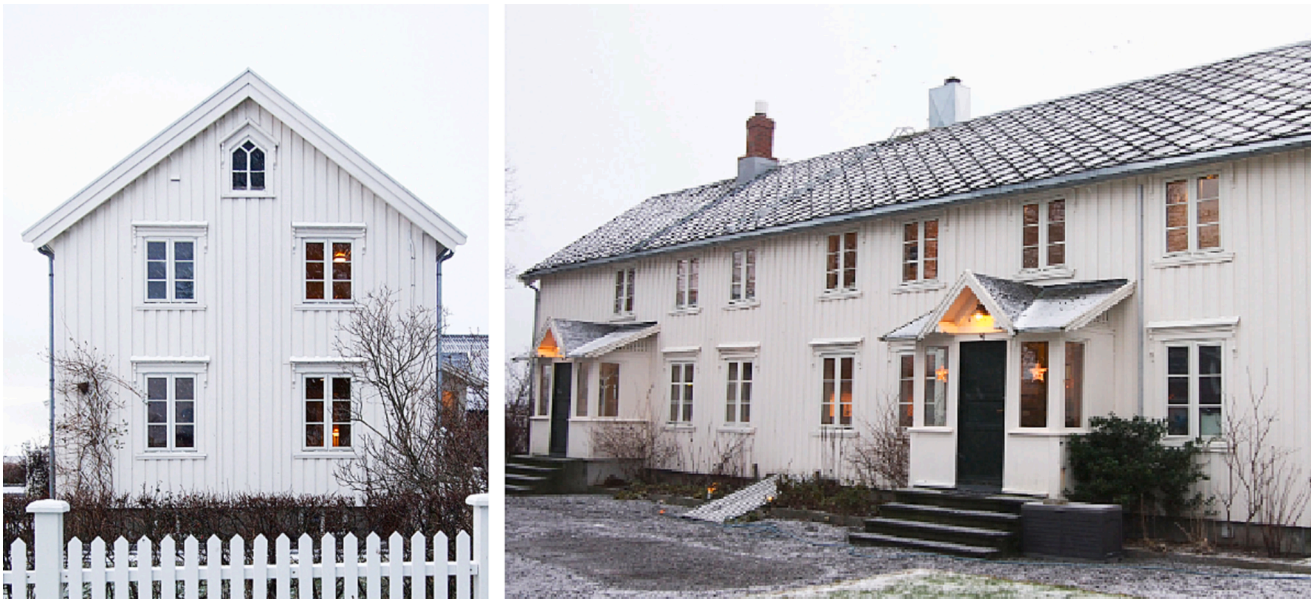
Fig. 6.14. The east (left) and north (right) façade of Viken depicting the current windows [107].

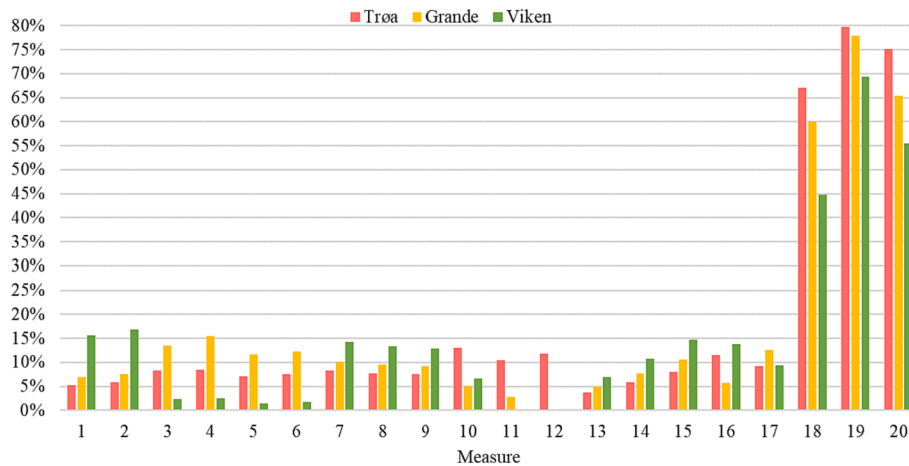
Fig. 6.15. Reduction in percentages of original net energy demand for all three buildings. Energy-saving measures and combinations of measures as given in Table 6.1.

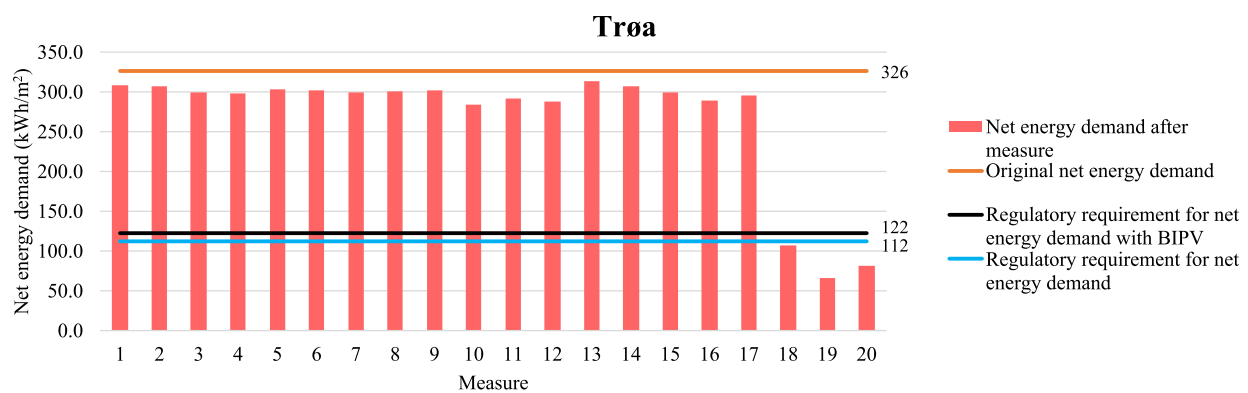
Fig. 6.16. Trøa's net energy demand after each individual measure and the combined measures, as well as original net energy demand and regulatory requirement for net energy demand with and without BIPV. Energy-saving measures and combinations of measures as given in Table 6.1.
