The challenge of rehabilitating relocated listed heritage Buildings: Requirements and opportunities

Malin Pedersen^{a,1}, Helga Margaretha Hognestad^{a,1}, Ronja Helle^{a,1,*}, Bjørn Petter Jelle^a

^a Norwegian University of Science and Technology (NTNU), Department of Civil and Environmental Engineering, NO-7491 Trondheim, Norway

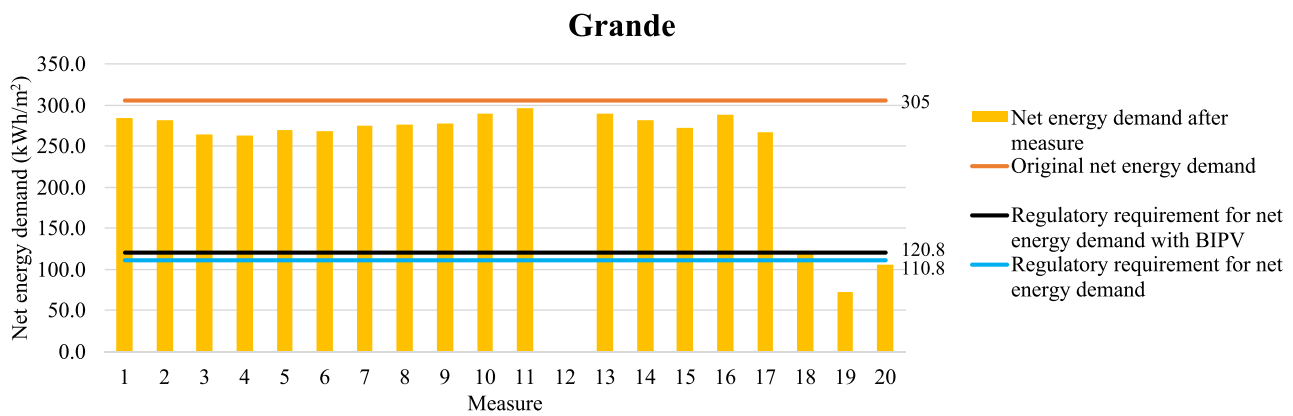
Fig. 6.17. Grande’s net energy demand after each individual measure and the combined measures, as well as original net energy Demand and regulatory requirement for net energy demand with and without BIPV. Energy-saving measures and combinations of measures as given in Table 6.1.

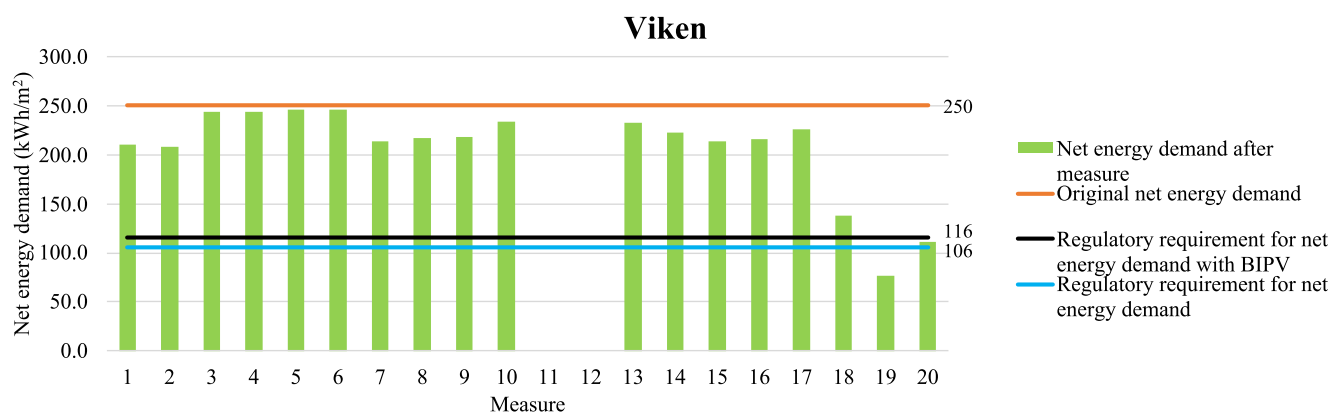
Fig. 6.18. Viken’s net energy demand after each individual measure and the combined measures, as well as original net energy demand and regulatory requirement for net energy demand with and without BIPV. Energy-saving measures and combinations of measures as given in Table 6.1.
