ADAPTIVE VENTILATION FOR OCCASIONALLY USED CHURCHES

P. Klenz Larsen¹, M. Wessberg¹, T. Broström¹

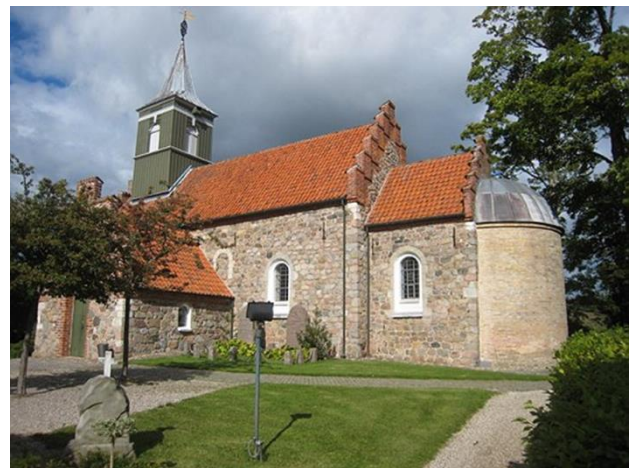
Figure 2 Exterior view of Nødebo Church from the south east. Solar heating of the interior through the small windows is too little to heat up the interior in summer.

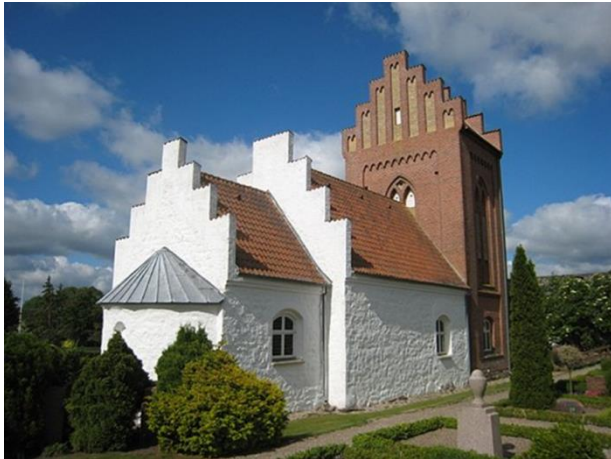
Figure 6 . Exterior view of Tyvelse Church from the northeast. The air supply to the nave and chancel was drawn from the attic to gain heat from the solar radiation to the tiled roof.

time, if the outside air was drier than inside. The fan had a damper which would be closed when the fan was not running. The air intake was through 12 small ducts in the lower part of the vaults. These openings remained open at all times. The advantage of taking the air from the attic was that there would be some preheating in the summer. On sunny days the temperature in the attic was higher than in the nave below due to the solar gain. It was assumed that warm air from the attic would raise the interior temperature in the nave slightly, and thereby lower the RH.

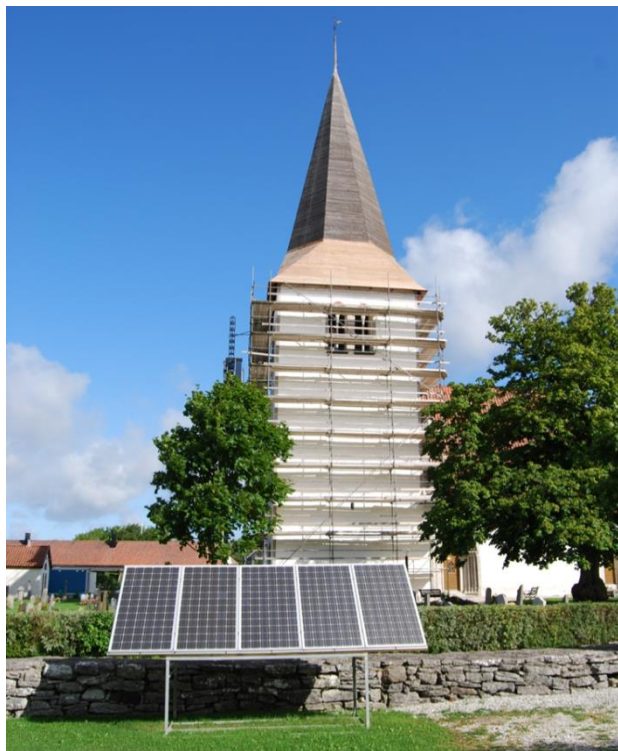
Figure 8 . Exterior view of Hangvar Church from the south. The photovoltaic elements for preheating the inlet air is located outside the churchyard fence.

In august 2012 adaptive ventilation was installed. A ventilation duct was installed from an opening in the tower staircase to the ventilator and then through a temporary tower door with an inlet valve. The exhaust air goes out through leaks in the building envelope, mostly windows and doors. Previous experiences have shown that there is a codependency between mixing ratio and temperature. Often when the outdoor air is dryer than the indoor air it is also cooler than the indoor air. Cool air is counterproductive when it comes to lowering the relative humidity. To prevent this type of ventilated driven cooling of the church, the adaptive ventilation system was fitted with a preheater drawing energy from solar photovoltaic panels placed just outside the churchyard fence.

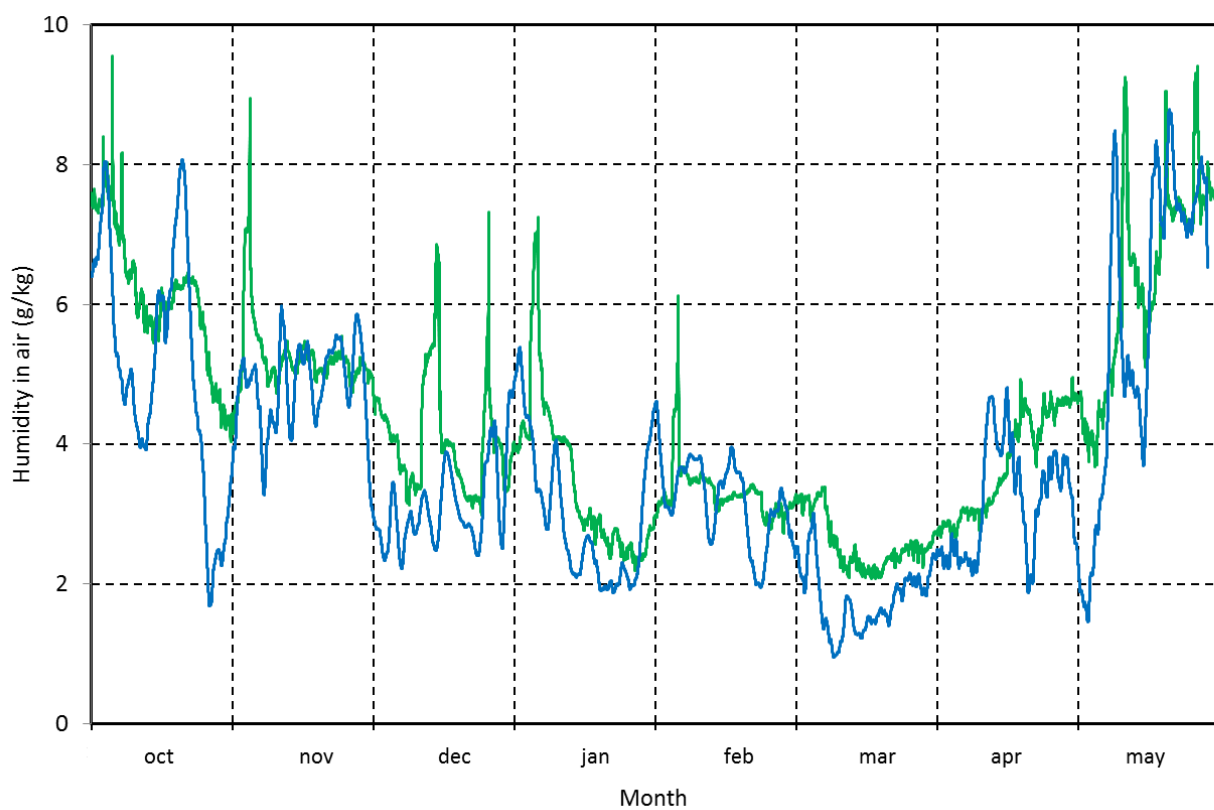
Figure 11 . The mixing ratio inside (green) and outside (blue) in Hangvar Church 2012/2013

The mixing ratio of the inside and outside air is shown in fig. 11. The inside humidity follows that outside most of the time, except for the heating episodes, where the inside air holds 2-3 g/kg more water vapour than the outside air. There is human activity only for a short while, so the increase in humidity is due to evaporation from the interior surfaces of the building and the furniture. The release of humidity is actually an advantage because it stabilizes the RH during the heating episodes. The drop in RH would be much larger if the interior of the church had less humidity buffer capacity. The surplus of moisture is soon removed by the ventilation, and the temperature gradually falls back to the starting point. These heating events illustrate the paradox of heat for humidity control, when the humidity buffer capacity of the building is large. The preheating of the intake air may have the same effect. Further studies will assess the effect of solar powered summer heating more in detail.
